**Stratigraphical Report  
O'Connell Street Sub-Station Excavation  
Dublin I**

Licence No. 02E1825

By  
Franc Myles with Peter Kerins  
Margaret Gowen & Co. Ltd.  
Job No. 99216-R10

For  
Railway Procurement Agency

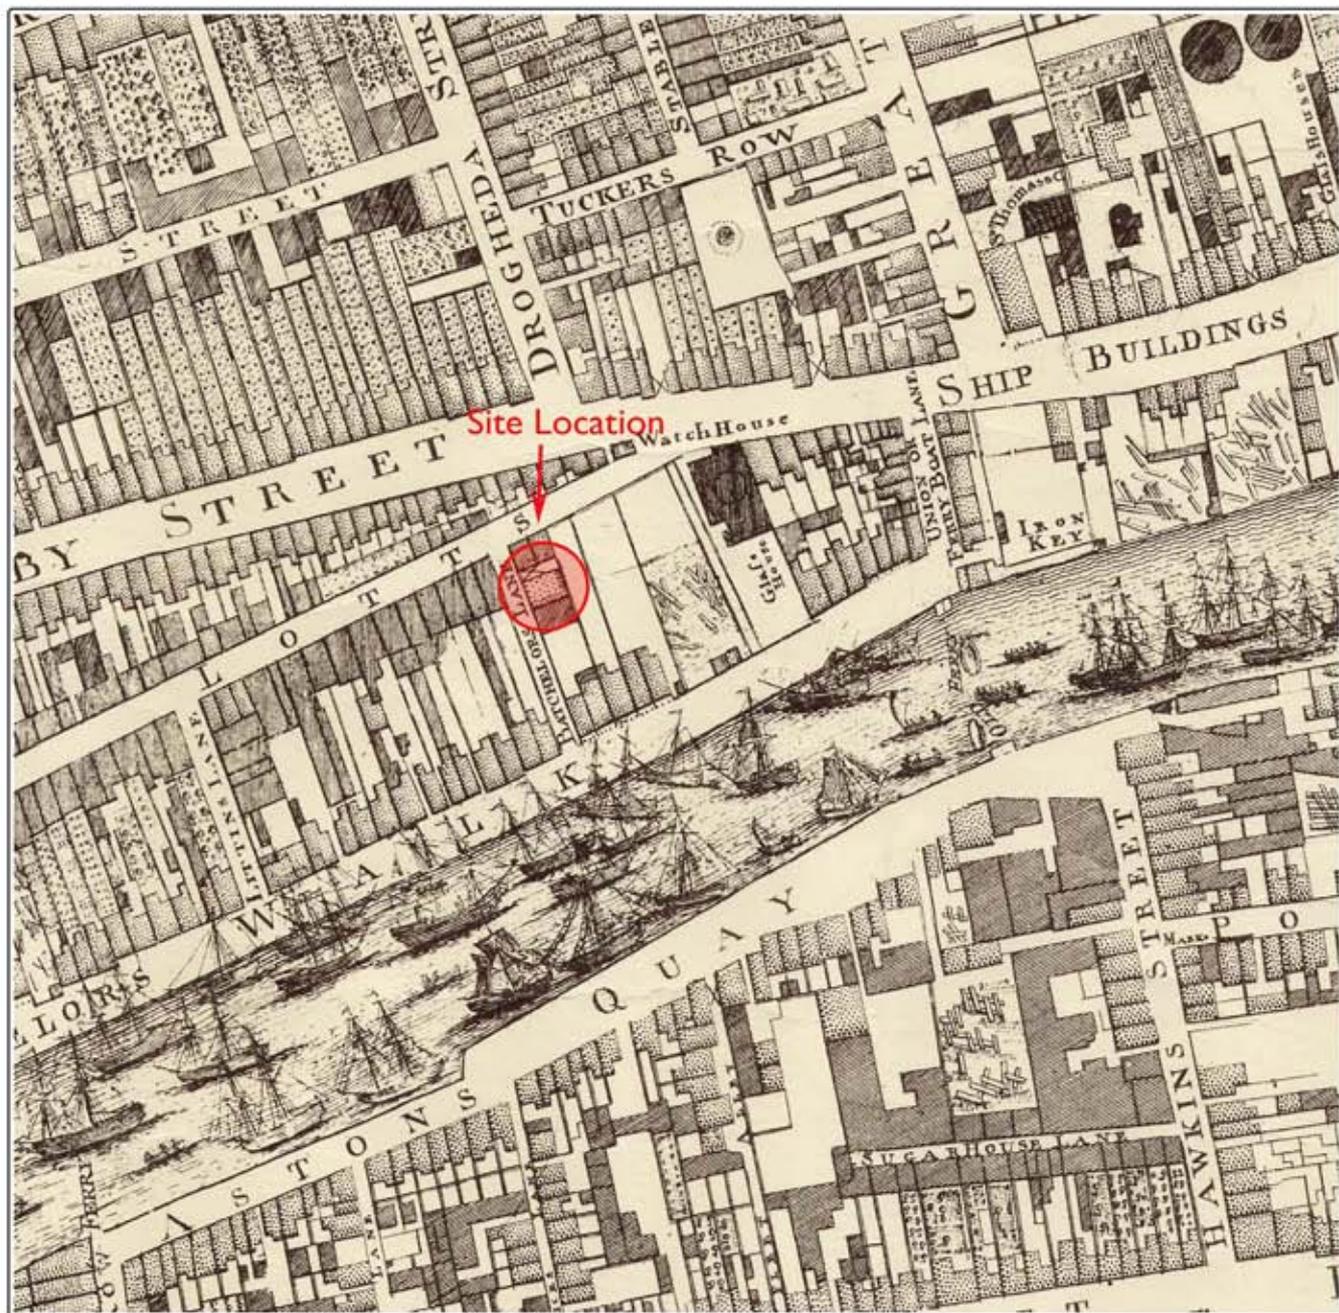
**Job** LRT, O'Connell Street,  
sub-station, Dublin 1  
**Ref.** 99216  
**Date** 29.04.05  
**Client** RPA  
**Scale** Not applicable  
**Fig. 4** Overlay of site on Rocque, 1756

- 3.2 Rocque's map of 1756 (Fig. 4) is the first map to show the individual plots and structures associated with them. It also shows a direct access through Bachelors Lane from the intersection of Drogheda Street, Abbey Street and the North Lotts to the quay at Bachelors Walk. The overlay of the excavation site onto Rocque's map depicts the probable location of the exposed structure in relation to the structures of 1756. The structure was located on the eastern side of Bachelors Lane and to the south of Lotts Lane. The second excavation on the site found the remains of what appeared to be a quay wall, approximately 15m north of the present structure with further structures to the north. When the wall went out of use it was deliberately buried under reclamation deposits. Lotts Lane appears to have been built over or close to the wall and respects its alignment. Rocque's map post-dates the quay wall and shows the present structure which was built on top of the reclamation deposits.

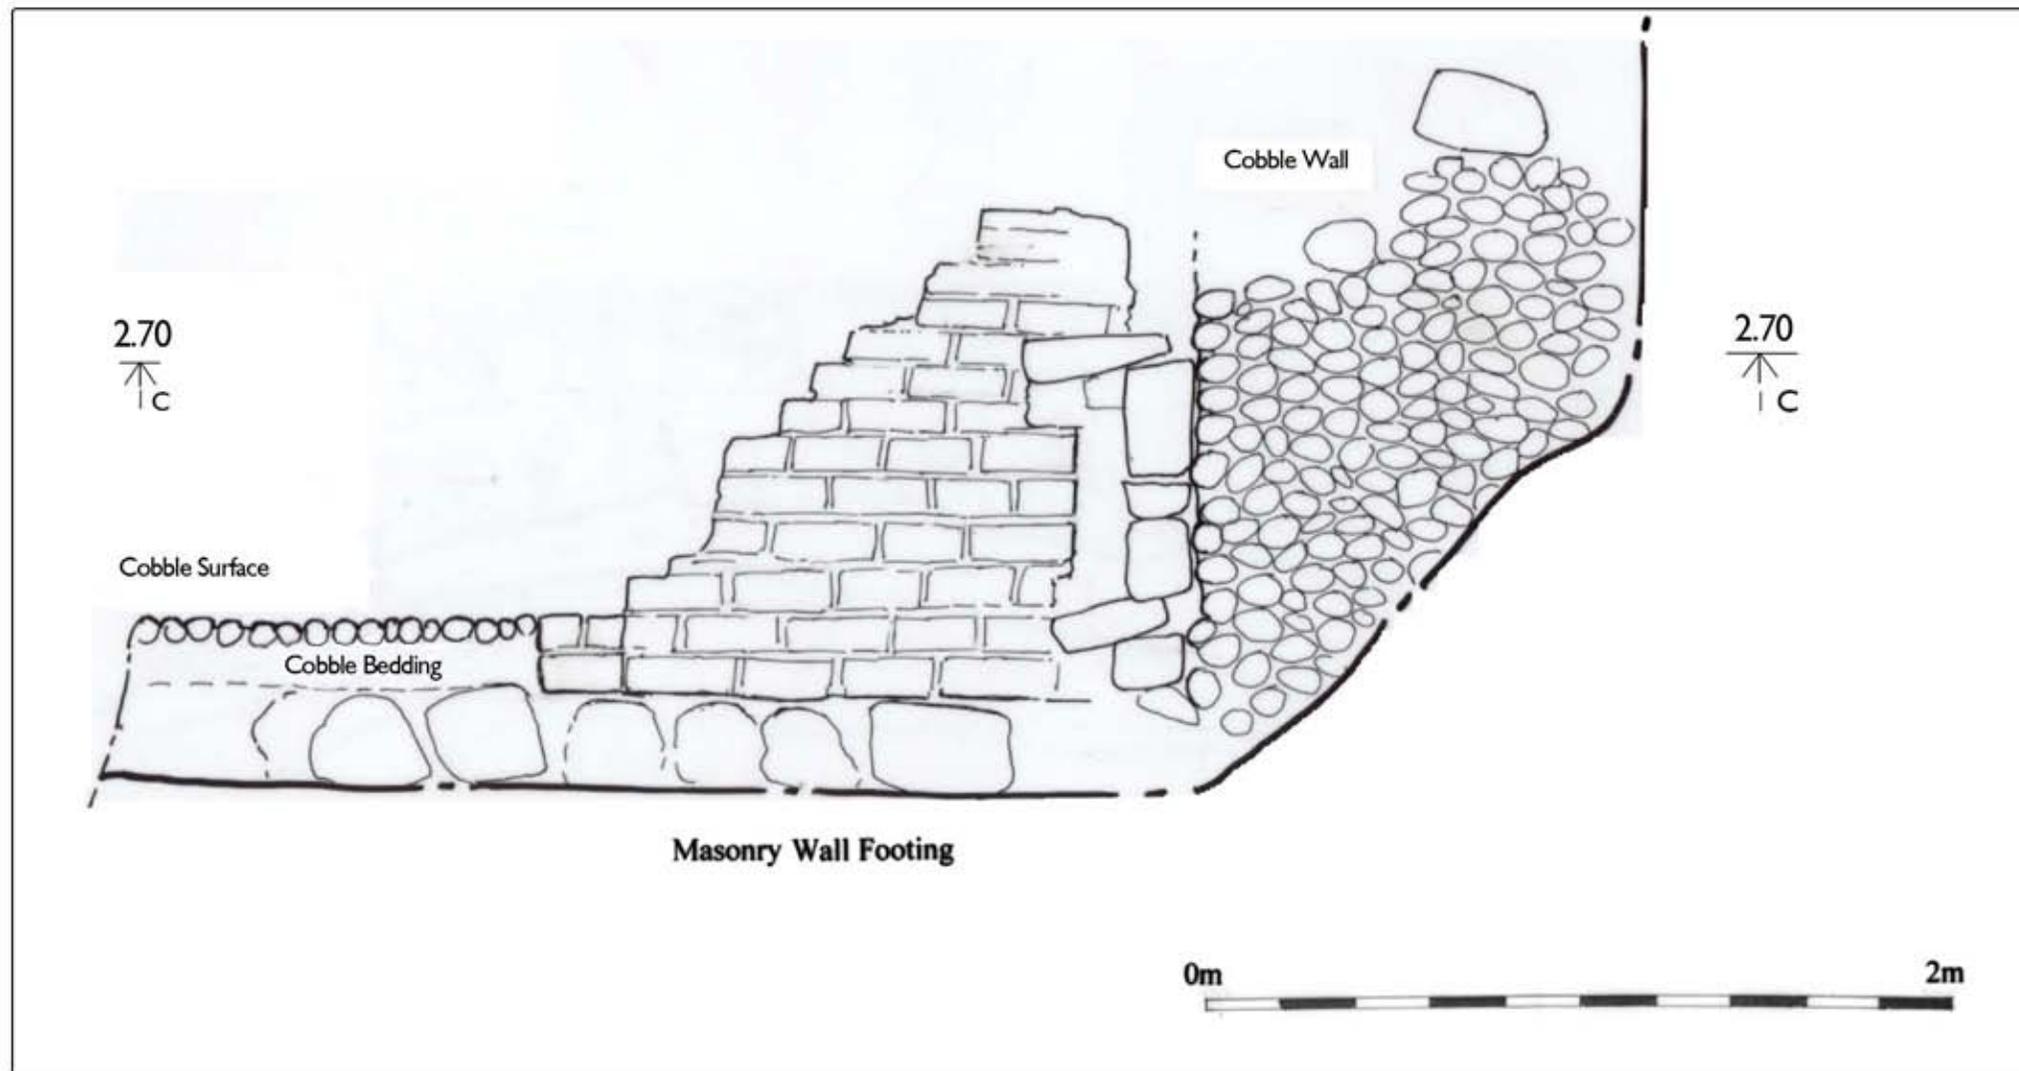
**Job** LRT, O'Connell Street,  
sub-station, Dublin 1  
**Ref.** 99216  
**Date** 03.05.05  
**Client** RPA  
**Scale** 1:20  
**Fig. 8** West-facing elevation

Line of ground level after removal of paving.

5.2.1 The cobble wall was only partially exposed and extended beyond the southern limits of excavation (Plate 2 and Fig. 8). Its visible remains measured 1.1m north-south in length by 1.5m in height. The width of the wall was not clearly established, as the overburden was not removed. Based on a single measurement close to the stop-end north wall it appeared to be 200mm in width.

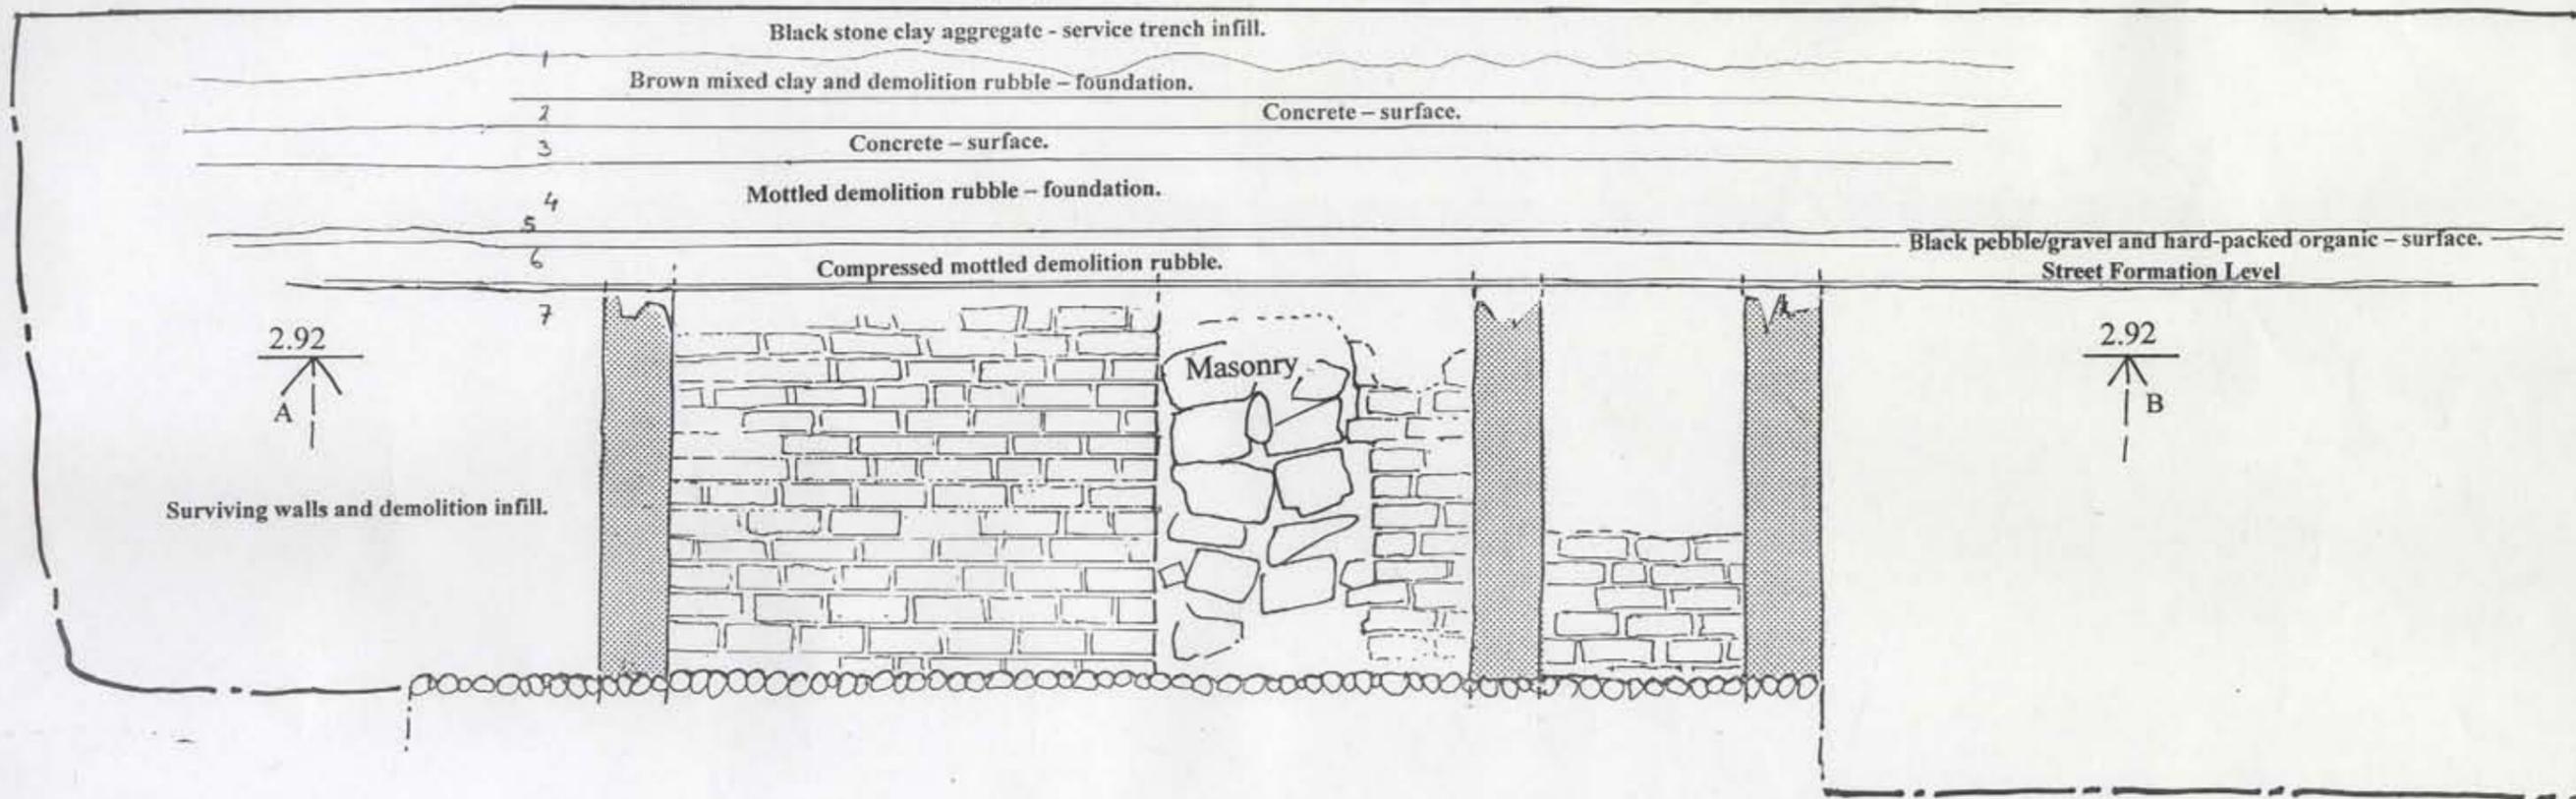
5.8.1 The general north facing section (Fig. 9) illustrates the general rise in ground level and the number of new surfaces laid out over time and up to the present day. Once the road widening began the upper levels of the buildings were demolished down to c.1.3m above old foundation level and the area infilled with rubble. More infill material was also brought in to raise the ground by 1.5m to the new street level for Sackville Street. The tip lines of the introduced infill can be seen in the photographs of the east and west sections on either side of the buildings

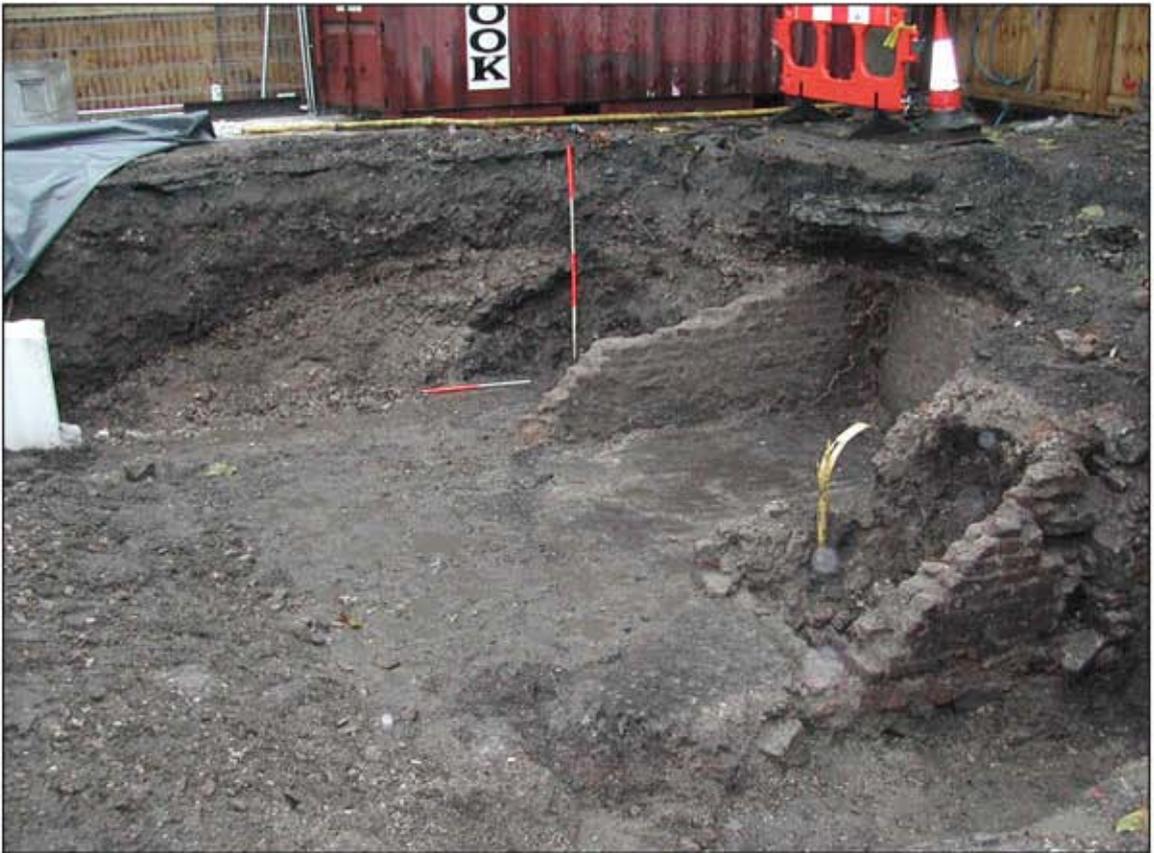
Plate 1 Exposed walls from northwest

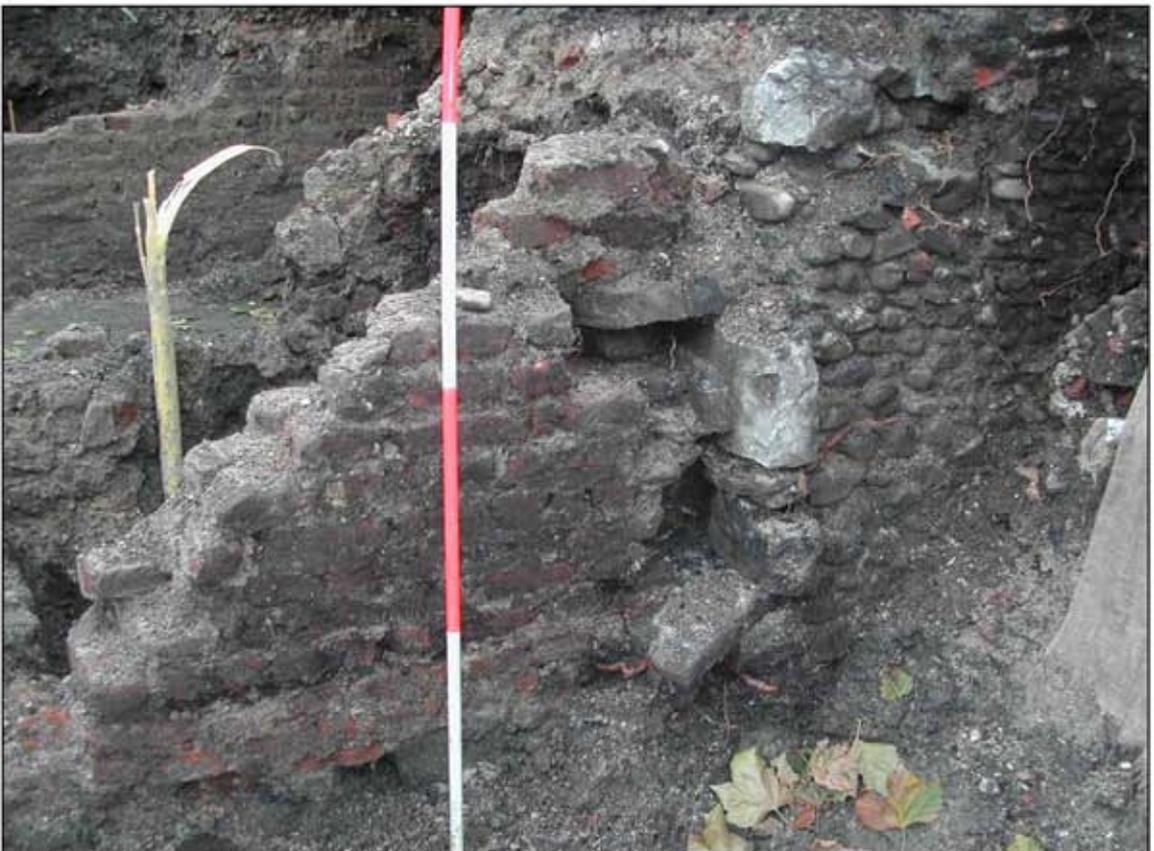
Plate 2 Cobble wall (right) at its junction with the brick latrine wall. Note protruding intermediary masonry blocks

5.2.4 As can be seen in Plate 2 the masonry wall was tied in to the back wall of a brick-built latrine. A 100mm gap between the two walls was filled with black organic-rich soil, containing broken pottery; bone and other domestic refuse material.

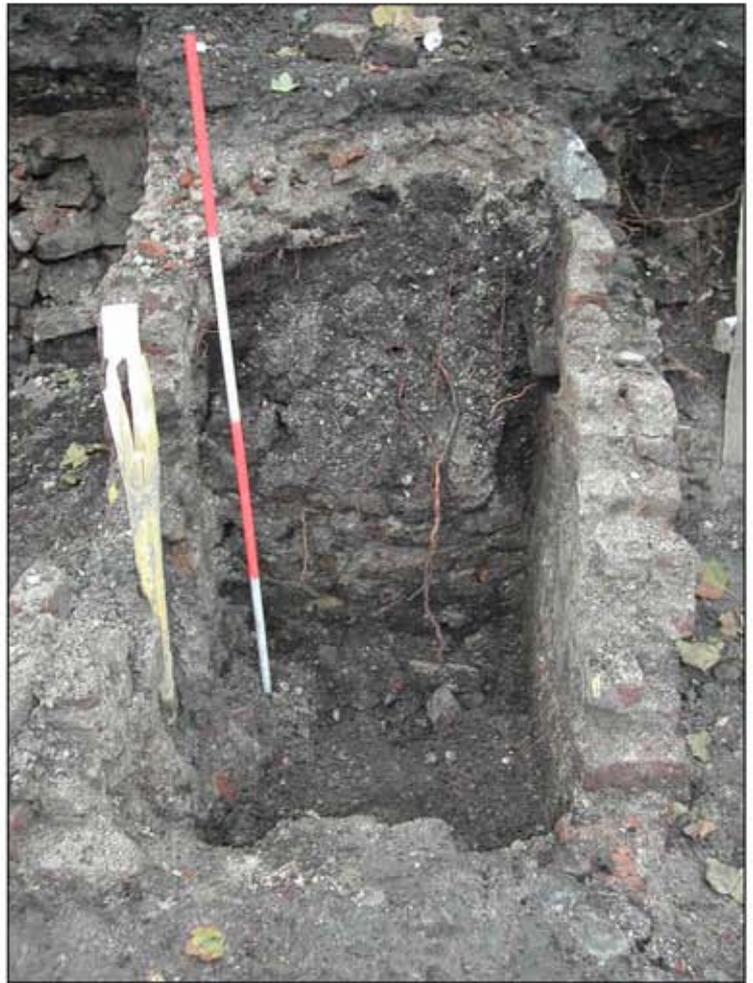
Plate 3 Elevation and section (north facing) of latrine

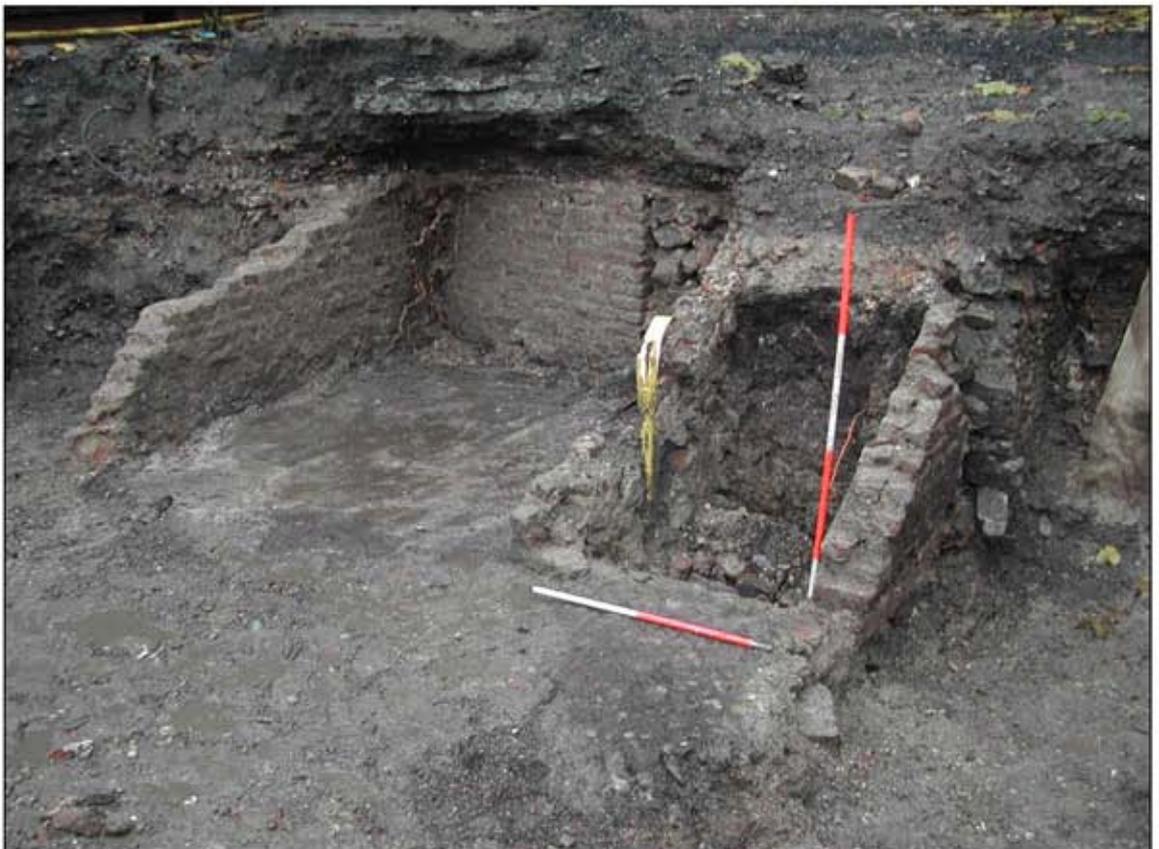
Plate 4 Latrine in the context of other structures

- 5.3.1 A quadrilateral out-building, used as a latrine, was constructed at the same time as the cobble wall or as part of later renovations/additions (Plates 4 and 5). The east wall of the out-building was obviously part of a more extensive structure as it extended further south and beyond the limits of excavation. It was 3m in length, 250mm in width and survived to a height of 1.3m.

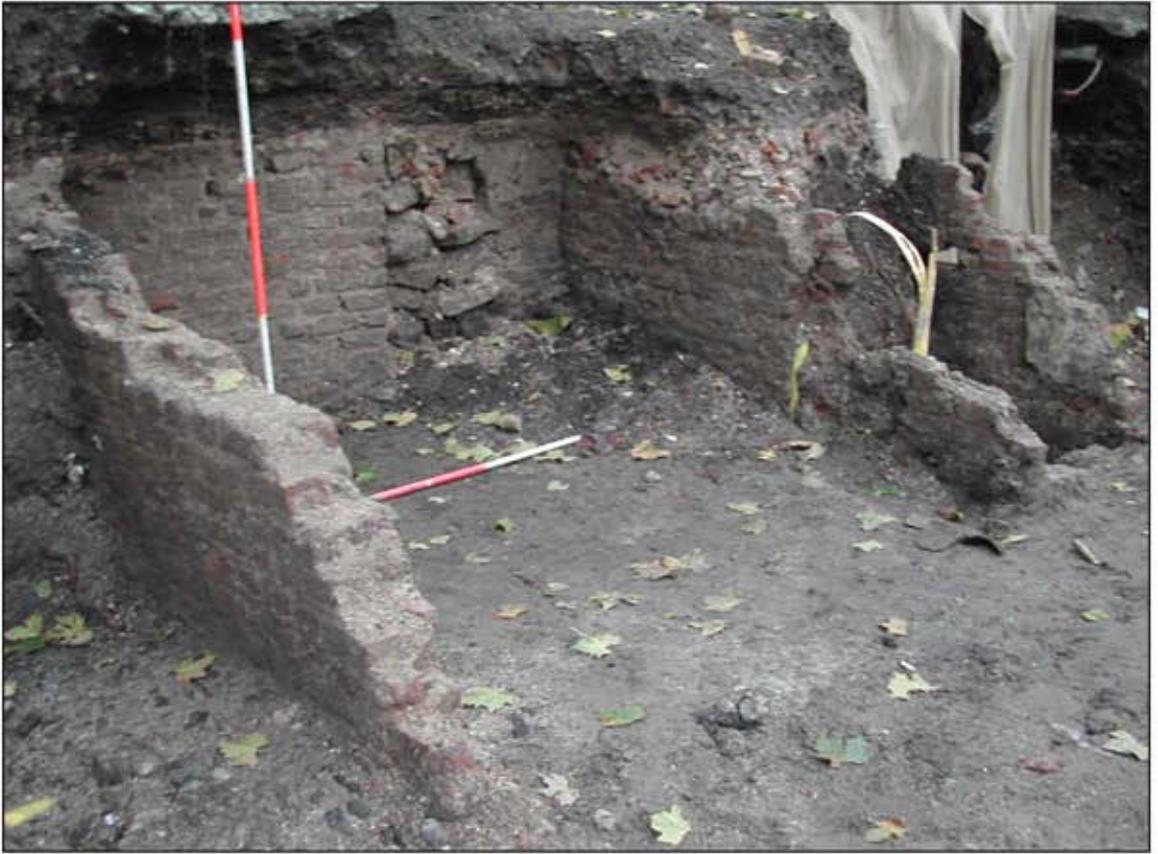
Plate 5 Eastern brick walls from the northeast

5.5.1 The eastern walls were built in a single phase of construction and helped to enclose a cobbled space or yard (Plate 5). Whether the back, east-west, wall was also part of a building to the south was not established as this area lay outside the limits of excavation.

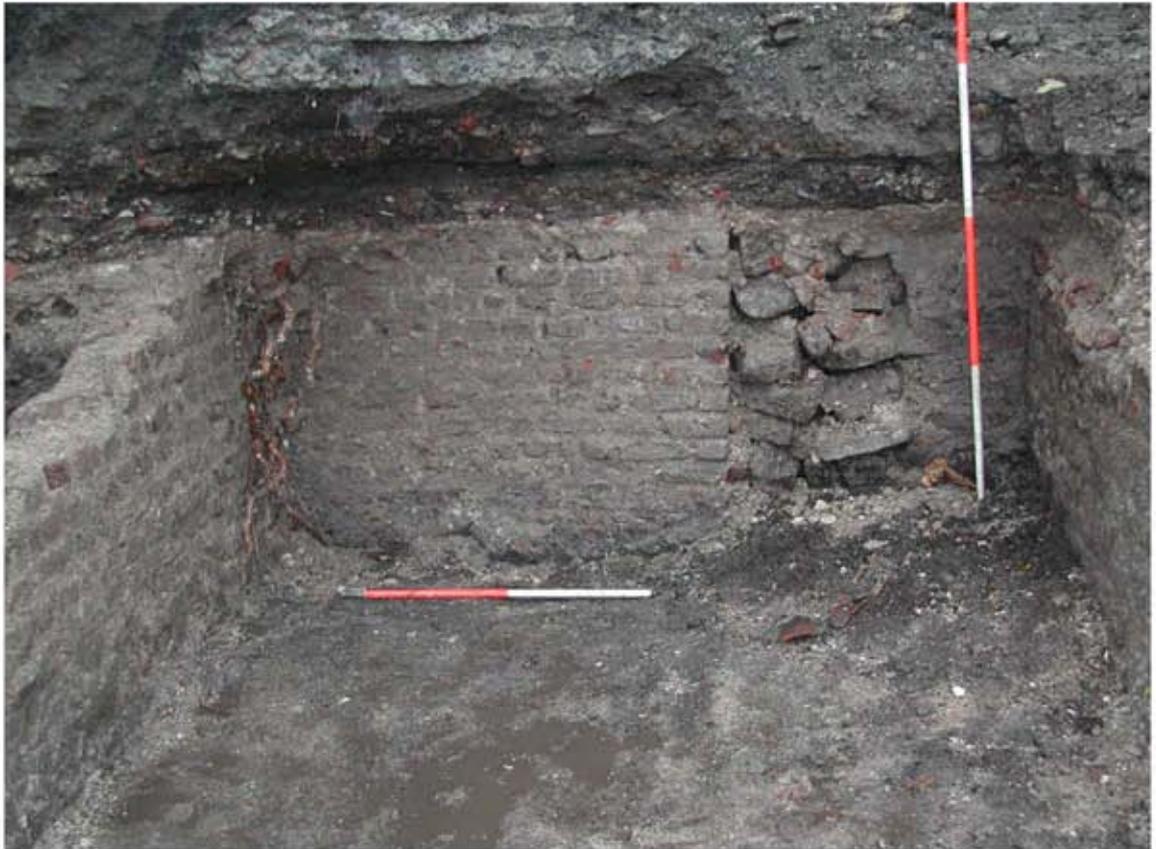
Plate 6 Space enclosed by brick walls. Note blockage in rough masonry

5.5.5 The opening between the eastern and western wall was infilled with large masonry blocks (Plate 6). The two wall sections were not in a true alignment and the eastern wall projected out in a more southerly direction.

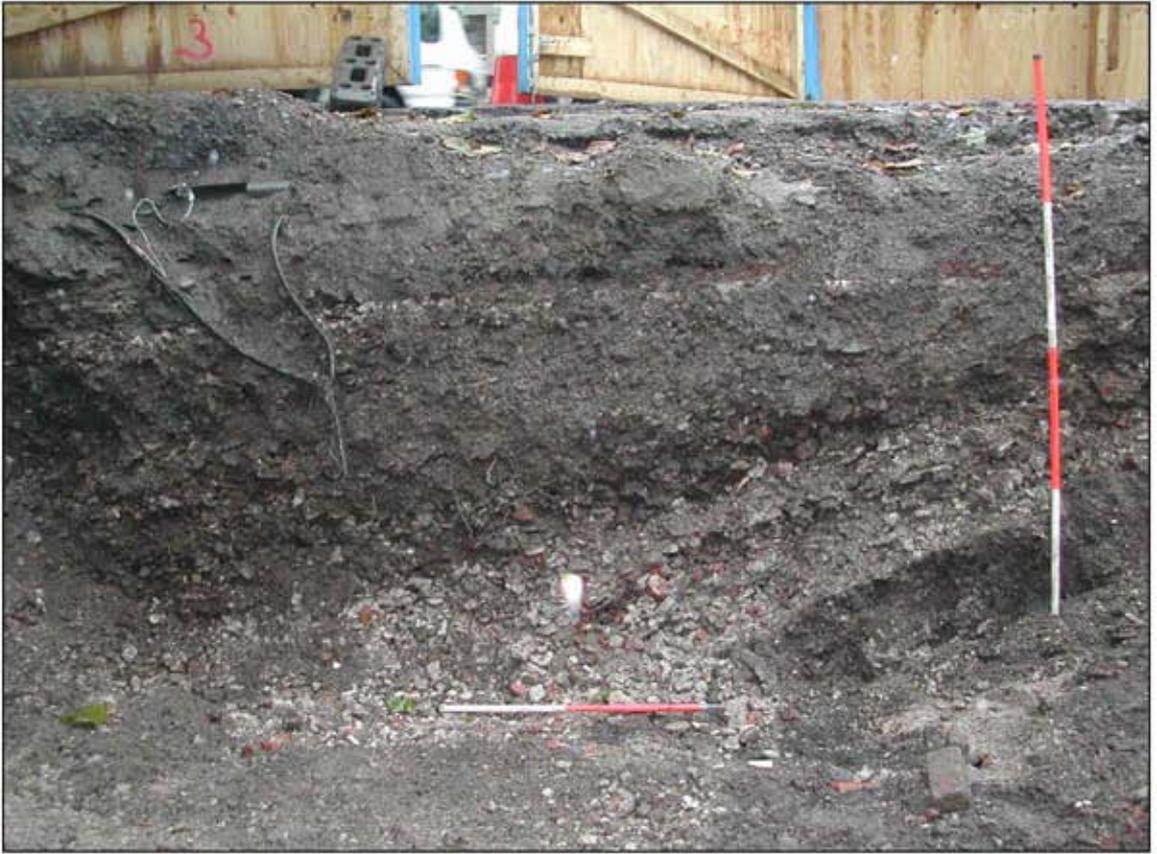
Plate 7 Tip lines in west-facing section

- 5.6.4 The northern and western side of the cobbled surface was heavily truncated, isolating the site from the area of the second excavation to the north. The tip line illustrating the rubble infill of this truncation can be seen in the section on Plate 7.
