**LUAS B1 Sandyford to Cherrywood  
Extension**

**Archaeological Test Excavation**

**Brenanstown**

**Site 3A and 3B**

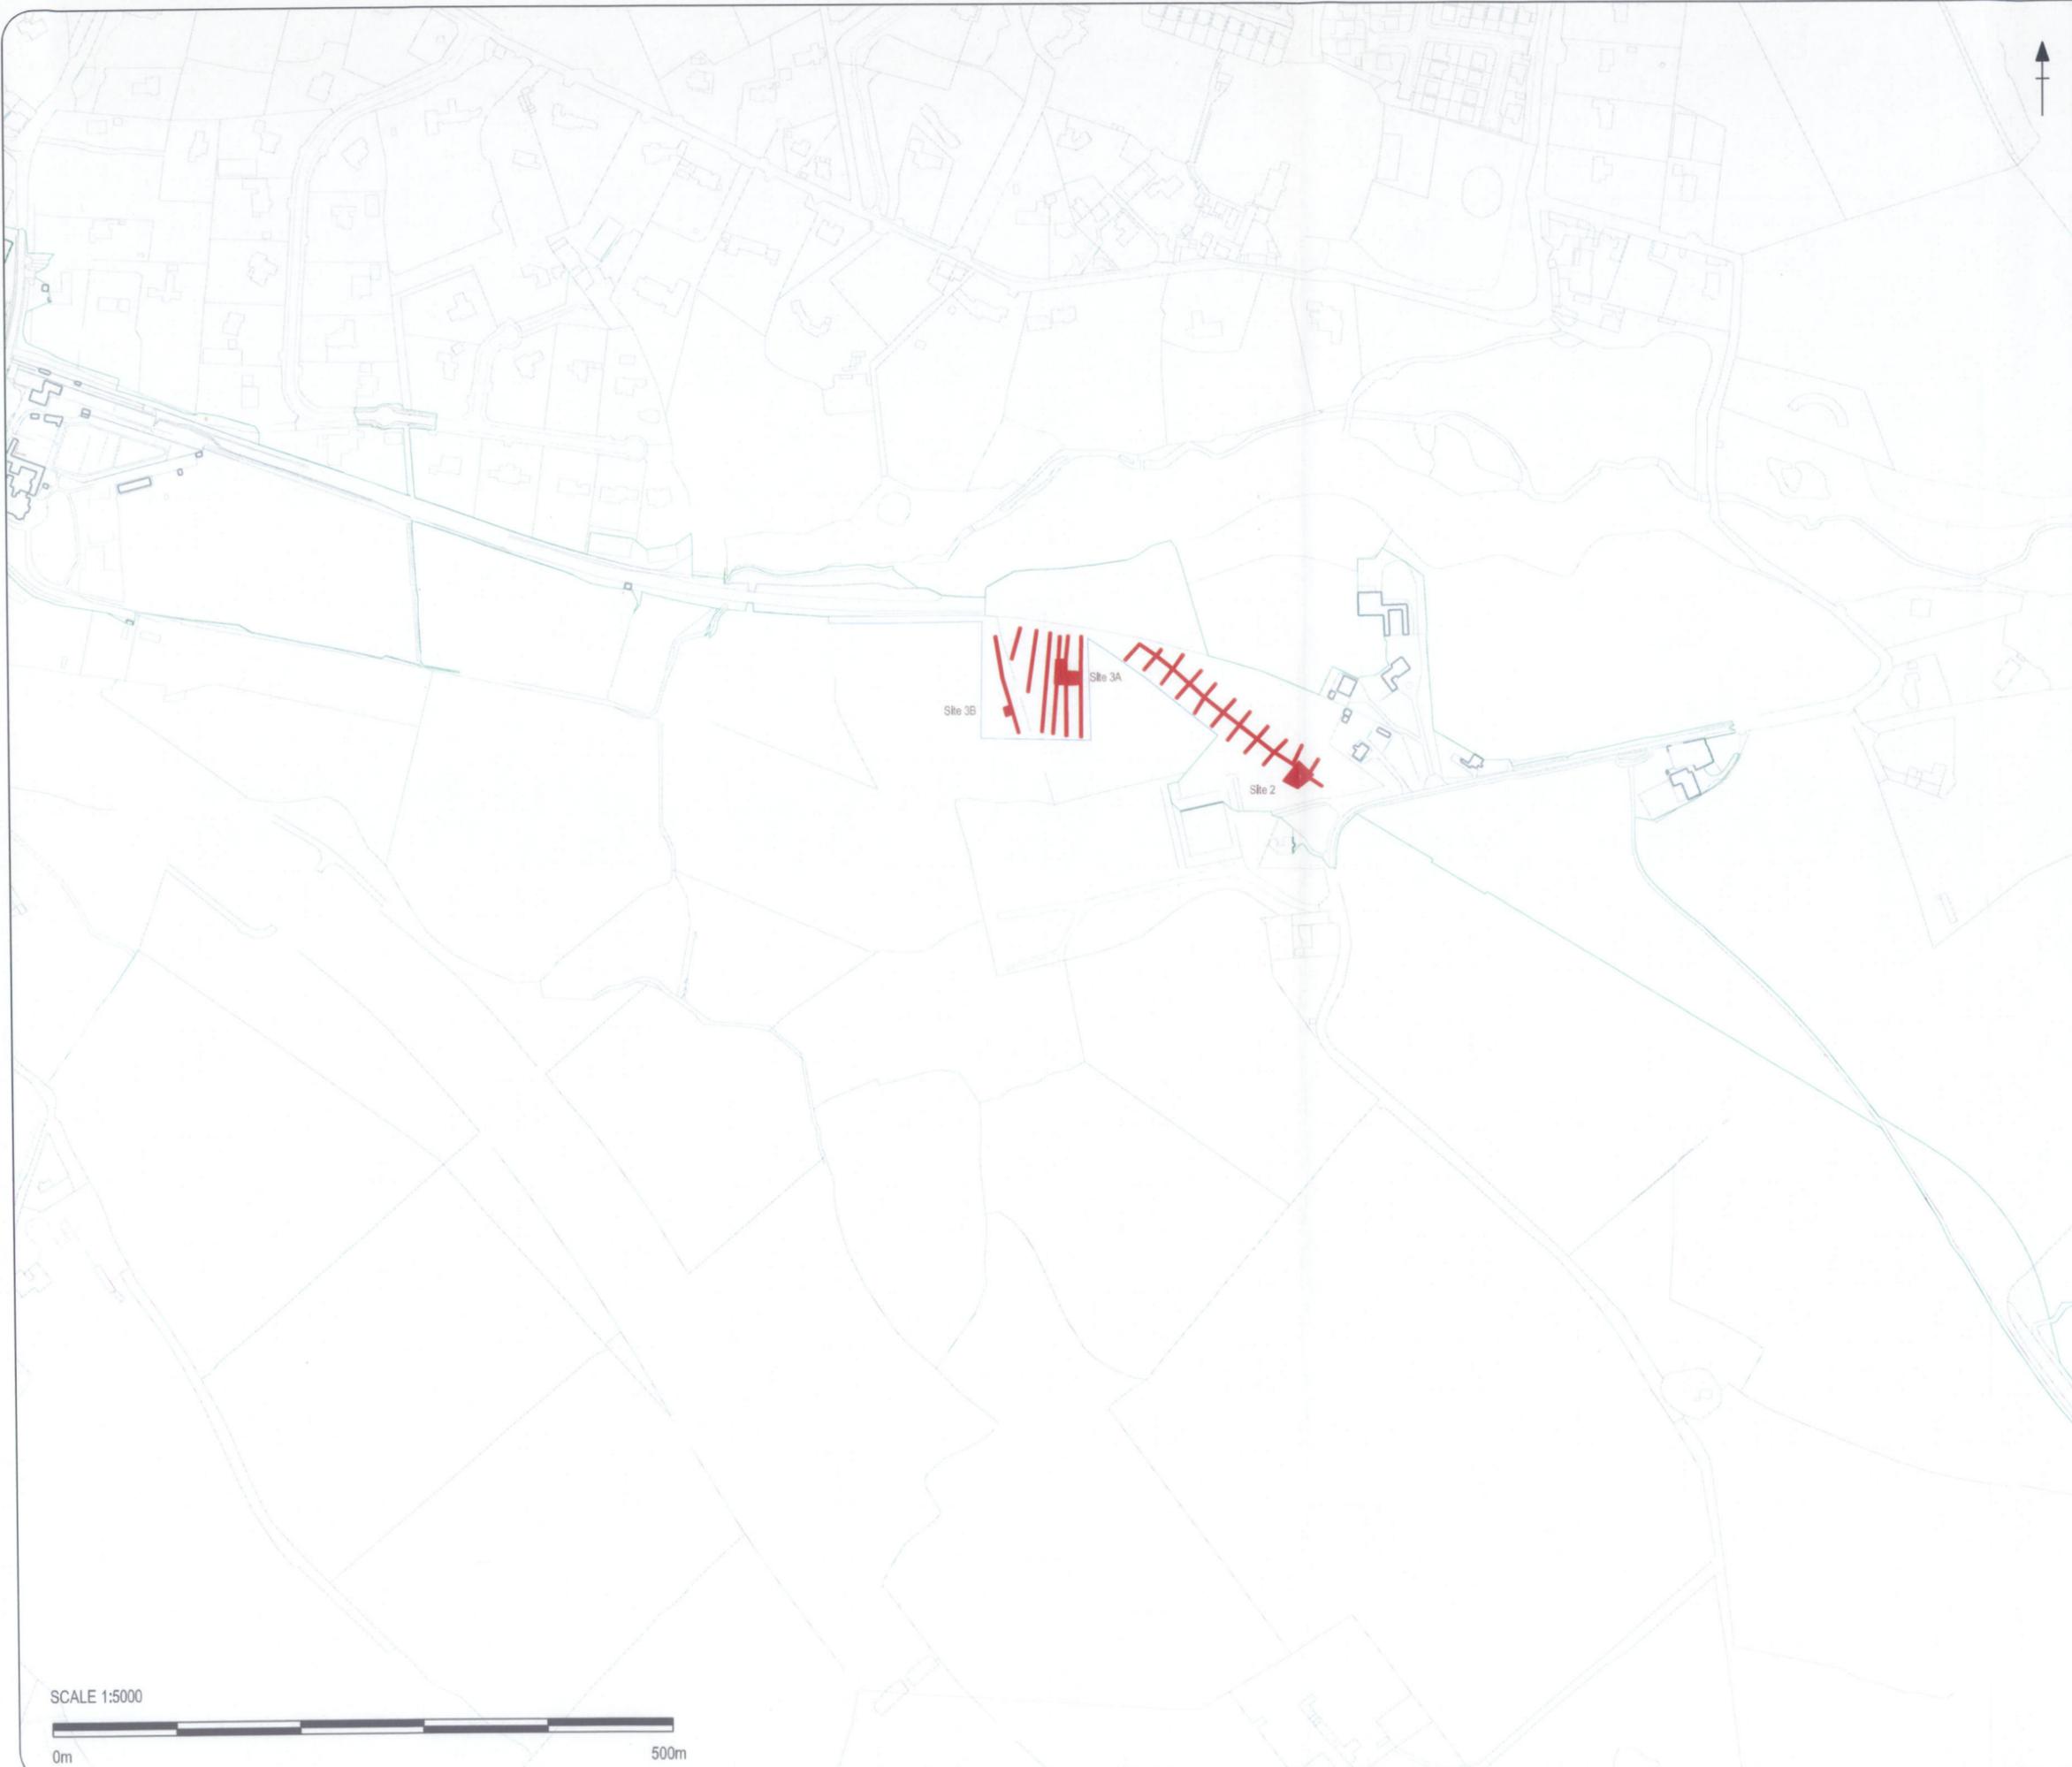
Figure No: 1	Client: RPA
Title: Site Location	Drawn By: AJ
Job No: 679 Brenan.	Date: 21/06/06

Figure 1: Site Location LUAS B1 Line: Brennanstown, location of site 3A and 3B.

Sites 3A and 3B are located in the townland of Brenanstown, c. 250m to the south of Brenanstown Road, Co. Dublin, in the civil parish of Tully and the Barony of Rathdown, (Site 3A NGR 322885E, 223968N; Site 3B NGR 322835E, 223932N; See Figure 1). The route of the proposed development extends proximate to two sites listed in the Record of Monuments and places: a Portal Tomb c. 75-150m to the northeast of this section of the line (DU026:007: located to the north of a small stream), a mill site c. 300m to the west (DU026:0080) and an enclosure (DU026:006) to the south.

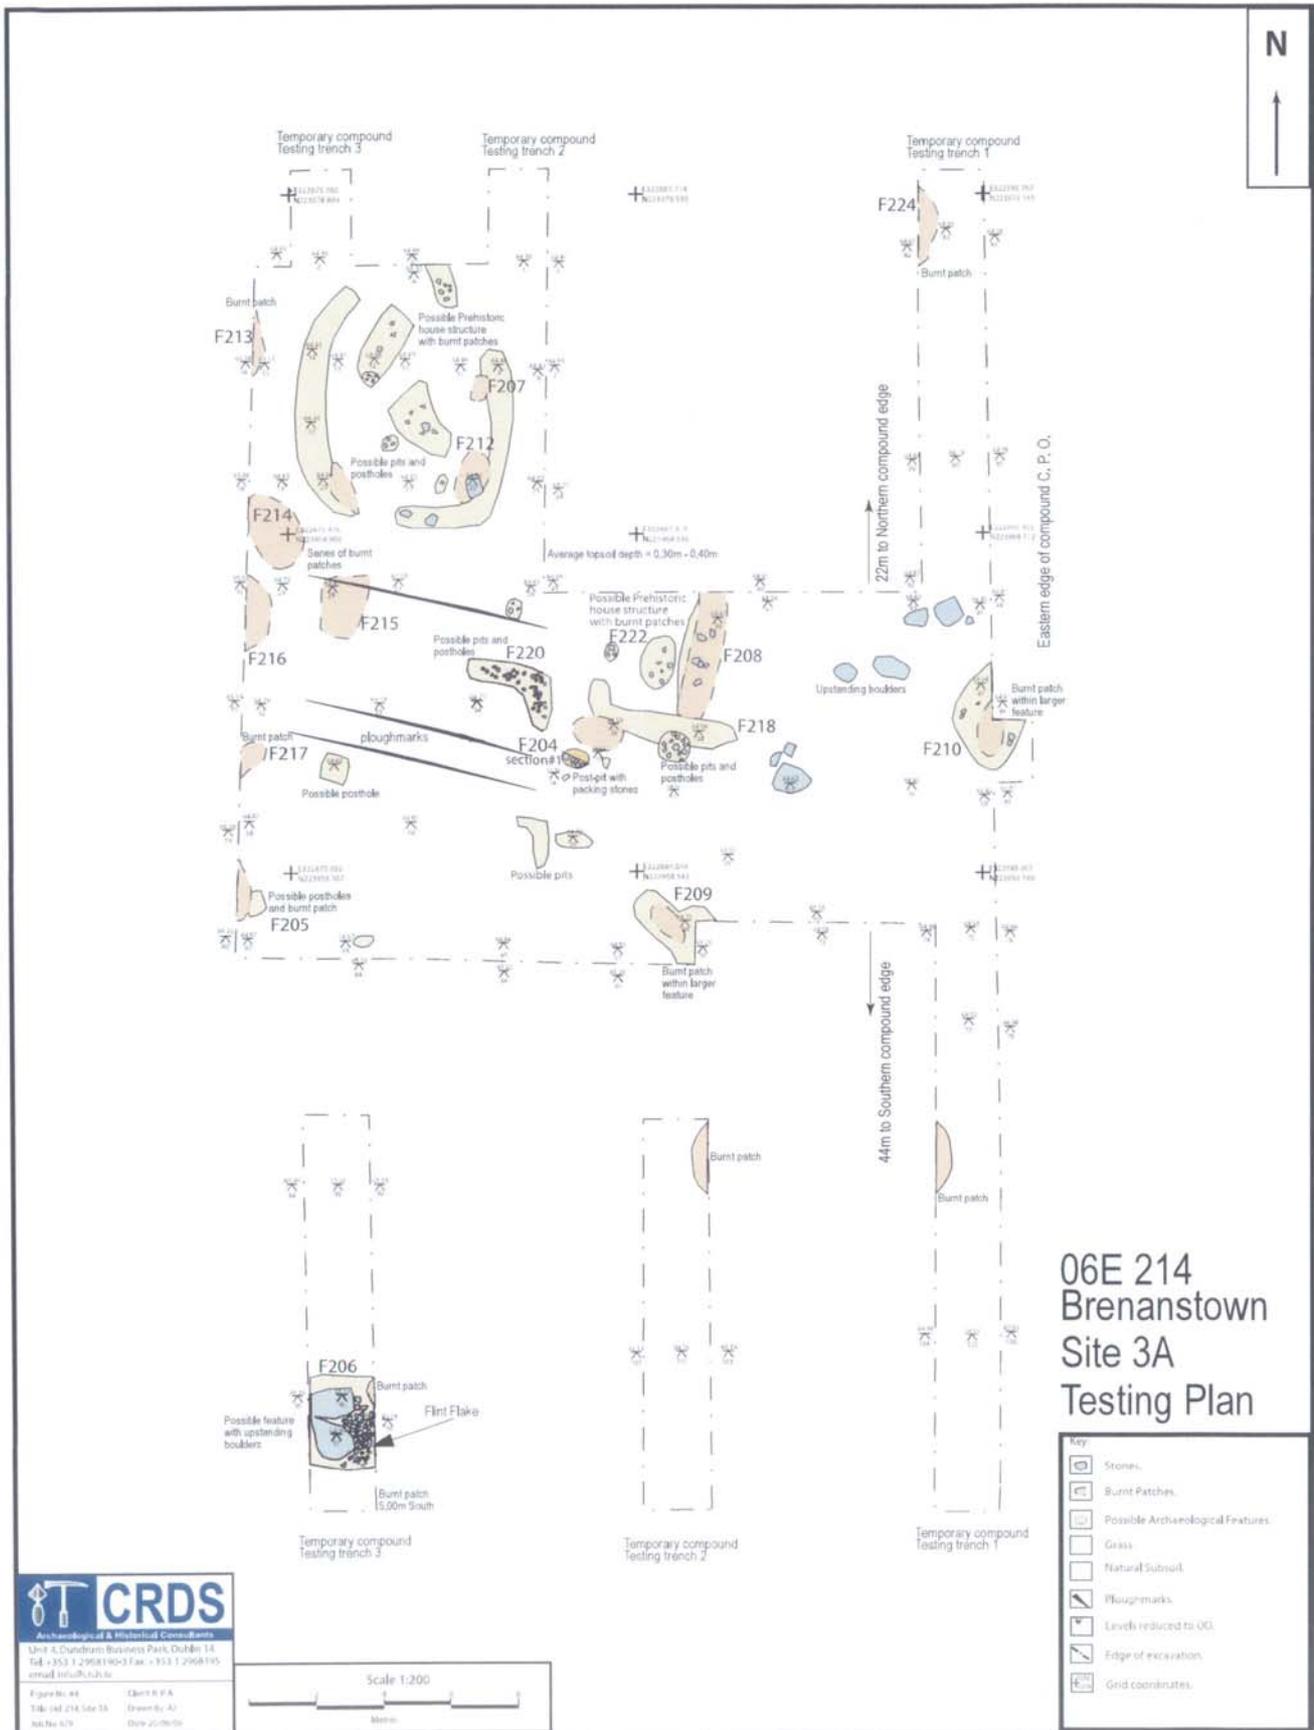
Figure 4: 06E214, Brenanstown, Site 3A, Testing plan.

An (L) shaped area was opened up, roughly 22m by 20m, to expose possible archaeological features noticed in the test trenches (figure 4). Many possible features were noticed along with associated in-situ burnt patches. One feature was sectioned in half, and was a fairly convincing small possible post pit with packing stones. There also appeared to be possible slot trenches, post holes, pits and associated burnt patches. This may be a small part of a much larger site not fully exposed yet. No datable evidence was retrieved but the feature types suggest that this site would be possibly Prehistoric in date. The possibility of unexposed archaeological remains is very high.

This site was located in the proposed area of the temporary compound just at the top of a small flat topped hill of undisturbed pasture. An (L) shaped area was opened up, roughly 22m by 20m, to expose possible archaeological features noticed in the test trenches. Many possible features were noticed along with associated in-situ burnt patches. As the area exposed was quite large, no attempt was made to hand clean all the features. A few selected small areas were cleaned thoroughly and only one feature was sectioned in half, a small possible post pit (F204) length 0.75m, width 0.50m and depth 0.35m+ with convincing packing stones within the fill. In the main area there appeared to be a couple of possible house type structures with possible slot trenches, post holes, pits and associated burnt patches. This may be a small part of a much larger possible settlement site not fully exposed yet. Possible pit (F220), possible pit (F222), burnt patch (F208), possible slot trench (F218) and possible posthole (F204) seemed to be part of one possible structure. The other possible structure seemed to be located around burnt patches (F207), (F212) and (F213). No secure datable evidence was retrieved and only one feature was tested but the generally ephemeral feature types suggest that this site could be Prehistoric in date. In the third test trench opened to the South of the main site an upstanding boulder, (F206) length 2.40m and width 2.00m, was found surrounded by much smaller cobbles, could possibly be a boulder burial. While cleaning around the cobbles in this feature a small flint flake was found, perhaps suggesting a Prehistoric date. Overall this area appears to be rich in archaeology of a possible Prehistoric date. The possibility of unexposed archaeological remains is very high.

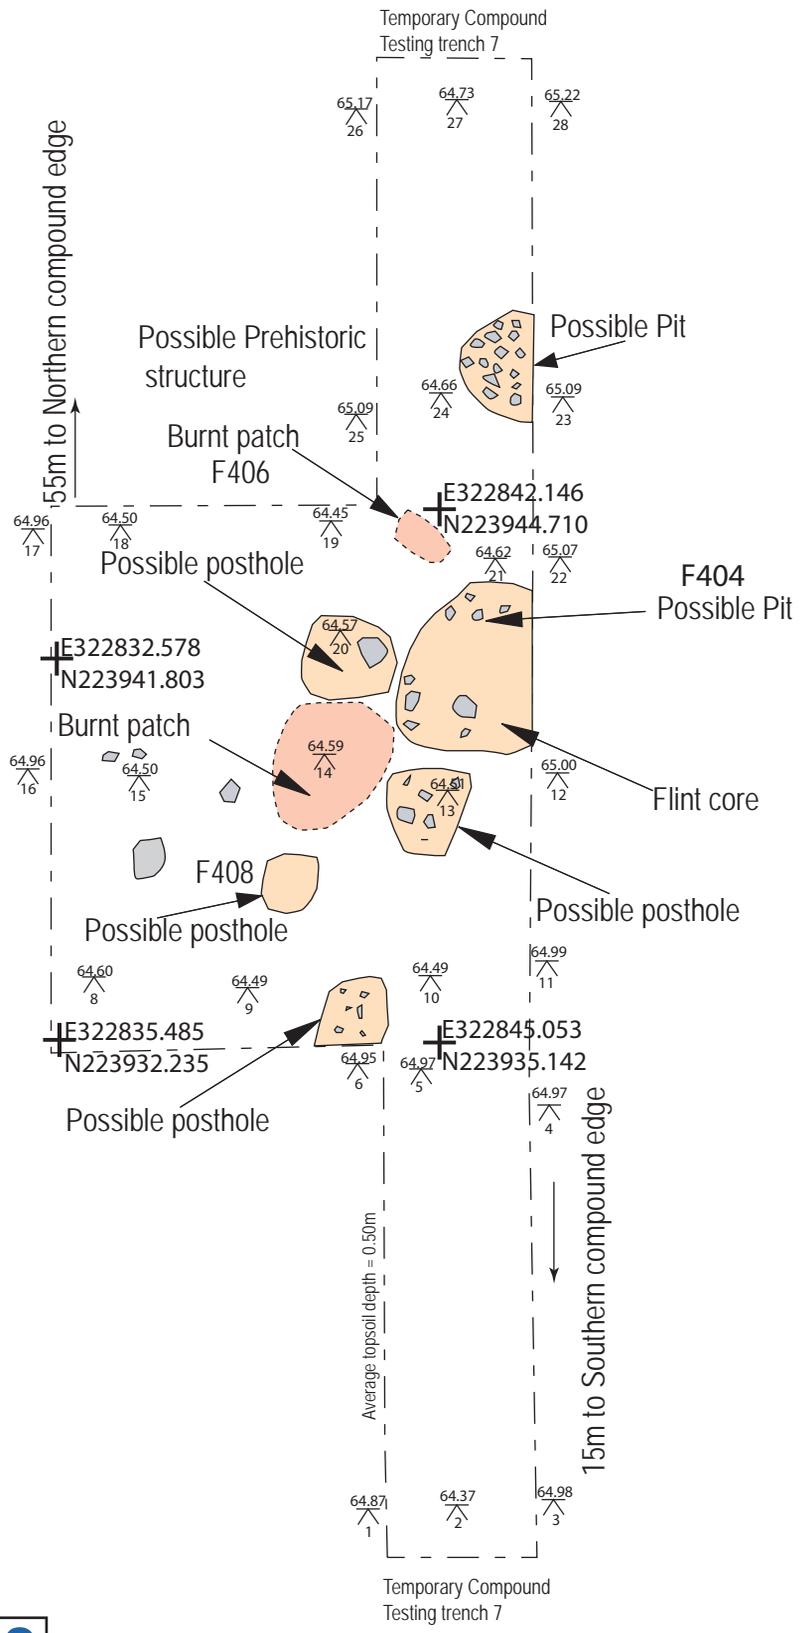
06E 214  
Brenanstown  
Site 3B  
Testing Plan

Figure 5: 06E 214 Brenanstown, Site 3B, Testing Plan.

An area of 6m by 7m was opened up to investigate a burnt patch which showed up in the test trench, (figure 5). There seemed to be possible pit or posthole type features surrounding the burnt patch. This represents similar remains to those uncovered in the previous site. A small flint core was uncovered while cleaning back one of the features suggesting a possible Prehistoric date. It would appear that this is part of the same archaeological complex of features of Site 3A. The possibility of unexposed archaeological remains is very high.

This site was located in the proposed area of the temporary compound just at the top of a small flat topped hill in the second field of undisturbed pasture. This much smaller site is around 30m to the West of site 3A and seemed to contain much the same type of features. An area of 6m by 7m was opened up to investigate a burnt patch which showed up in the seventh test trench. There seemed to be possible pit or posthole type features surrounding the burnt patch. This could represent another possible structure similar to those uncovered in the previous site. A small flint core was uncovered while cleaning back a possible pit, (F404) length 2.20m and width 1.65m suggesting a possible Prehistoric date. No features were tested on this site and only a clean back of the general area was attempted around possible posthole (F408), possible pit (F404) and burnt patch (F406). It would appear that this could be part of the same archaeological complex of features as site 3A. The possibility of unexposed archaeological remains is very high.

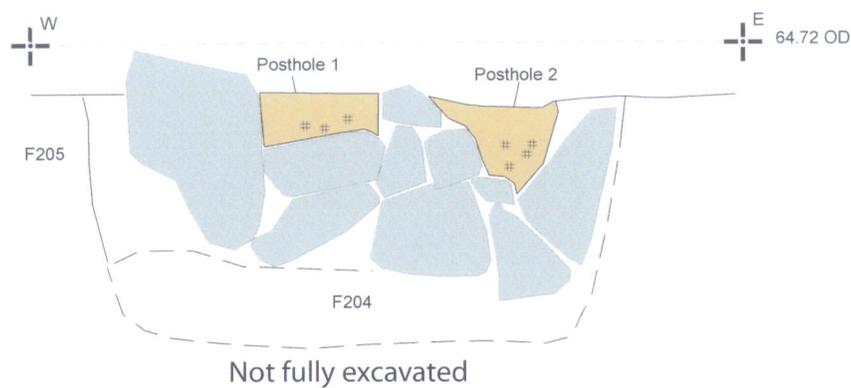
06E0214  
 Brenanstown Site 3A  
 Section of F205  
 Possible posthole pit  
 with packing stones.

Figure 6 : South facing section of pit F205, Site 3A, with two possible postholes and packing stones.

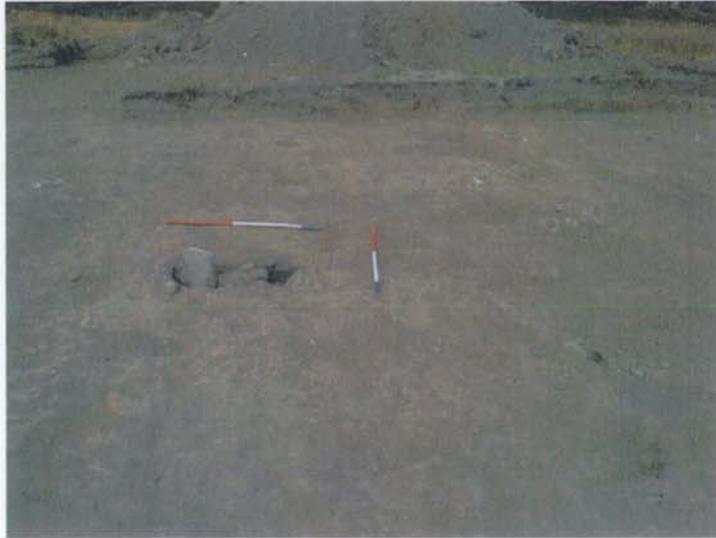
Plate: 1 06 E 214, Brenanstown, Site 3A, F204, Large post-pit with packing stones and charcoal lumps, facing North.

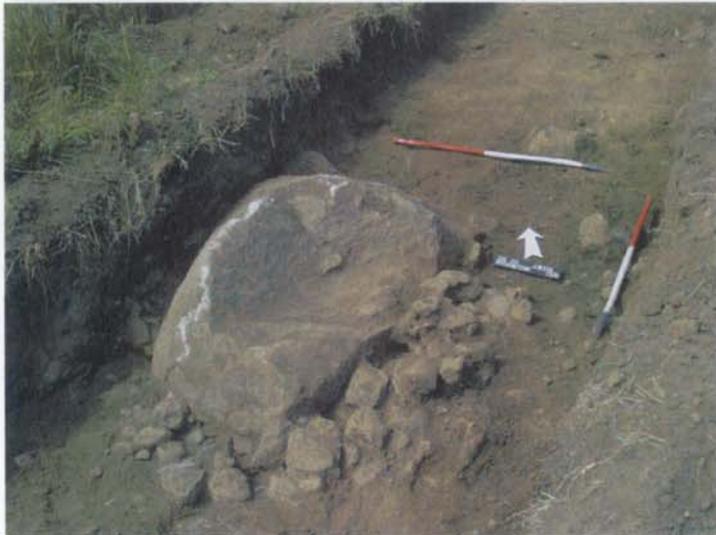
Plate: 2 06 E 214, Brenanstown, Site 3A, F206, Large feature with upstanding boulder and surrounding stones, facing North.

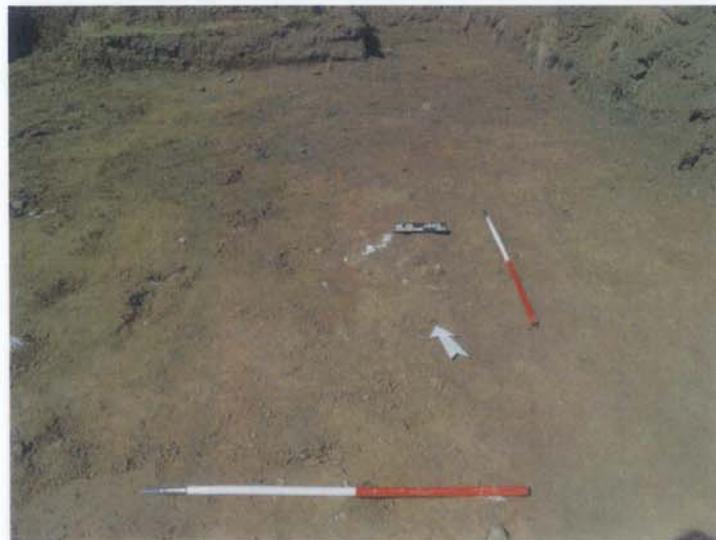
Plate: 3 06 E 214, Brenanstown, Site 3A, F207 Large burnt patch and associated features, possible Prehistoric settlement evidence, facing North East.

F. No	Feature Type	Period	Max. Length	Max Width	Max Depth	Feature Description	Feature Interpretation
207	Deposit	Unknown	0.55 m	0.30 m	-	Sub rectangular burnt patch. The deposit consists of light orange/red silty clay. It is plastic, dry and moderately sorted. The orientation is north/south.	Sub rectangular burnt patch that can be related with another burnt patch F212. The deposit was not tested. The period and function are unknown
208	Cut for Possible slot trench	Unknown	3.50 m	1.00 m	-	Possible slot trench running north/south. This feature was not fully excavated and not fully exposed as it continues under the northern edge. There is a large amount of burnt patches in the fill F211.	Possible slot trench running north/south. The feature was not tested. It could be related with another feature, F218. The period and function are unknown
209	Deposit	Unknown	1.30 m	0.50 m	-	Sub rectangular burnt patch. The deposit consists of light orange/red silty clay. It is plastic, dry and moderately sorted. The orientation is north west/south east.	Sub rectangular burnt patch. The deposit was not tested. The period and function are unknown

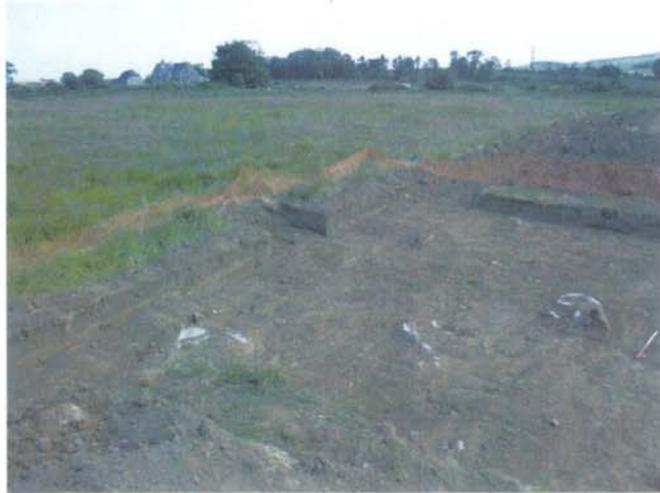
Plate:4 06E 214, Brenanstown, Site 3A, General site shot, Facing South East

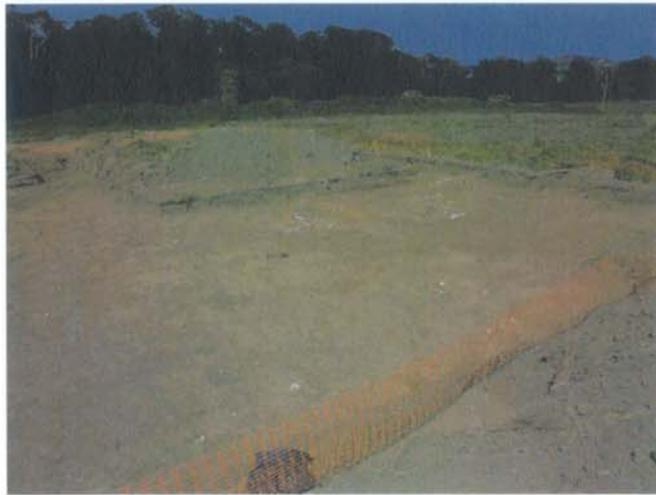
Plate: 5 06E 214, Brenanstown, Site 3A, General site shot, Facing North East

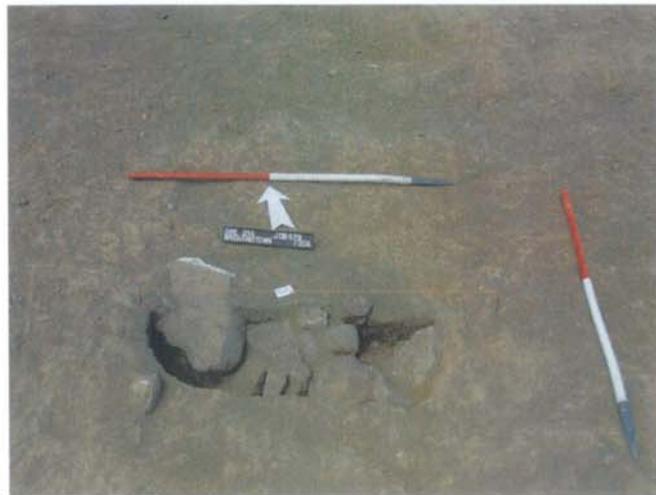
Plate:6 06E 214, Brenanstown, Site 3A, Post pit with packing stones, Facing North

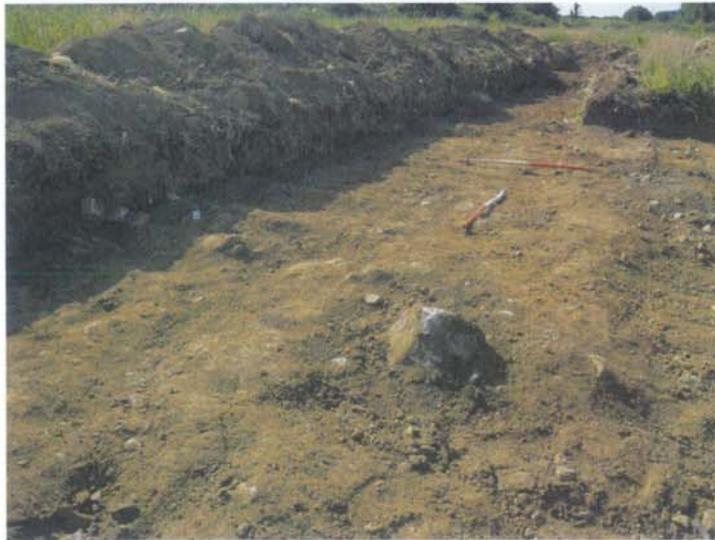
Plate: 7 06E 214, Brenanstown, Site 3B, Possible pits and postholes, Prehistoric settlement evidence? facing South East.

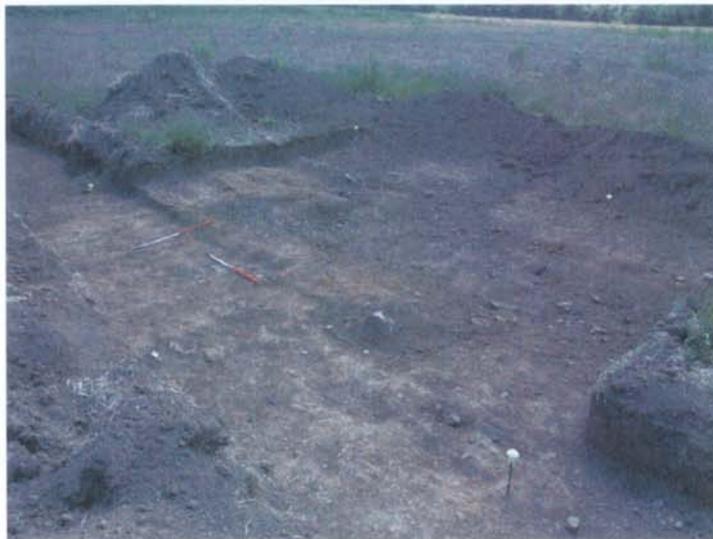
Plate: 8 06E 214, Brenanstown, Site 3B, General site shot, Prehistoric settlement evidence? facing South West.

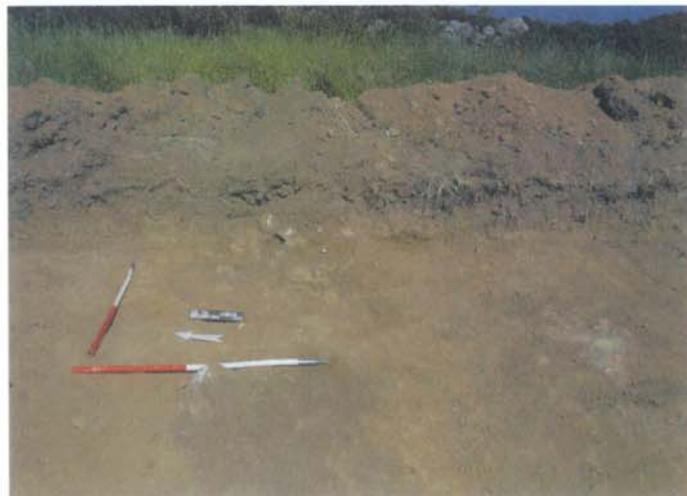
Plate: 9 06E 214, Brenanstown, Site 3B, F404, Small pit with flint core, Prehistoric settlement evidence? facing East.
