**Connolly Station - Point Theatre**

**LUAS C1 Extension**

**Preliminary Archaeological Monitoring Report**

**Licence Number: 07E167**

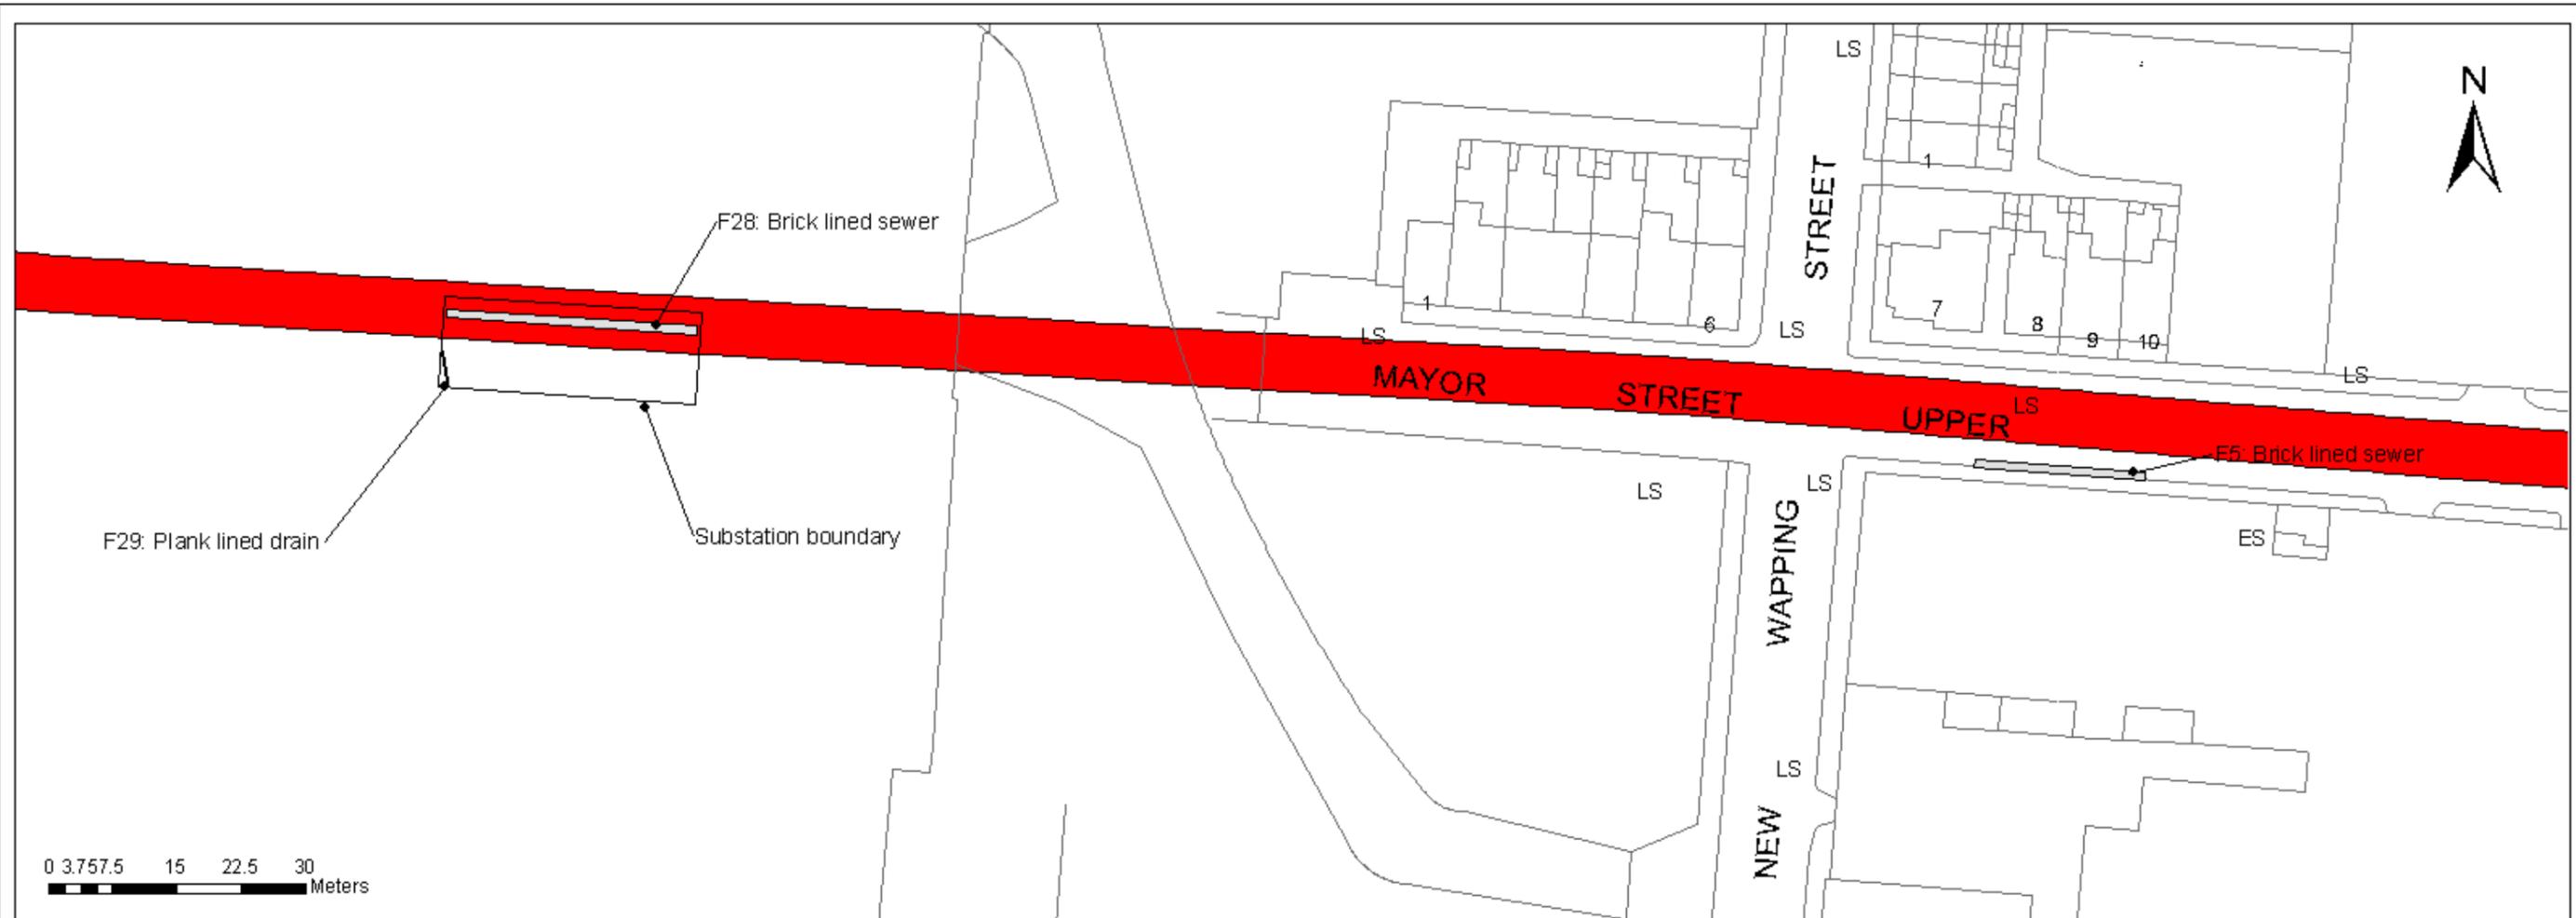
F29: Plank lined drain

At -1.7m OD in the south west corner of the substation **F29**, a short section of a plank lined drain was located, also depicted on **Figure 8**. A total of 42 post medieval pottery fragments and 2 clay pipe stems found associated with this feature. The feature was cut into a deposit which had frequent occurrences of oyster shell. The planks formed a box profile, originally made up of 4 planks (top in this section missing). It extends north west outside the area of the substation (feature cut by pile wall). The planks were not fixed to each other but simply abutted.

The plank lined drain was located in layer **F20** which may be an estuarine deposit, but given the high quantity of 19th century pottery sherds (none of which showed any signs of being water rolled and therefore not derived from the river Liffey) found directly associated with it, it is more likely to be fill material. During the construction of the 19<sup>th</sup> century buildings and factories in the North Lotts area a lot of building material was dredged up from the Liffey and or the beach at Clontarf which would have contained shell material.

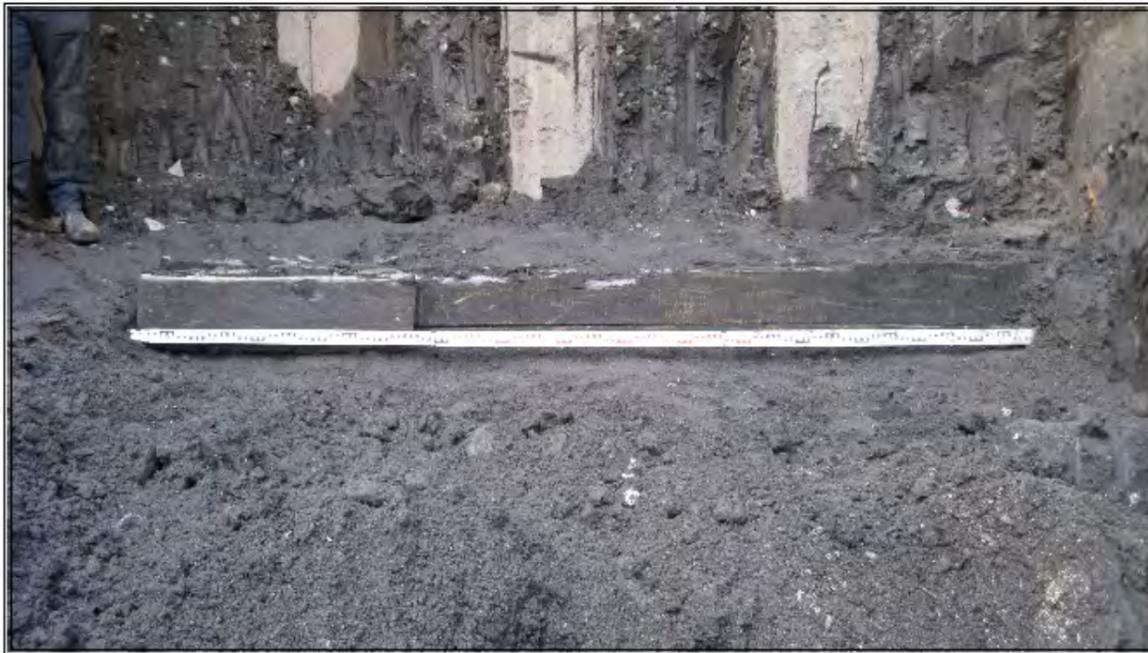
F28: Brick Lined sewer

The first feature encountered was **F28**, a brick lined sewer of a similar type to those previously discussed. **F28**, orientated east west, was located in a highly disturbed layer of about 3m in depth which contained several modern concrete sewers which had similar alignments, see **Figure 8**. The substation itself was located under the railway lines that led to the CIE depot and the remains of existing railway lines from the 19<sup>th</sup> century were also observed. Due to the highly disturbed nature of the bulk of the ground it was not possible to identify 18<sup>th</sup> century reclamation deposits.

The brick lined sewer **F28** is probably from the same drainage network found all along Mayor street Lower and Upper, and is likely to have once fed directly into Spencer Dock through either culvert arch **F11** or **F12**.

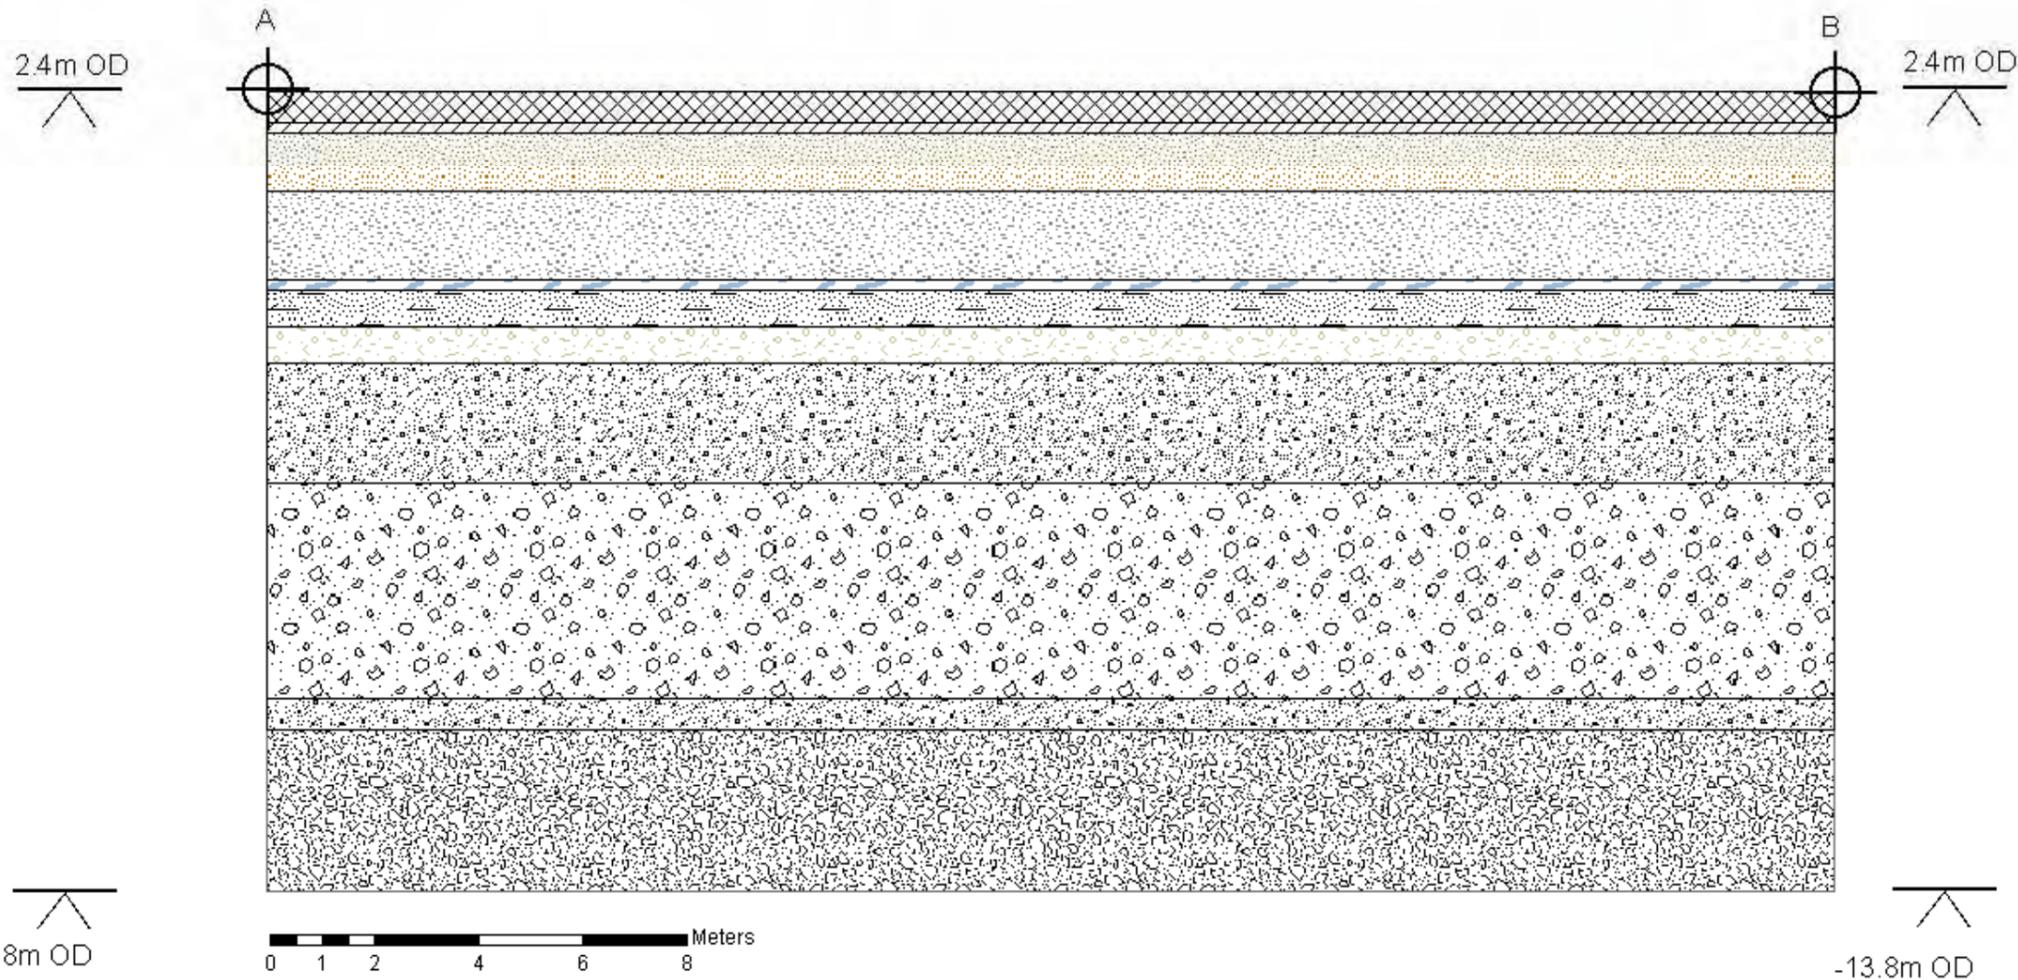
**Stratigraphy at Substation**

- F15 - Compacted hard core, made ground
- F16 - Brown gravelly clay, made ground
- F17 - Yellow fine sand, 18th C. reclamation material?
- F18 - Grey sandy silt/clay 18th C. reclamation material?
- F19 - Silt, easturine deposit
- F20 - Sandy silt, easturine deposit
- F21 - Coarse sand, easturine deposit
- F22 - Medium gravel, paleo-shore?
- F23 - Gravelly clay, glacial till?
- F24 - Medium gravel, glacial till?
- F25 - Gravelly clay, glacial till

Figure 9: Stratigraphy of south facing section of substation	
Spencer Dock, Moor Street Upper	
Scale:	1:131
Sheet No.:	SI0008
Revision No. 01/167	
<small>*The information contained herein has been provided by ERM for your use pursuant to the conditions of the ERM Contract. You should not rely on this information. ERM does not accept any liability for any loss or damage, including consequential loss or damage, arising from the use of this information. ERM does not accept any liability for any loss or damage, including consequential loss or damage, arising from the use of this information. ERM does not accept any liability for any loss or damage, including consequential loss or damage, arising from the use of this information.</small>

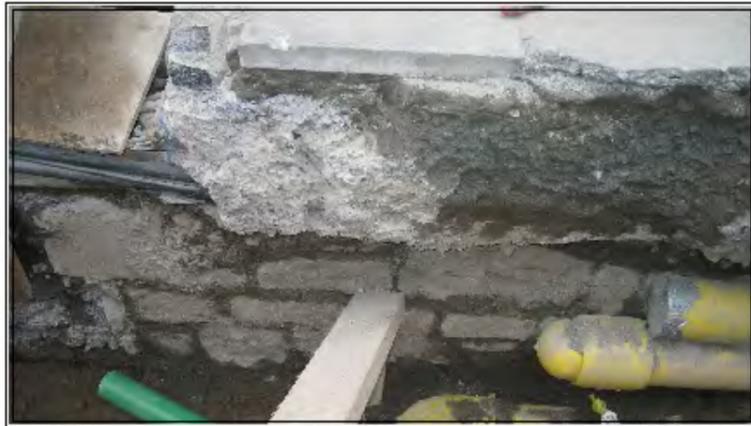
F6: Limestone wall foundations

north east corner of the CHQ building and is most likely a continuation of **F2**. Only 2m of this wall was exposed in the trench. This feature was labelled as **F6**. The foundations were not impacted on and reburied.

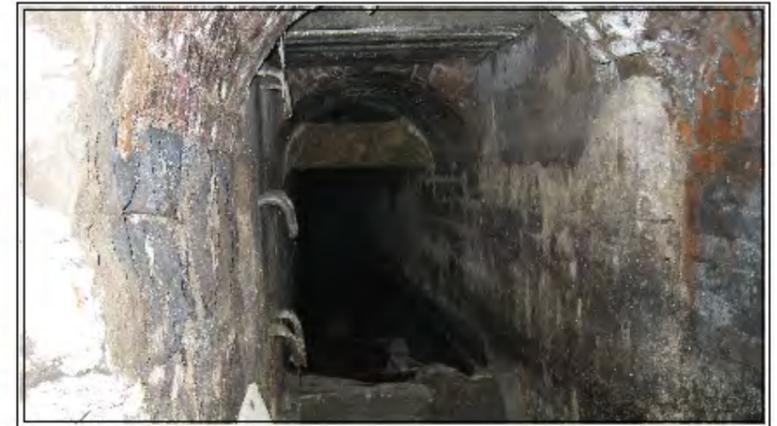
F7: Brick lined sewer

The last feature encountered in this area was **F7**, the remains of a brick lined sewer. This sewer had limestone wall foundations, c.0.75m high by 0.9m in width finished off with a brick arch on top of the foundations, adding 1.25m to internal height of sewer, total height: 2m. Certain sections of the sewer had been rebuilt or reinforced some time in the past with concrete (probably during the 1990's during the construction of the IFSC). Only a short section of this sewer was uncovered, construction works broke through **F7** and reinforced the structure.

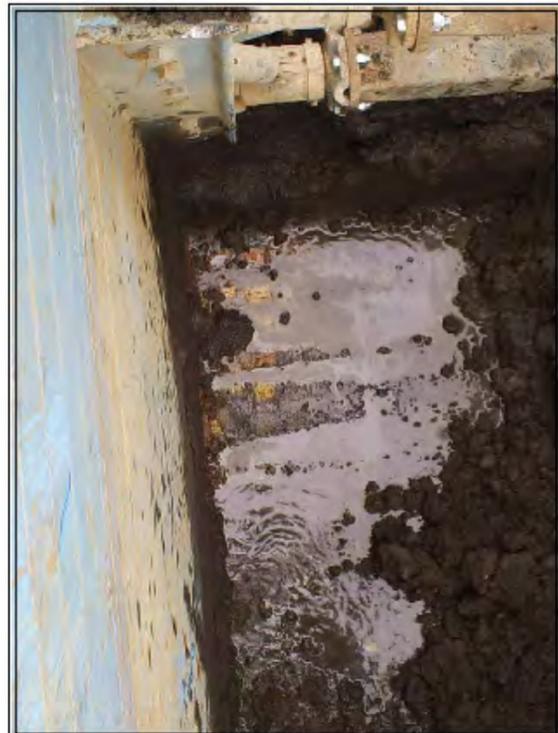
F5: Brick lined sewer

The only features to be found along this section were the remains of two brick lined sewers, **F5** and **F14**.

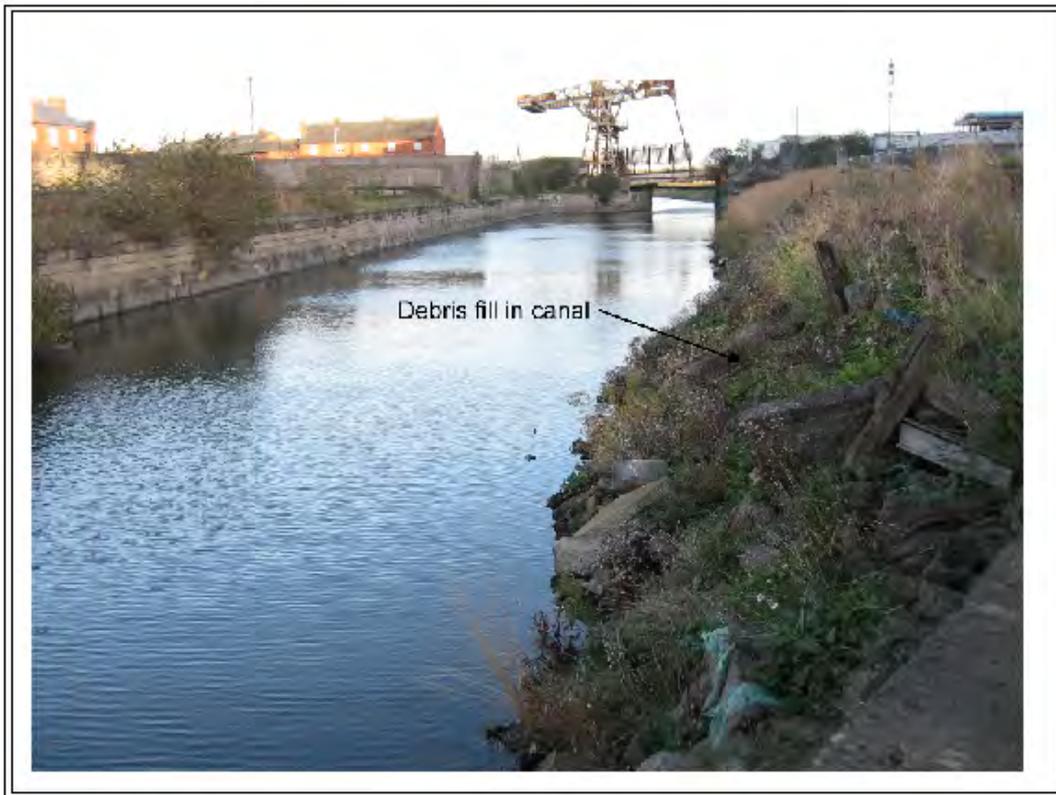
Plate 4: Example of material dumped in canal at Spencer Dock

In the Spencer Dock area on **Figure 7** and **Figure 12** it is clear how much of the dock was reclaimed by CIE when one of their warehouses burnt down in the 1960's. A goods store (containing a consignment of Belleek pottery) burnt down, the remains of the building being bulldozed into the canal and retained by steel larsen sheet piles. The **front cover** picture shows the removal of this debris from the dock.

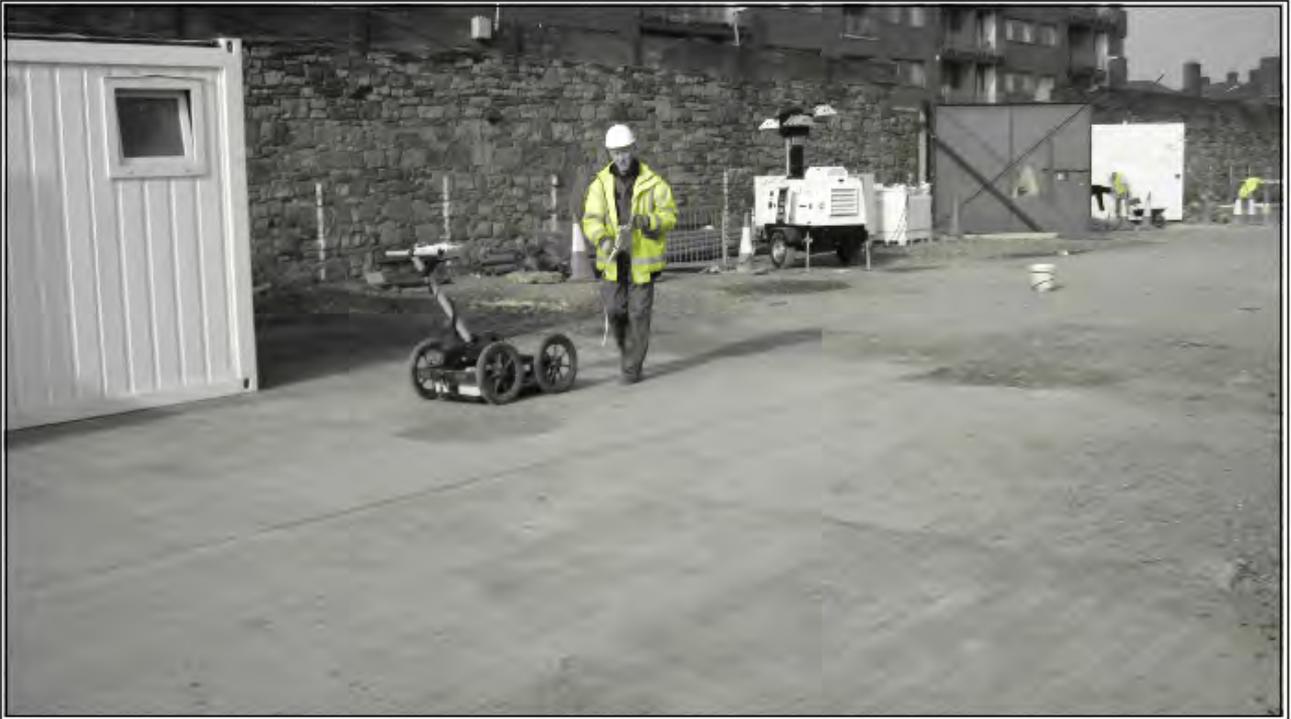
Plate 5

<p>Geotechnical                  The Full Time                  Design/Build/Operate                  Dublin, Ireland                  Phone: +353 1 662 266                  Fax: +353 1 662 268                  www.gti.ie</p>
<p><b>Excavation Reference:</b>                  07E167</p>
<p><b>LOCATION:</b>                  Connally Station to the Point</p>
<p><b>DRAWING TITLE:</b>                  Plate 5: Spencer Dock ground penetrating radar survey for                  west bridge abutment                  Plate 6: Spencer Dock west abutment excavation</p>
<p><small>Copyright © 2010 Geotechnical                  The Company is not liable in any way for the use of the information contained in this document for any purpose other than that for which it was prepared. The Company is not responsible for any loss or damage arising from the use of the information contained in this document for any purpose other than that for which it was prepared.</small></p>

Directly opposite the arches on the west dock wall where two identical arches **F9** and **F10**. **F9** is opposite **F11** and **F10** is opposite **F12**. A geo-radar survey was conducted over the suspected **F9** and **F10** sewer locations to see if they were intact (see **Plate 5**). Results were inconclusive.

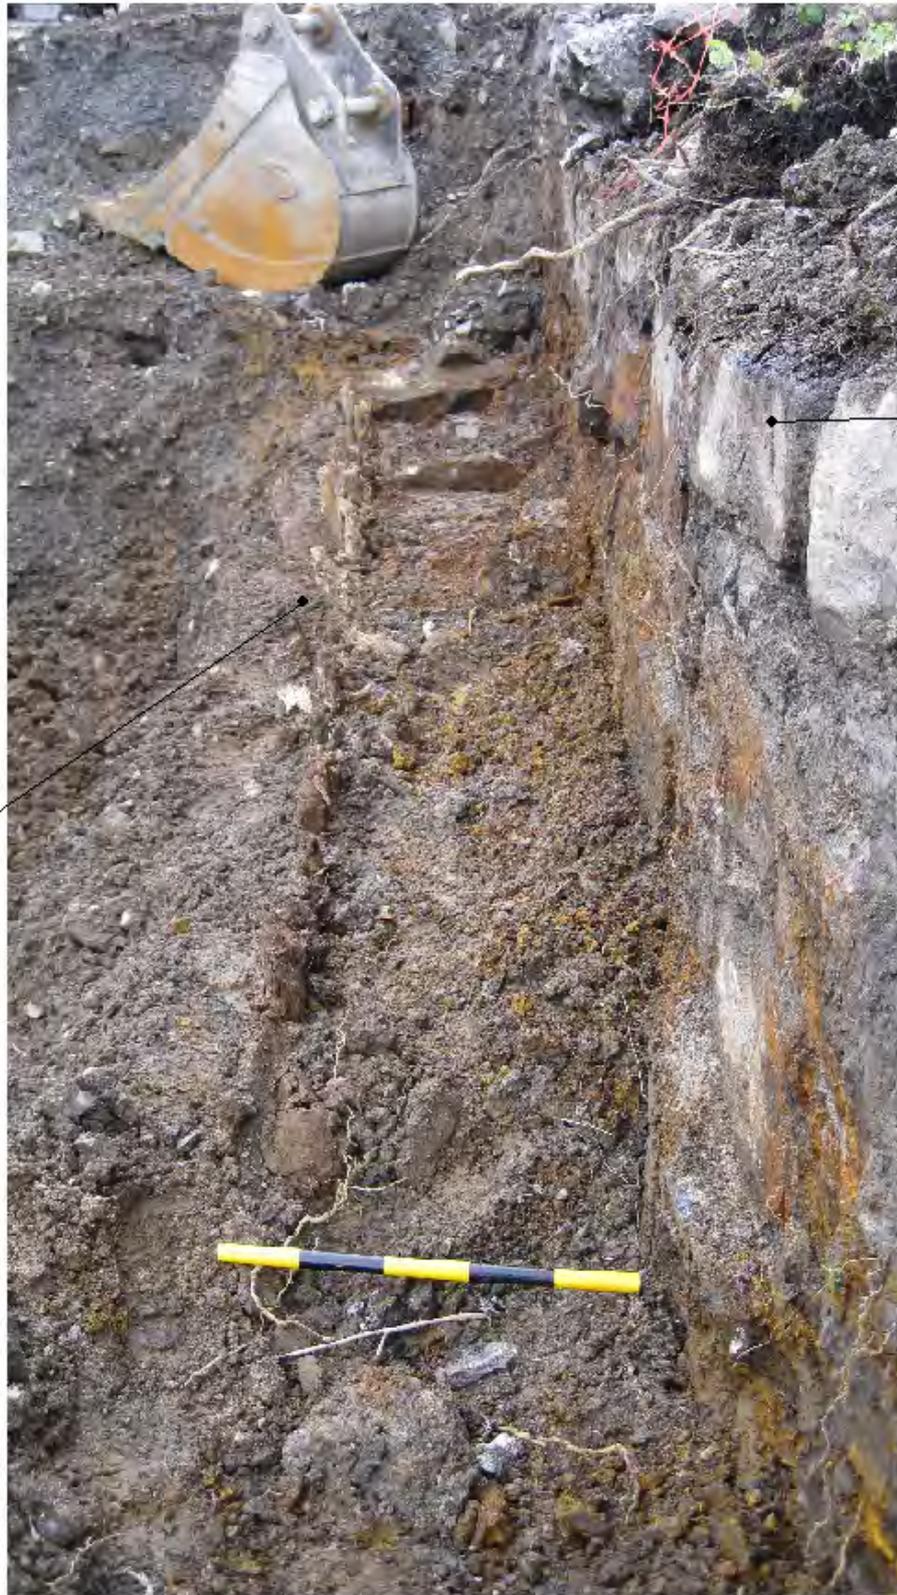
Plate 7: Timber planking F26 at west abutment

One feature was located during the excavation for the west abutment, **F26**, a short length of timber planking (see **Plate 7** and **Plate 8**). At a depth of 1.5m below the top of the west wall (i.e. 1.24m OD) on the western side a line of pine planking, driven in to the ground was encountered. This was 0.5m west of the face of the quay wall. Similar timber shuttering has been observed during the demolition of the Spencer Dock Lock on the Pearse site, 140m due south of the west abutment site. Each plank was c.3cm thick, c.28cm wide and of an indeterminate length (being left *in situ*, not being impacted on and not fully exposed).

West face of west dock wall

F26  
Timber planking

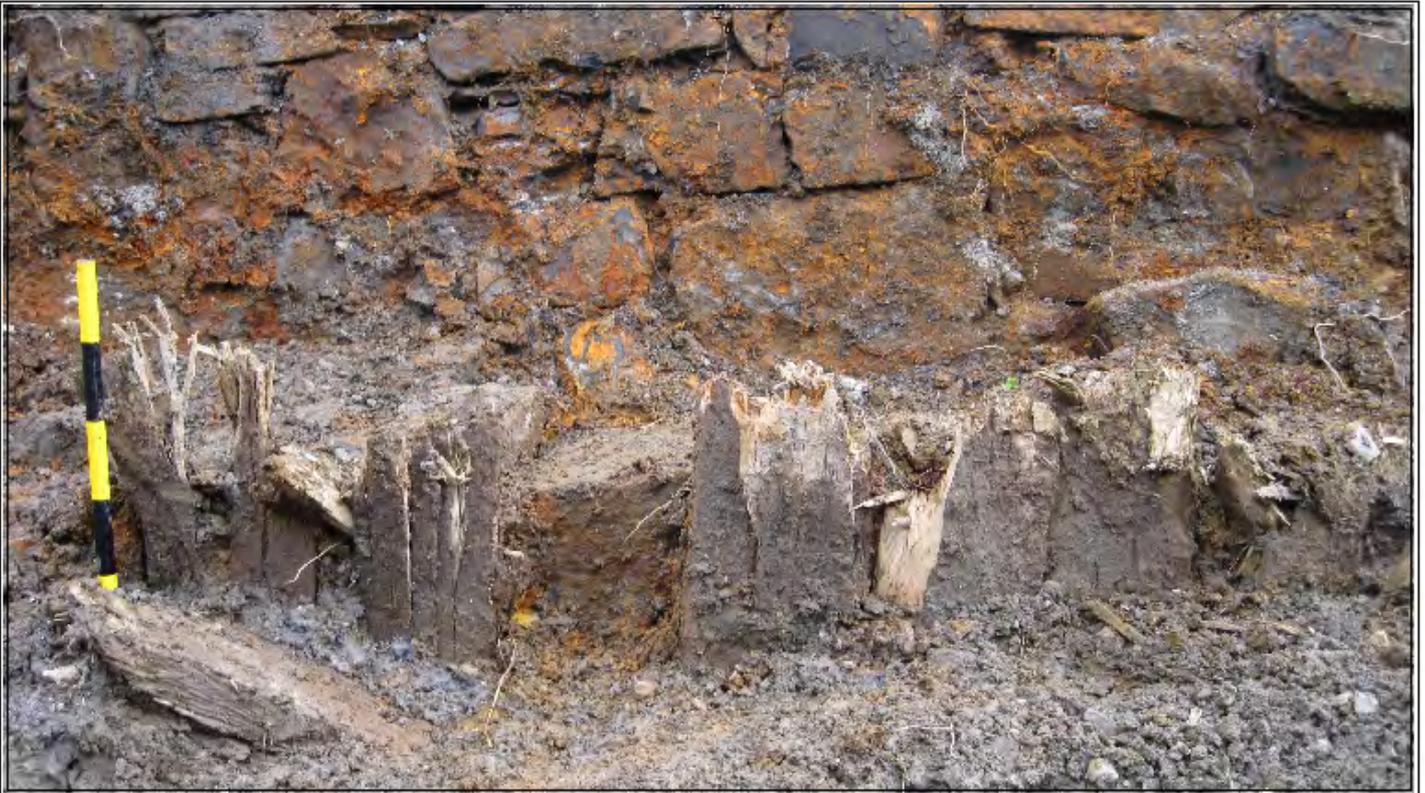
Plate 8: Detail of timber planking F26 at west abutment

Camera scale = 0.5m
