From: O'Malley Vincent
Sent: Tuesday 5 November 2019 15:30
To: Nea Christian
Subject: RE: Re. Reactive Maintenance works at Donemark Bridge (CC-N71-009.00)

Re. Reactive Maintenance works at Donemark Bridge (CC-N71-009.00)

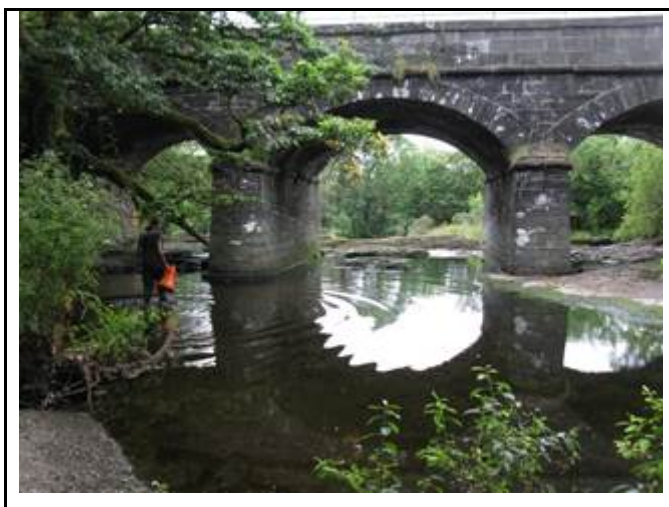
CC-N71-009.00 - Donemark Bridge

<p>X, Y (ITM): 500464 550107</p> <p>Main channel Mealagh River, Bantry, Co. Cork. Snorkel and wading survey 50m US & DS of bridge. Average width / depth: 12m / 0.50m. Bedrock dominated DS, with outcrops US. Gravel, pebble in long glide US. Some FGA and silt. Good salmonid habitat; many fish observed.</p> <p>FPM Absent; [REDACTED] DS of bridge comprised all bedrock, then long cascade to saline habitat (tidal).</p>
--	--

The immediate environs of Donemark Bridge was surveyed for Freshwater Pearl Mussel in 2019 by Aquatic Service Unit [ASU (2019). *Munster Bridge Term Maintenance Contracts. LOT 5. Specialist Surveys 2019 - Fresh Water Pearl Mussel. Report prepared for TII*] – full copy attached. The following is extracted from ASU (2019). The area within which the tree has fallen and works are to be undertaken is located with the area considered as part of the ASU survey (ASU, 2019).
