# Development of a Specification for Surface Dressing

**Tom Casey,**  
Chartered Engineer,  
Transport Infrastructure Ireland

**Brian Mulry,**  
Chartered Engineer,  
PMS Pavement Management Services Ltd.

29/09/16

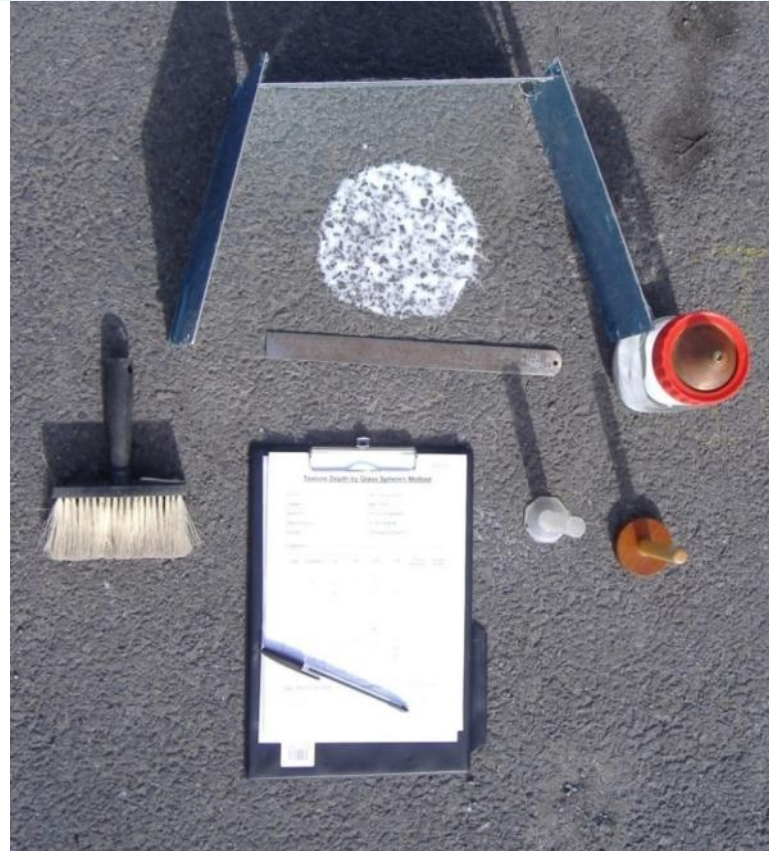
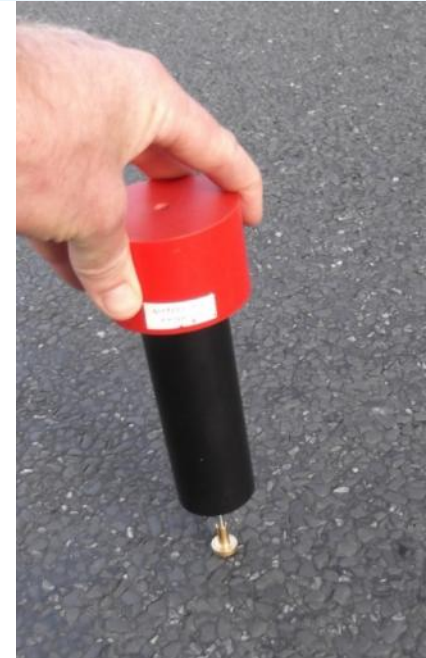
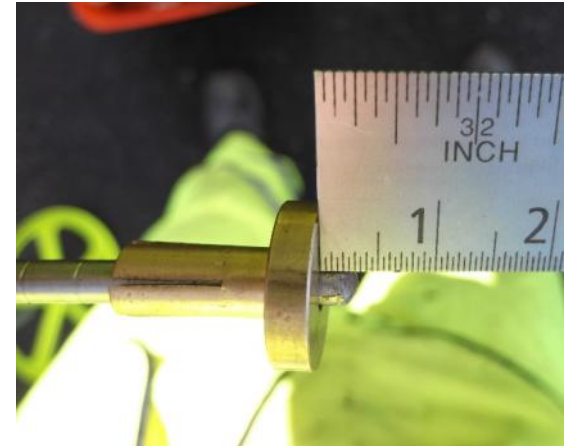
- Texture (volumetric patch test)
- Hardness Test (CTRA Probe)
- Sampling of Binder and Chippings for lab testing
- Road temperature
- Ambient temperature

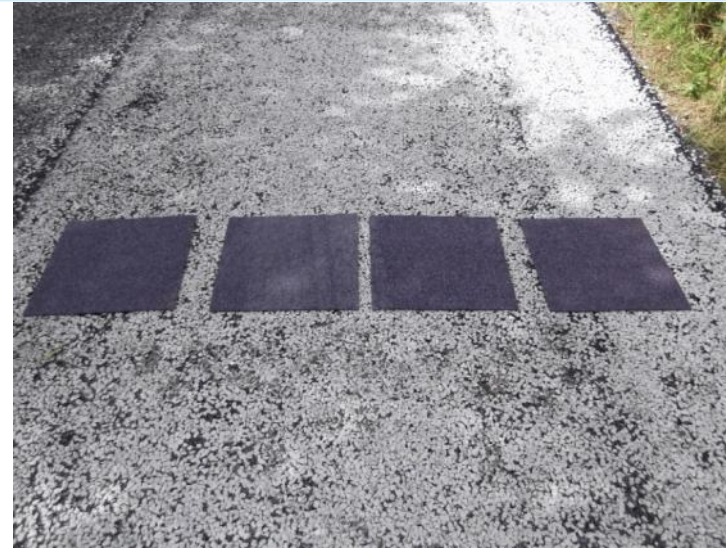
- Rate of Spread of Binder (Carpet Tile Test)
- Rate of Spread of Chippings (Box test)
- Site Photos

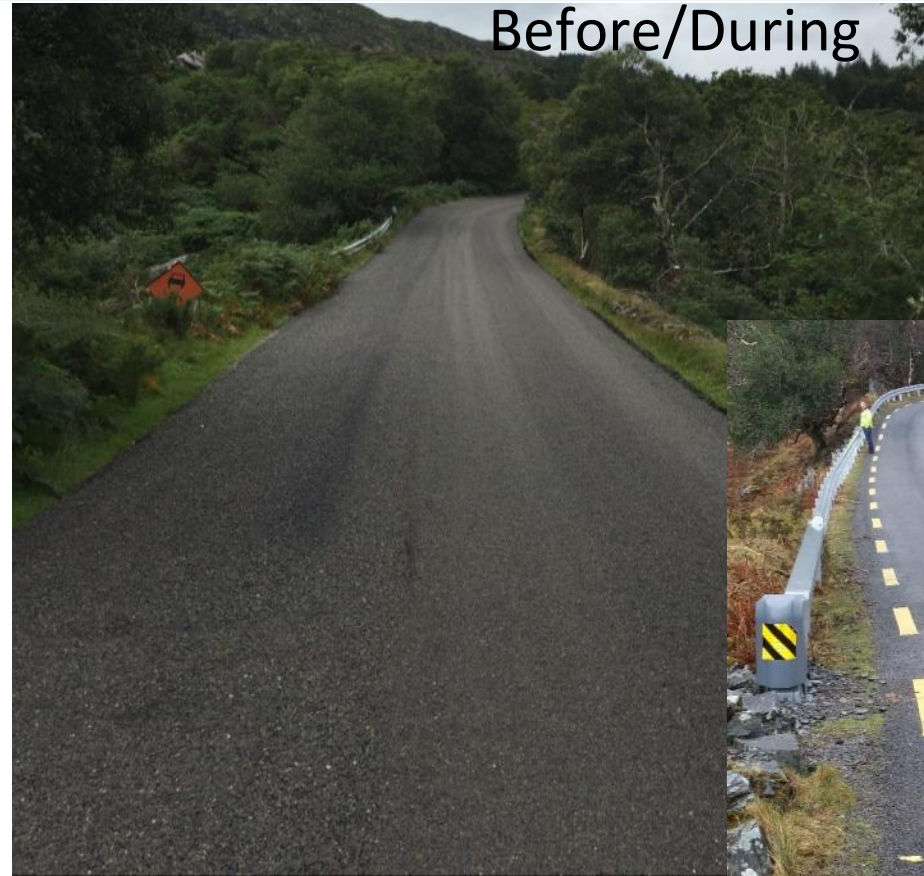
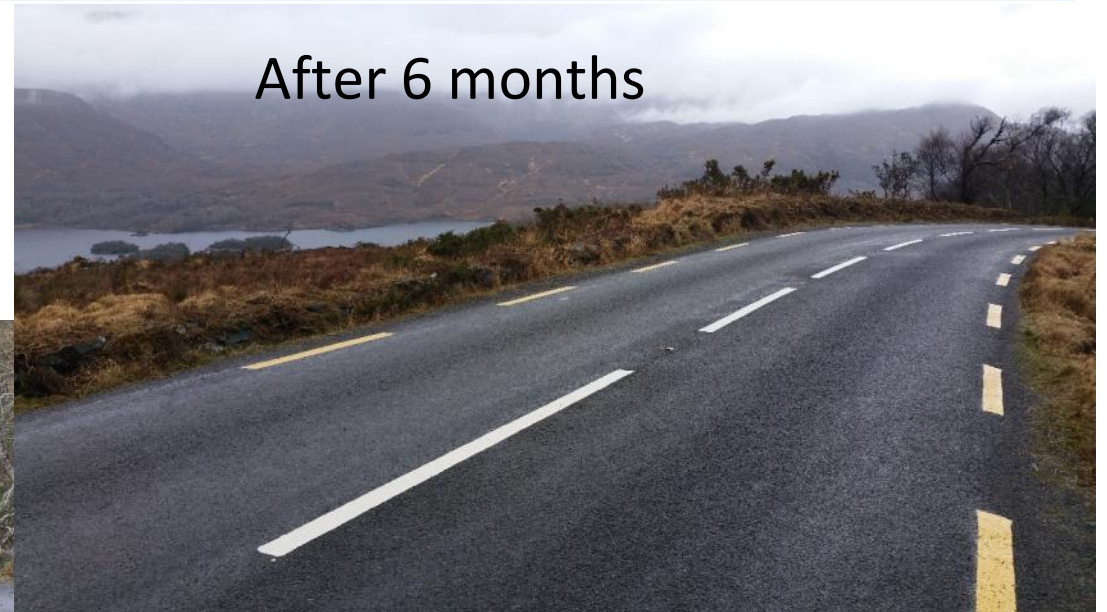
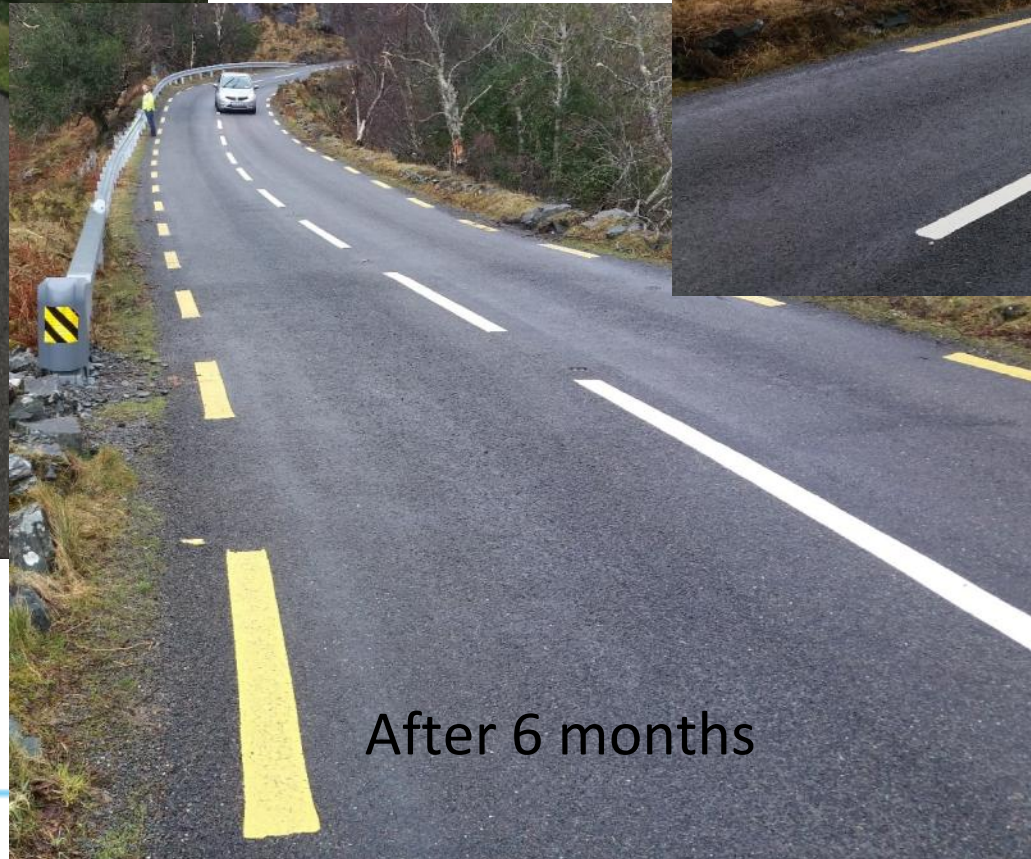
Site 1

- Performing well
- Generally in good condition with little or no defects

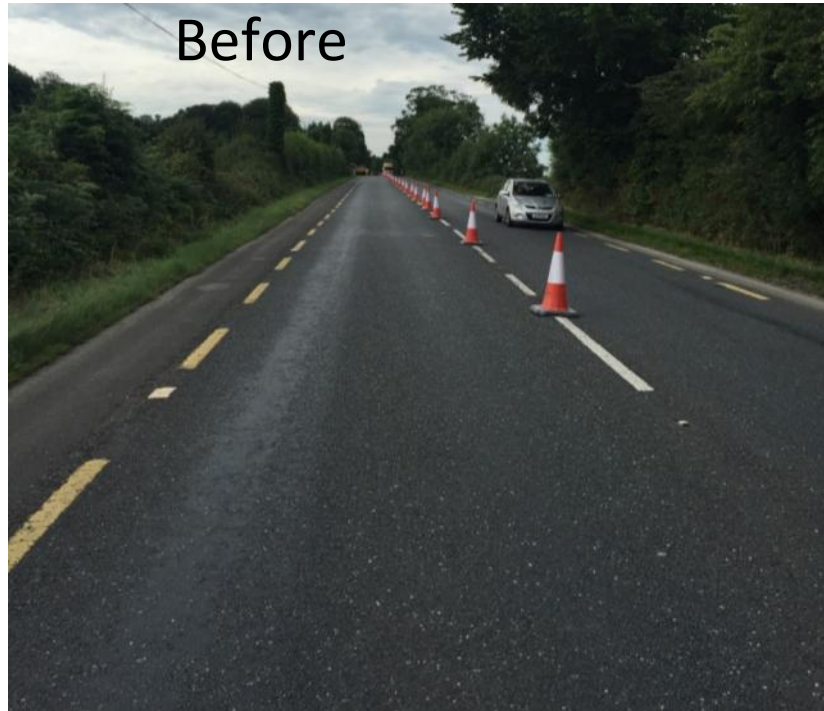
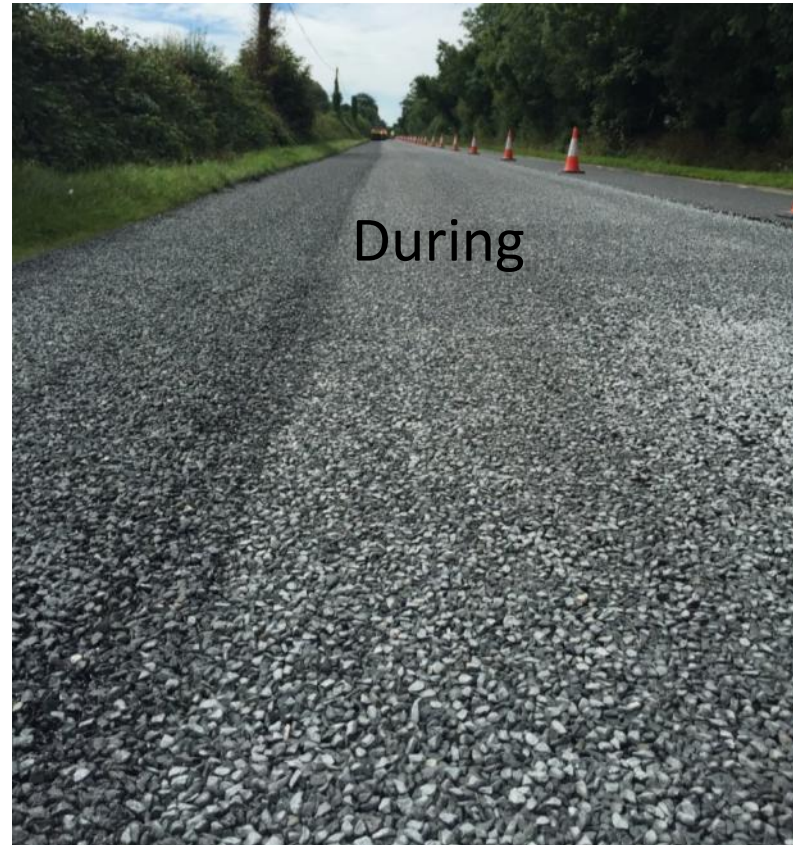
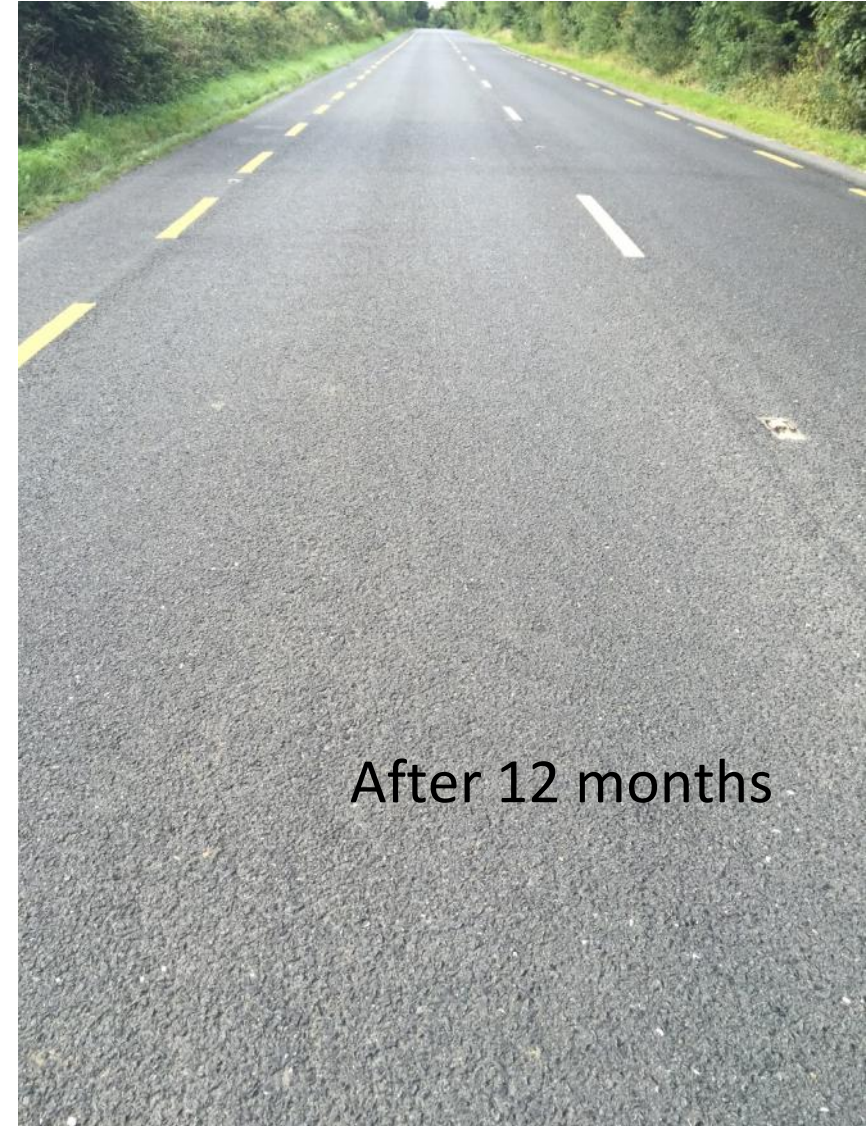
## Site 3

- Performing reasonably well
- Some loss of 2<sup>nd</sup> layer
- Very minor/localised defects

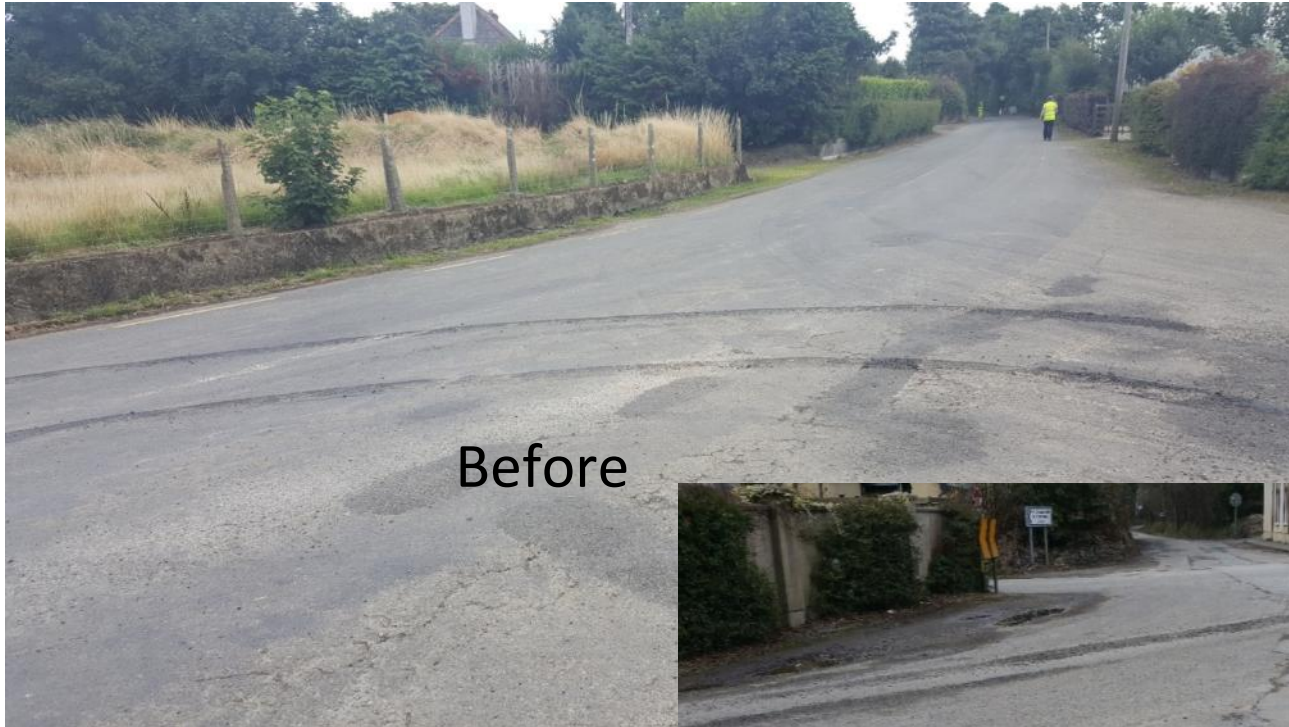
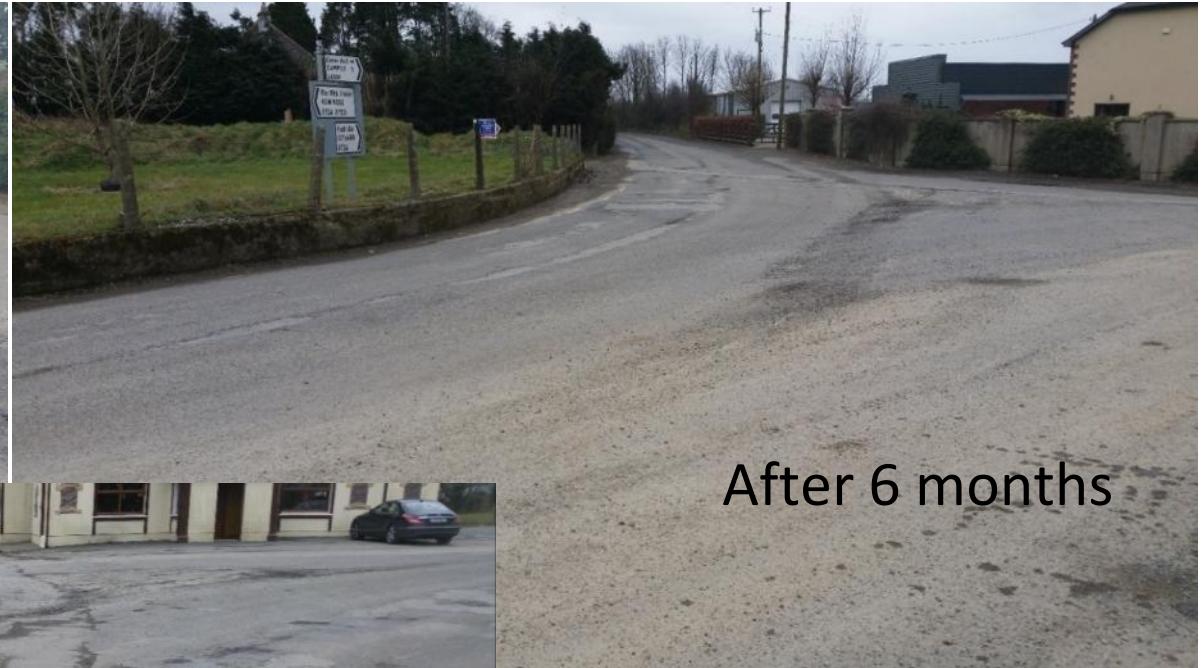
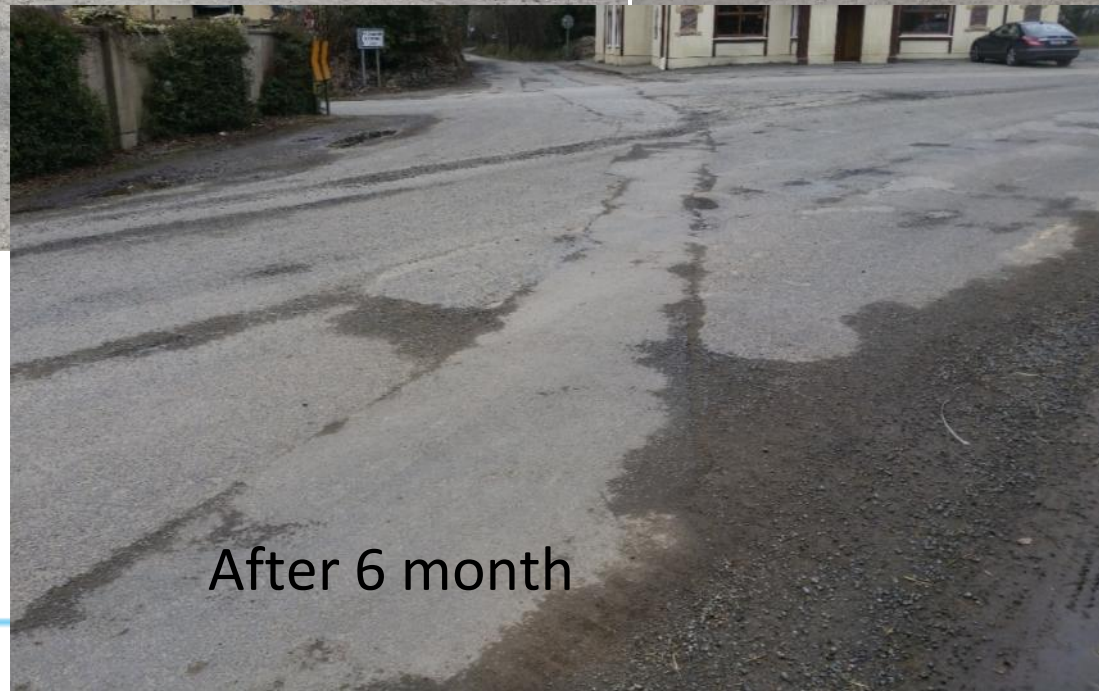
## Site 5

- Highly stressed site
- Structural defects not repaired
- Drainage issues
- Trench/utility cut works occurred after surface dressing

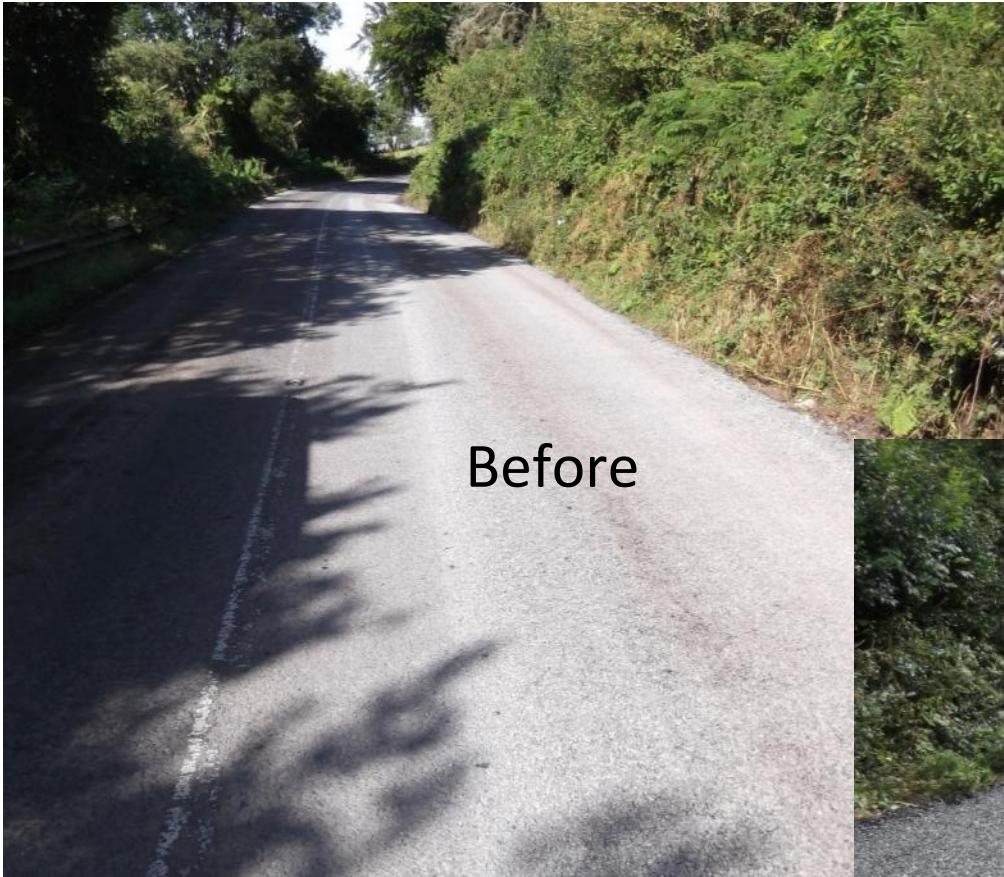
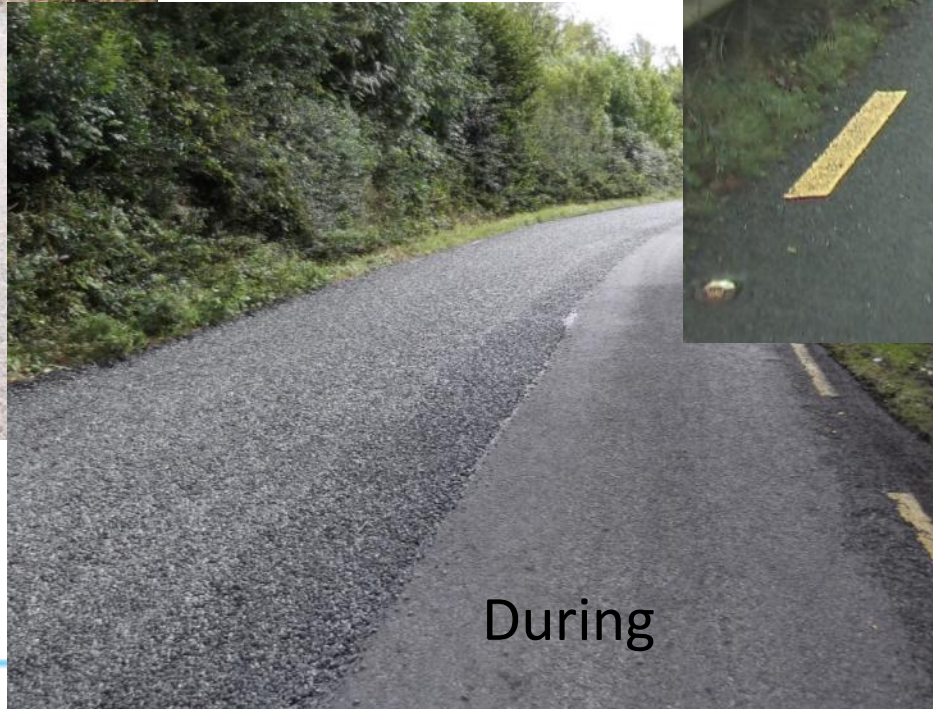
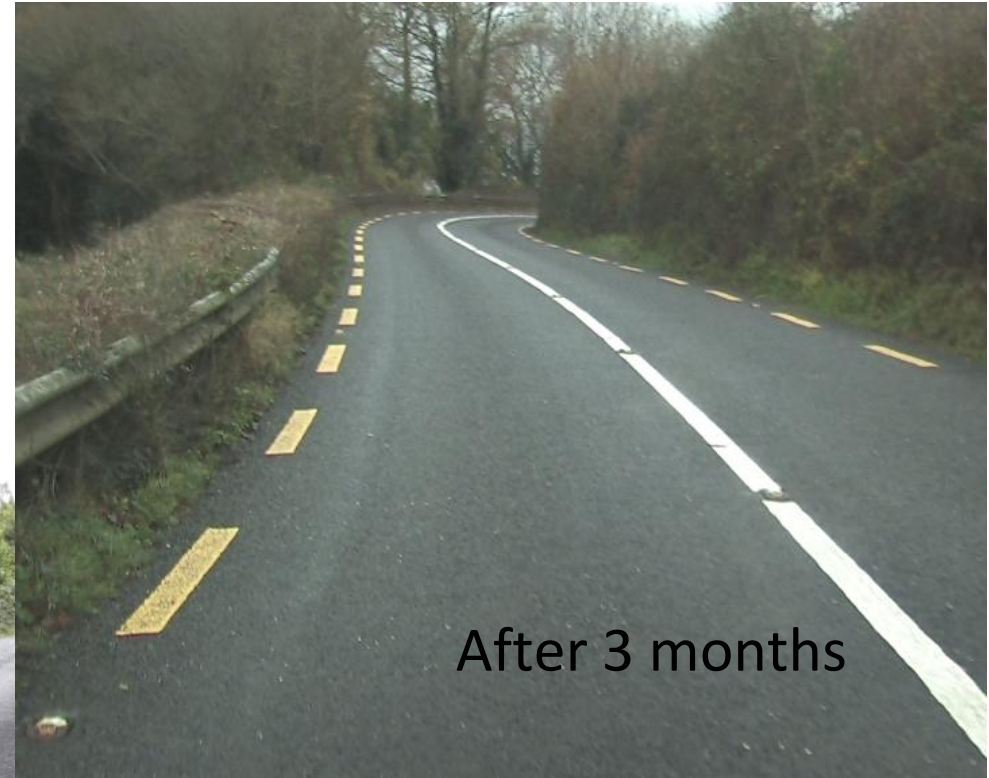
## Site 6

- Most controlled site
- Performing very well
- Very good condition
- No defects

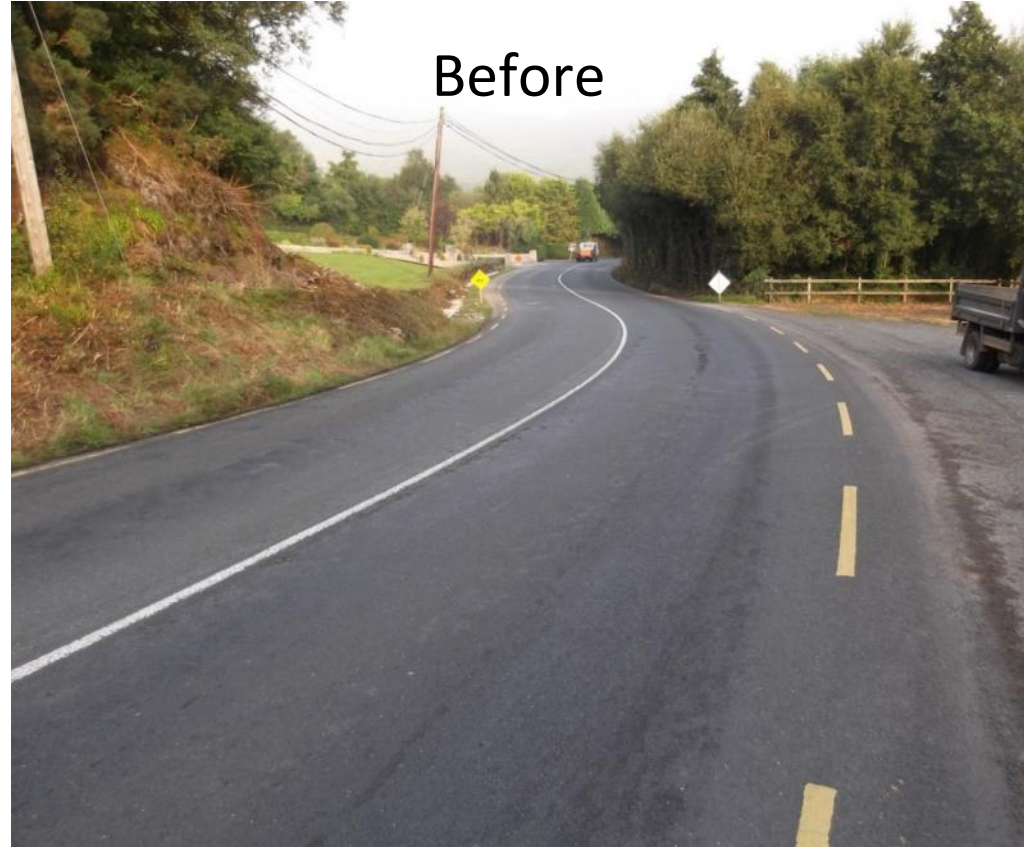
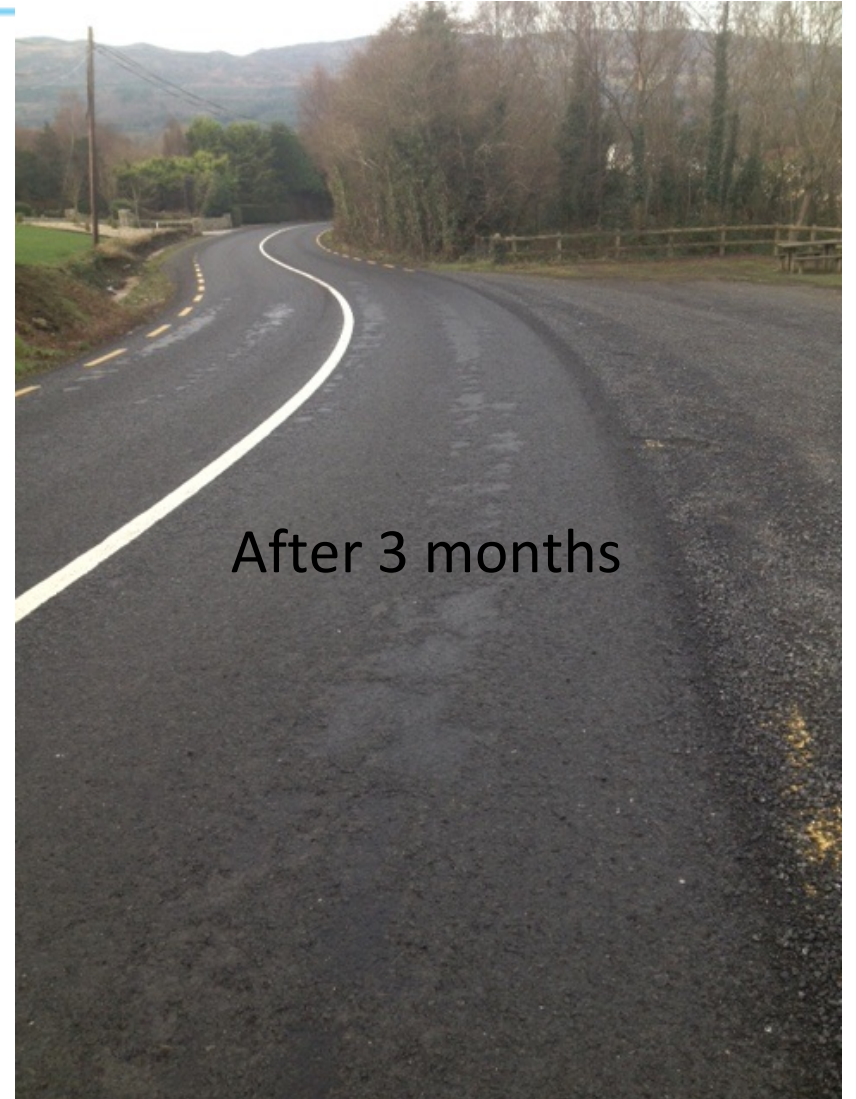
## Site 12

- Failure (2<sup>nd</sup> Layer)
- Late Season
- Non-compliant binder
- Non-compliant chips

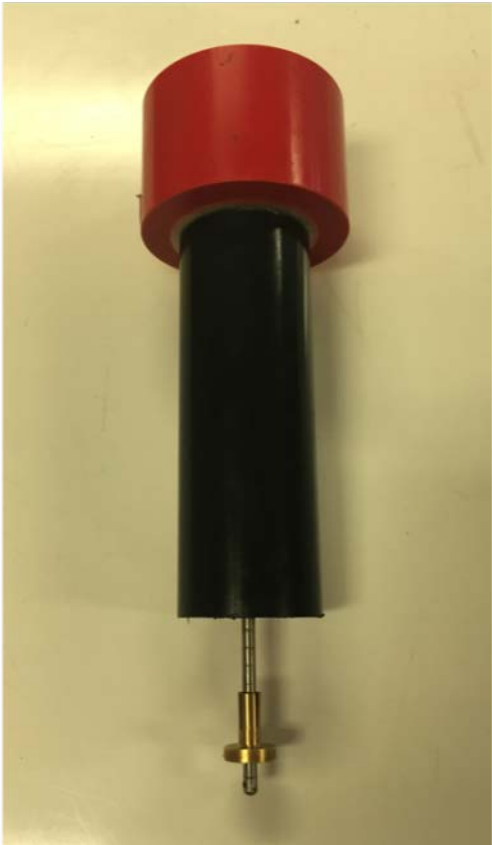
TRL/CTRA Hardness Probe

- Road hardness currently measured using the TRL/CTRA Probe.
- Spring loaded penetrometer with a 4mm diameter spherical head.
- International experience indicates that narrow head tends to displace chips and may give inconsistent/misleading results.

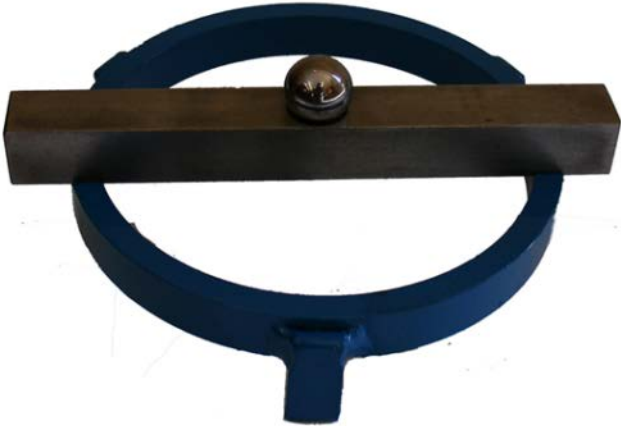
- Alternative approaches based on a 19mm ball bearing.
- South African Hammer (SAH)
- Australian Ball Penetrometer
- Current research project is investigating the relationship between, and consistency of, the 4mm CTRA Probe and the 19mm devices for Irish road surfaces.
