11. Hearth and home: Bronze Age structures in south Tipperary

Melanie McQuade and Colm Moriarty

Archaeological investigations in advance of the N8 Cashel–Mitchelstown Road Improvement Scheme identified 57 previously unrecorded sites that ranged in date from the Early Neolithic period (4000–3600 BC) to the post-medieval period (AD 1550–present). The majority of sites (40) produced evidence for Bronze Age activity and this paper focuses on the structural remains from that period.

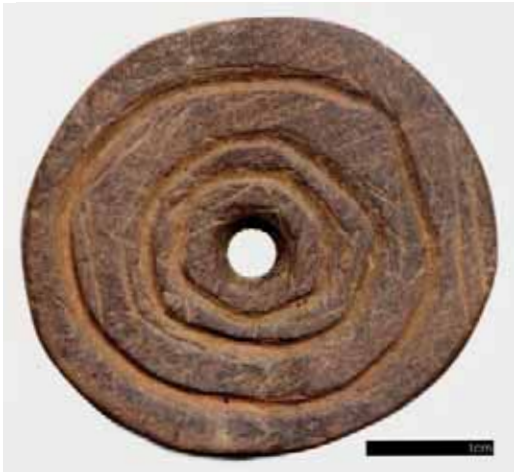
Illus. 7—Decorated spindle-whorl from Killemy, site 203.3 (John Sunderland).

It is also likely that dwellings were multi-purpose buildings where numerous activities besides eating and sleeping were carried out. Many crafts, such as textile production, were probably indoor activities. Evidence of such activities comes from spindle-whorls (Illus. 7), used for spinning yarn, which were recovered from three different sites, and the discovery of a baked clay loom-weight (Illus. 8), which is a rare find from an Irish site, suggests that weaving was carried out at Knockgraffon (site 137.1). Further evidence of craftworking came from examples of burnishing stones, which may have been used for textile production or, more likely, in leather-working.

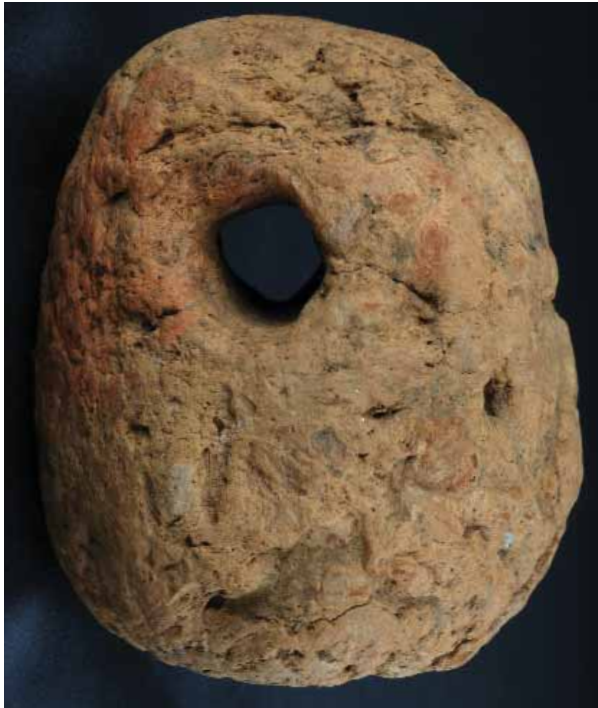
Illus. 8—Baked clay loom-weight (99 mm long) from Knockgraffon, site 137.1 (John Sunderland).
