NW Term Maintenance Contract 3

Year 4 NIS Part 2

Transport Infrastructure Ireland

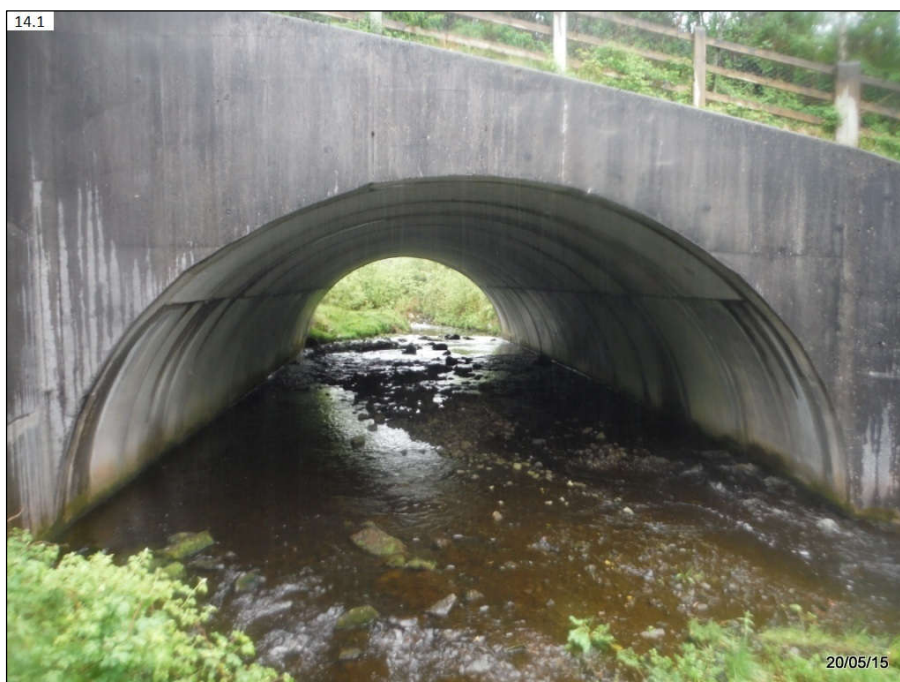
Plate 2-1 Druminnin Bridge.

The Druminnin Bridge is a single span concrete structure with an overall span width of 10.1m. Steel safety barriers line the carriageway. The bridge carries the N15 over the Clogher Stream and is located 35m upstream of Lough Eske and Ardnamona Wood SAC. Plate 2.1 displays the west elevation of the structure.

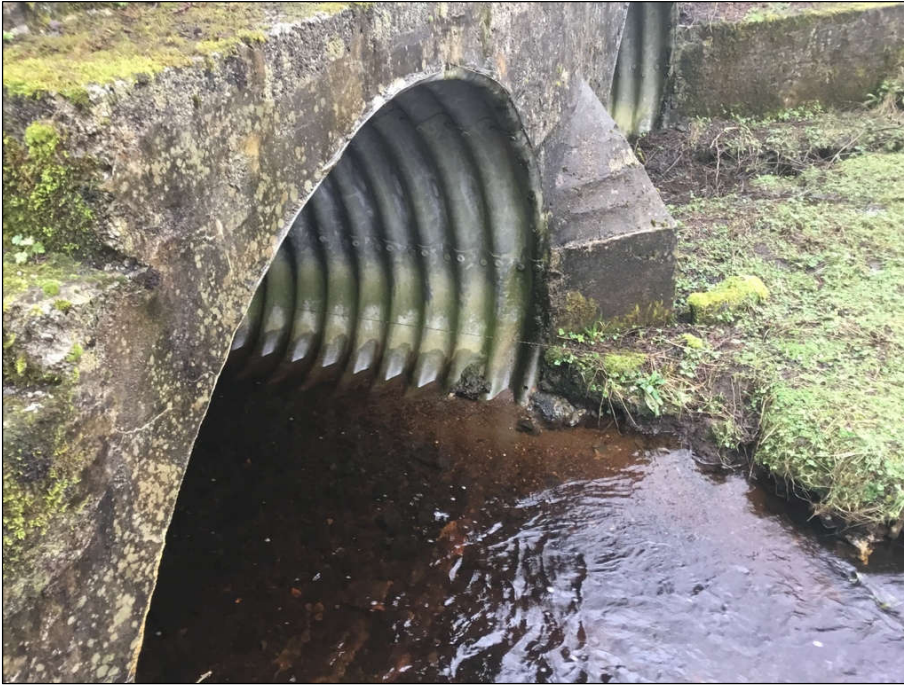
Plate 2-2 Kilraine Bridge.

Kilraine Bridge is a double span masonry arch structure with pipe extensions with an overall span width of 7m. Masonry parapet walls line the road. The bridge carries the N56 over the Kilrean Upper Stream 300m upstream of West Of Ardara/Maas Road SAC. Plate 2.2 displays the structure.

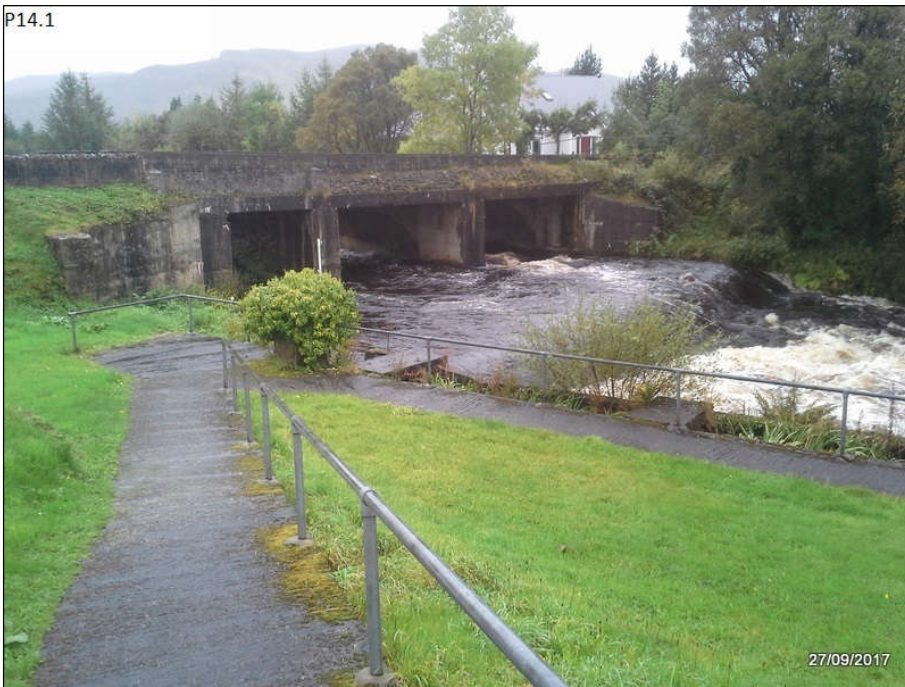
Plate 2-3 Mullanieran Bridge.

Mullaneiran Bridge is a triple span masonry arch and concrete slab structure with an overall span width of 14.3. Masonry parapet walls line the road. The bridge carries the N56 over the Owenea River within West Of Ardara/Maas Road SAC. Plate 2.3 displays the west elevation.

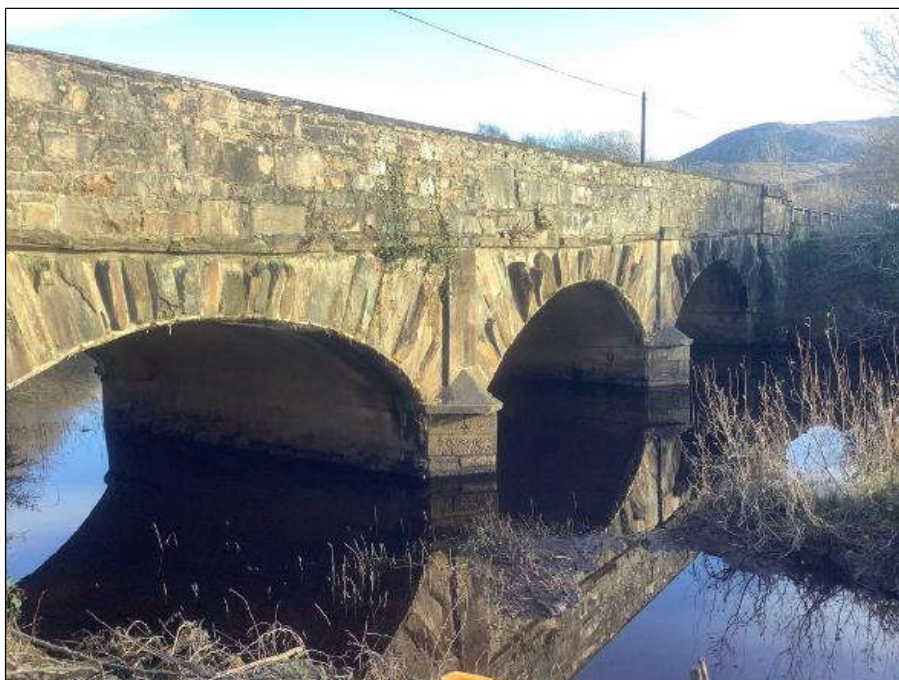
Plate 2-4 Owencarrow River Bridge.

The Owencarrow River Bridge is a 3-span masonry bridge which carries the N56 over the Owencarrow River. Masonry parapets line the road. The bridge is located within the Cloghernagore Bog and Glenveagh National Park SAC. Derryveagh and Glendowan Mountains SPA is located 3.7km downstream of the bridge. Plate 2.4 shows the bridge.

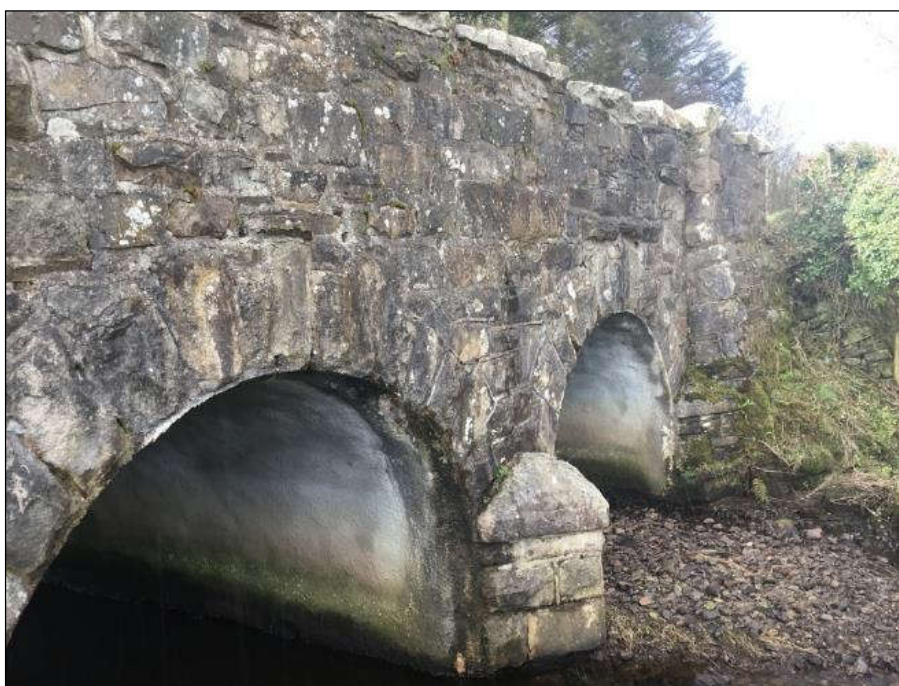
Plate 2-5 Termon Bridge.

Termon Bridge is a double span masonry arch bridge with an overall span width of 7.2m. Masonry parapet walls line the roadway. The bridge crosses the Drumluragh River and is located within Leannan River SAC and 7.6km upstream of Lough Fern SPA. Plate 2.5 shows the face of Termon Bridge.

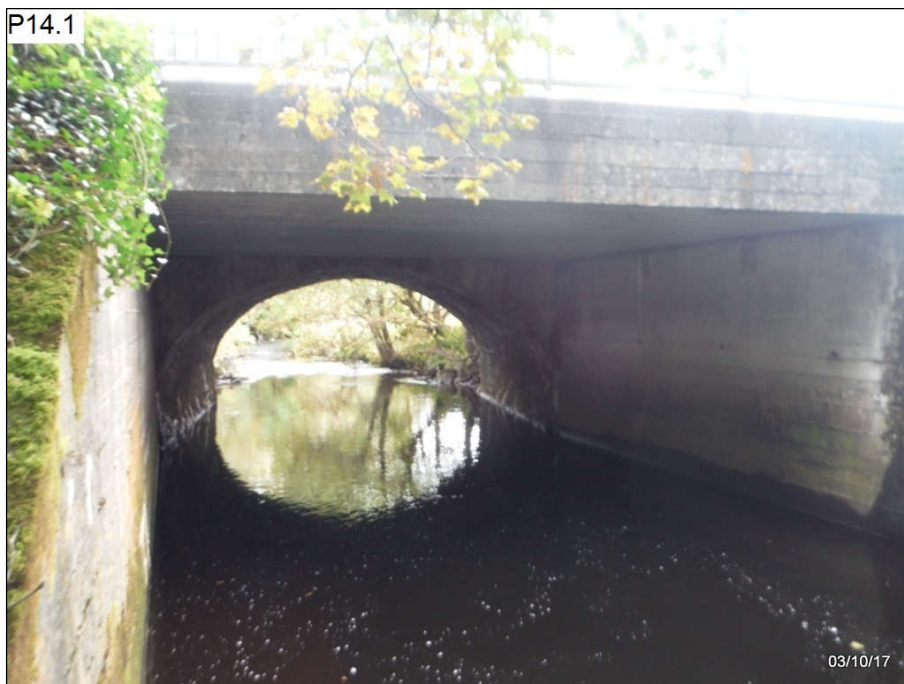
Plate 2-6 Procklis Bridge.

Procklis Bridge is a single span masonry arch structure with concrete slab extension with an overall span width of 6.3m. The road is lined by steel safety barriers. The bridge crosses the Lurgy River within Leannan River SAC and 4.7km upstream of Lough Fern SPA. Plate 2.6 displays the western elevation of the structure.

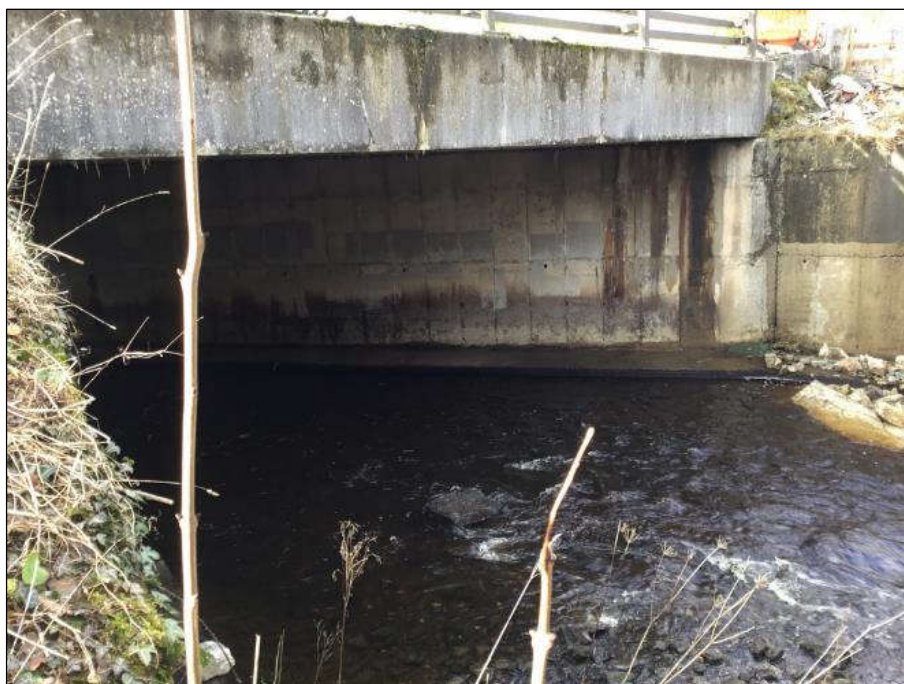
Plate 2-7 Lurgy Bridge.

Lurgy Bridge is a single span concrete slab structure with an overall span width of 10.62m. Steel safety barriers line the road. The bridge crosses the Lurgy River within Leannan River SAC and 3.5km upstream of Lough Fern SPA. Plate 2.7 displays the face of the structure.

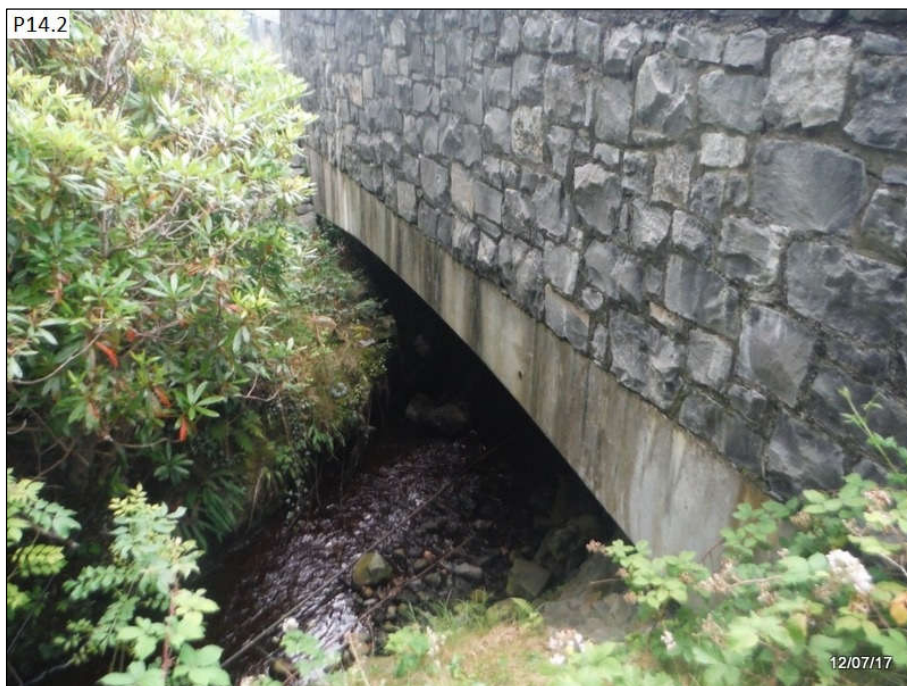
Plate 2-8 Kylemore Abbey Bridge.

Kylemore Abbey Bridge is a single span masonry arch and concrete slab structure with an overall span width of 6.58m. Masonry walls and steel safety barriers line the road. The bridge crosses a tributary of the Dawros River 100m upstream of The Twelve Bens/Garraun Complex SAC. Plate 2.8 displays the north elevation of the structure. Rhododendron can be seen growing close to the bridge in Plate 2-8.

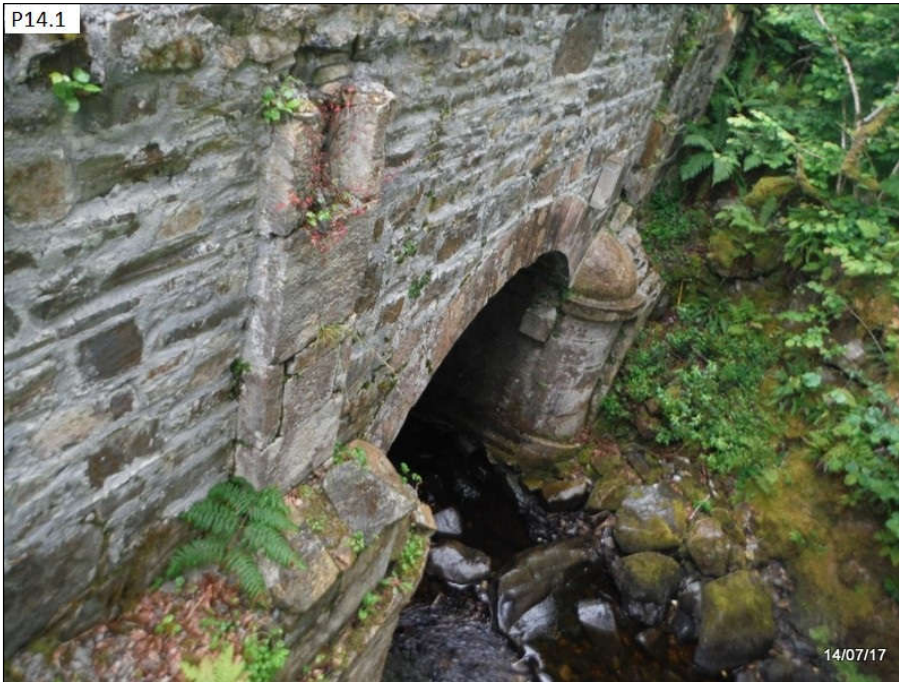
Plate 2-9 Emlaghdauroe Bridge.

Emlaghdauroe Bridge is a single span masonry arch and concrete slab structure with an overall span width of 4.7m. Masonry walls and steel safety barriers line the road. The bridge spans an unnamed stream that flows into Ballynahinch Lake. It is located within The Twelve Bens/Garraun Complex SAC. Connemara Bog Complex SPA is located 3.2km downstream of the bridge. Plate 2.9 displays the south elevation.

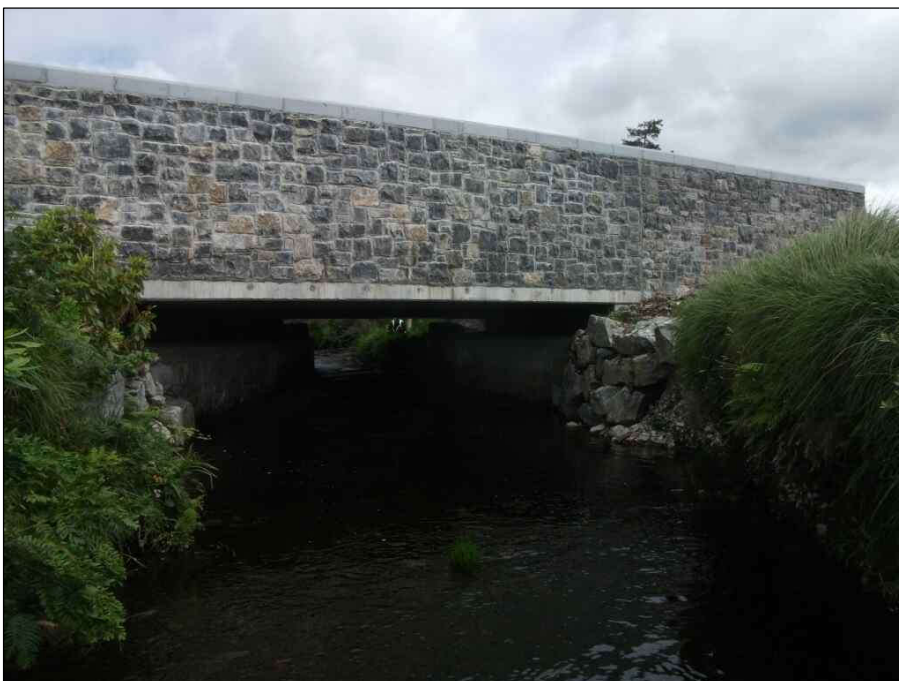
Plate 2-10 Lettery Bridge.

Lettery Bridge is a single span concrete slab structure with an overall span width of 8.17m. Masonry parapet walls line the roadway. The bridge crosses an unnamed stream within 50m of The Twelve Bens/Garraun Complex SAC. Connemara Bog Complex SPA is located 4.6km downstream of the bridge. Plate 2.10 displays the south elevation.

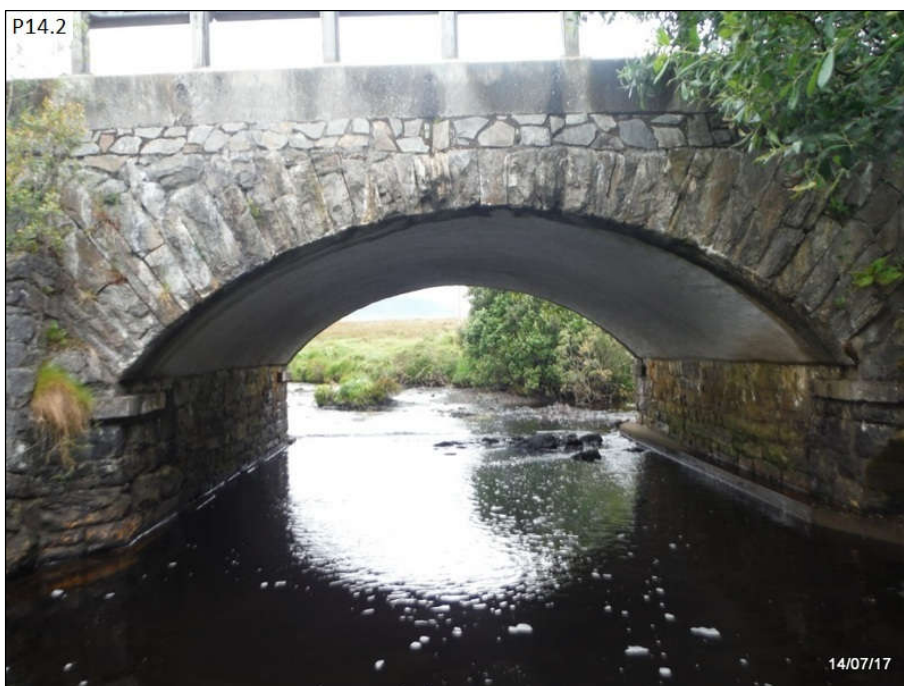
Plate 2-11 Caher Bridge.

Caher Bridge is a single span masonry arch bridge with an overall span width of 6.12m. Steel safety barriers line the road. The bridge crosses the Owentooey River within Maumturk Mountains SAC and 15.2km upstream of Connemara Bog Complex SPA. Plate 2.11 displays the south elevation.

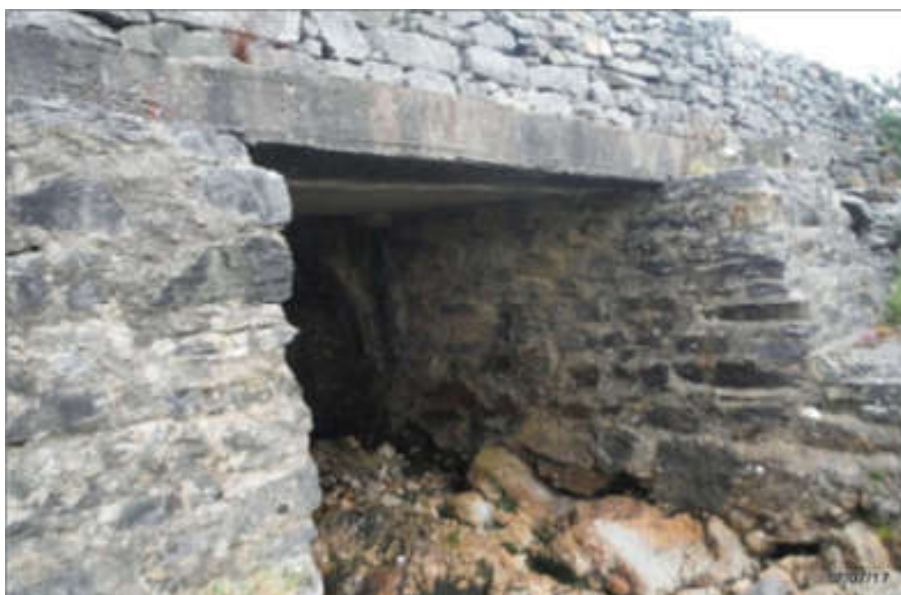
Plate 2-12 Bunsconnive Bridge.

The Bunsconnive Bridge is a single span bridge. It is a masonry arch in the north side, and it has been widened using a reinforced concrete slab in the south side. The span is 3.17m. The substructure consists of 2 masonry abutments. There are masonry parapets on both sides of the carriageway. The structure is within Connemara Bog Complex SAC and located 2.5km upstream of the of Connemara Bog Complex SPA. Plate 2.12 shows the south elevation.

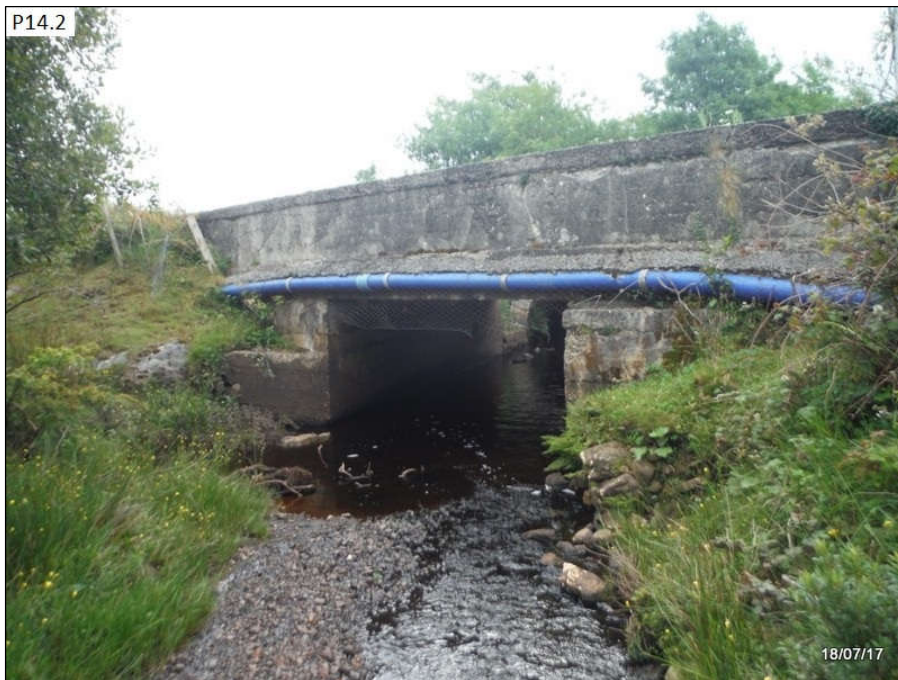
Plate 2-13 Glengowla Bridge.

Glengowla Bridge is a single span concrete slab structure with an overall span width of 3.67m. Concrete parapet walls line the road. The bridge crosses the Bunowen River within Lough Corrib SAC and 6.8km upstream of Lough Corrib SPA. Plate 2.13 displays the north elevation.

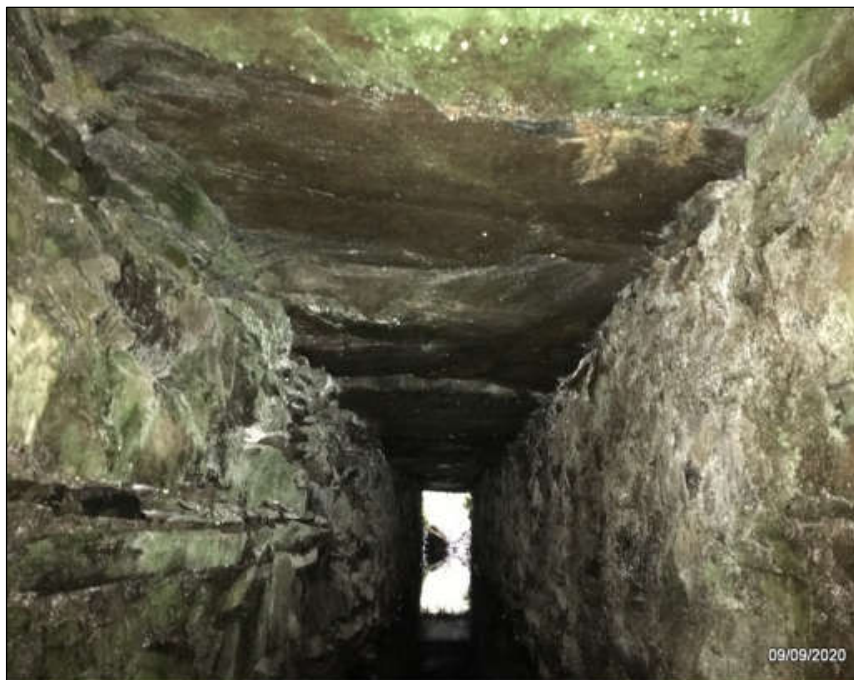
Plate 2-15 Bracklagh Bridge.

Bracklagh Bridge is a single span masonry box structure. There are no safety barriers or parapet walls along the road. The bridge carries the N59 over the Rooghaun Stream 750m upstream of Mweelrea/Sheeffry/Erriff Complex SAC. Plate 2.15 displays the bridge.

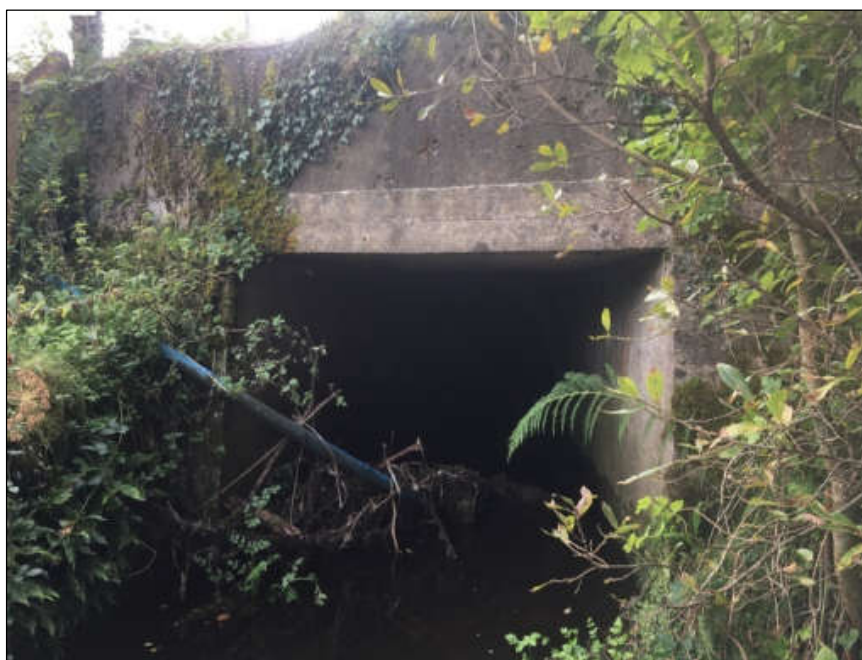
Plate 2-16 Carrowrevagh Bridge.

Carrowrevagh Bridge is a single span masonry arch and concrete slab structure. Masonry and concrete parapet walls line the road. The bridge carries the N59 over the Rooghaun Stream 250m upstream of Mweelrea/Sheeffry/Erriff Complex SAC. Plate 2.16 displays the bridge.

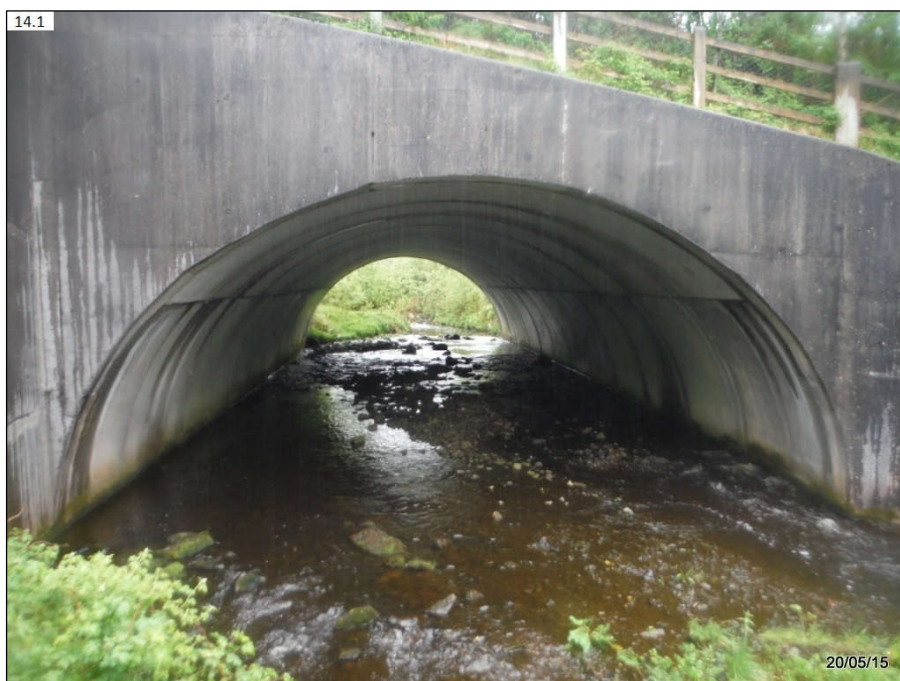
Plate 5-1 Druminnin Bridge.

The Druminnin Bridge is a single span concrete structure with an overall span width of 10.1m. Steel safety barriers line the carriageway. The bridge carries the N15 over the Clogher Stream and is located 35m upstream of Lough Eske and Ardnamona Wood SAC. Plate 5.1 displays the west elevation of the structure.

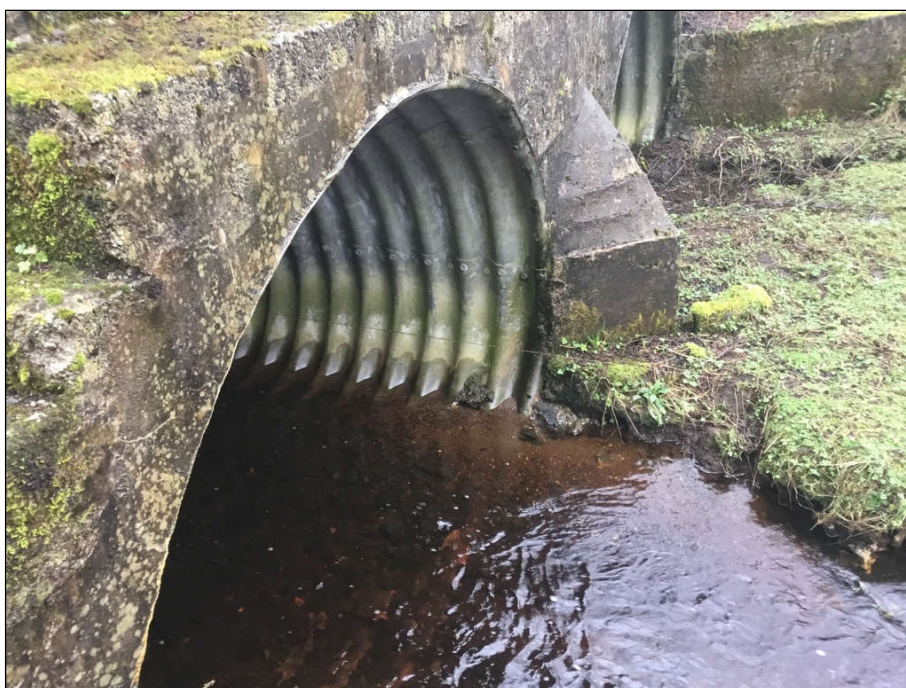
Plate 5-2 Kilraine Bridge.

Kilraine Bridge is a double span masonry arch structure with pipe extensions with an overall span width of 7m. Masonry parapet walls line the road. The bridge carries the N56 over the Kilrean Upper Stream 300m upstream of West Of Ardara/Maas Road SAC. Plate 5.2 displays the structure.

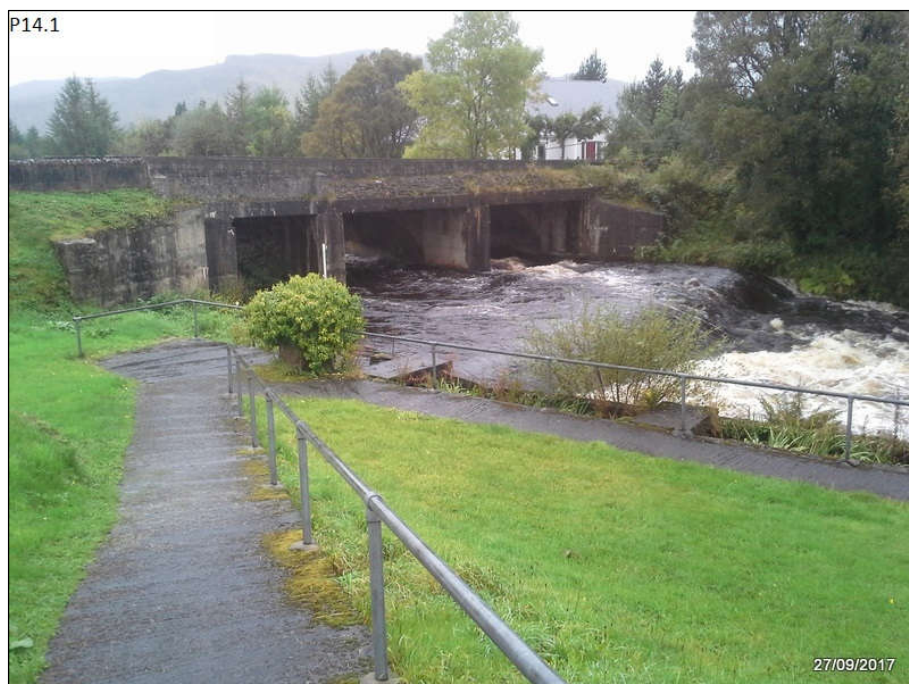
Plate 5-3 Mullanieran Bridge.

Mullaneiran Bridge is a triple span masonry arch and concrete slab structure with an overall span width of 14.3. Masonry parapet walls line the road. The bridge carries the N56 over the Owenea River within West Of Ardara/Maas Road SAC. Plate 5.3 displays the west elevation.

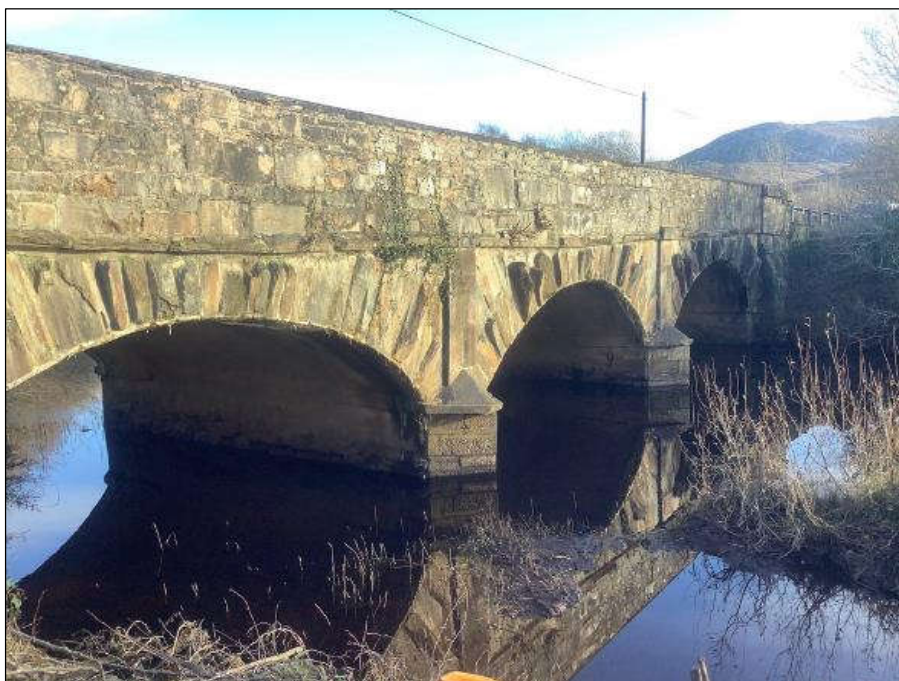
Plate 5-4 Owencarrow River Bridge.

The Owencarrow River Bridge is a 3-span masonry bridge which carries the N56 over the Owencarrow River. Masonry parapets line the road. The bridge is located within the Cloghernagore Bog and Glenveagh National Park SAC. Derryveagh and Glendowan Mountains SPA is located 3.7km downstream of the bridge. Plate 5.4 shows the bridge.

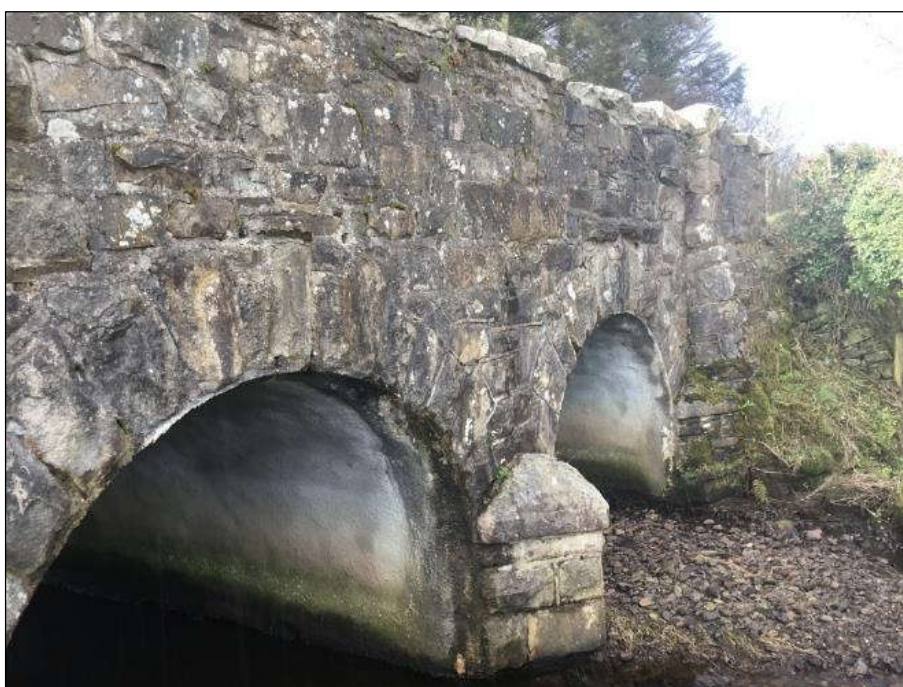
Plate 5-5 Termon Bridge.

Termon Bridge is a double span masonry arch bridge with an overall span width of 7.2m. Masonry parapet walls line the roadway. The bridge crosses the Drumluragh River and is located within Leannan River SAC and 7.6km upstream of Lough Fern SPA. Plate 5.5 shows the face of Termon Bridge.

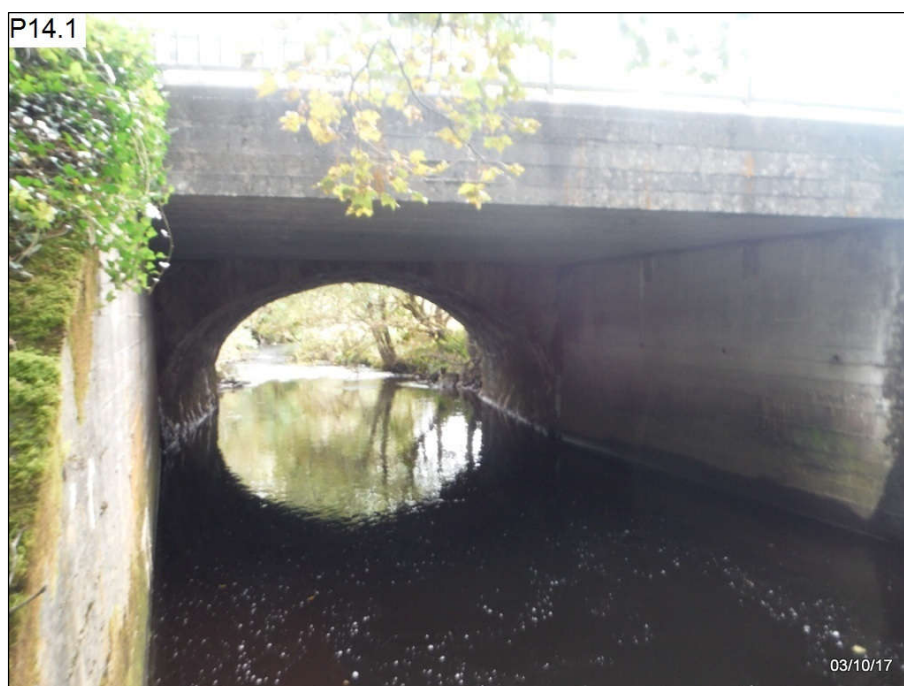
Plate 5-6 Procklis Bridge.

Procklis Bridge is a single span masonry arch structure with concrete slab extension with an overall span width of 6.3m. The road is lined by steel safety barriers. The bridge crosses the Lurgy River within Leannan River SAC and 4.7km upstream of Lough Fern SPA. Plate 5.6 displays the western elevation of the structure.

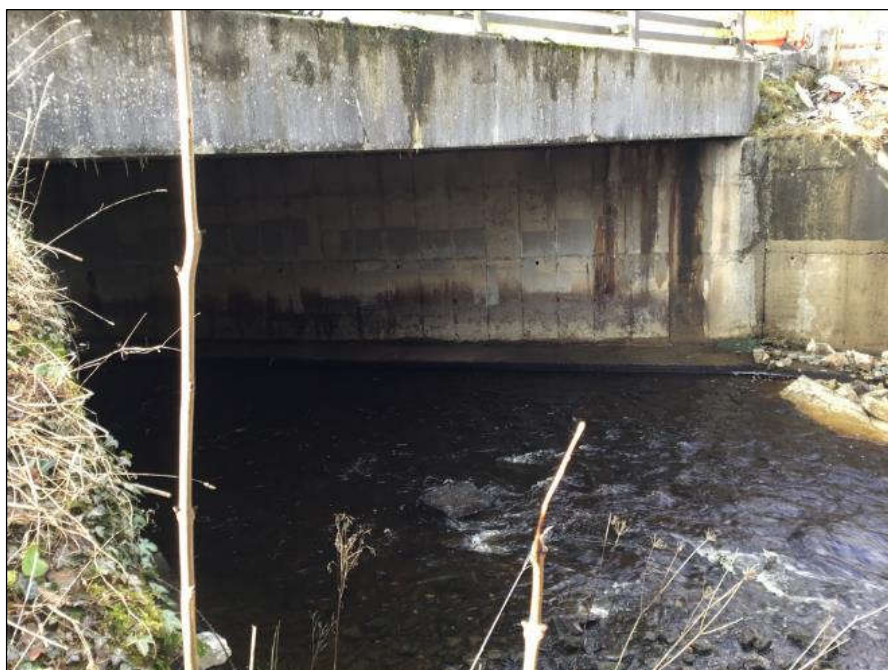
Plate 5-7 Lurgy Bridge.

Lurgy Bridge is a single span concrete slab structure with an overall span width of 10.62m. Steel safety barriers line the road. The bridge crosses the Lurgy River within Leannan River SAC and 3.5km upstream of Lough Fern SPA. Plate 5.7 displays the face of the structure.

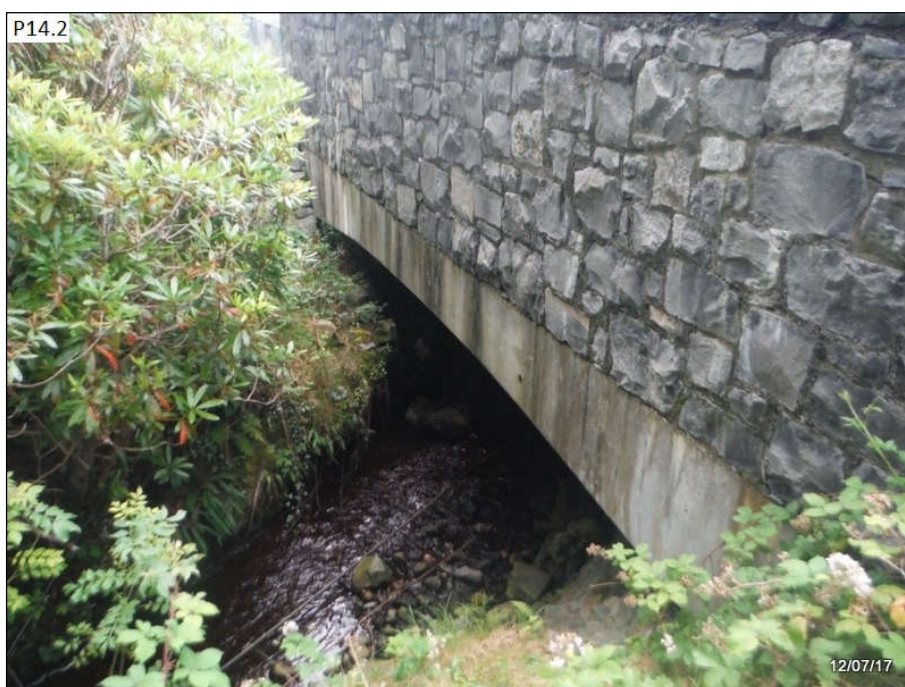
Plate 5-8 Kylemore Abbey Bridge.

Kylemore Abbey Bridge is a single span masonry arch and concrete slab structure with an overall span width of 6.58m. Masonry walls and steel safety barriers line the road. The bridge crosses a tributary of the Dawros River 100m upstream of The Twelve Bens/Garraun Complex SAC. Plate 5.8 displays the north elevation of the structure.

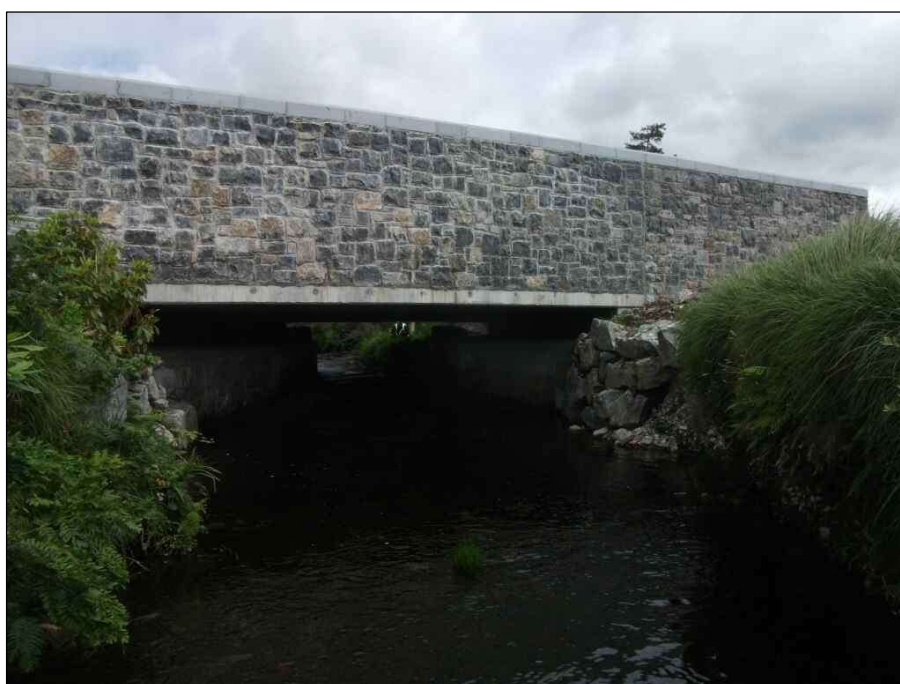
Plate 5-10 Lettery Bridge.

Lettery Bridge is a single span concrete slab structure with an overall span width of 8.17m. Masonry parapet walls line the roadway. The bridge crosses an unnamed stream within 50m of The Twelve Bens/Garraun Complex SAC. Connemara Bog Complex SPA is located 4.6km downstream of the bridge. Plate 5.10 displays the south elevation.

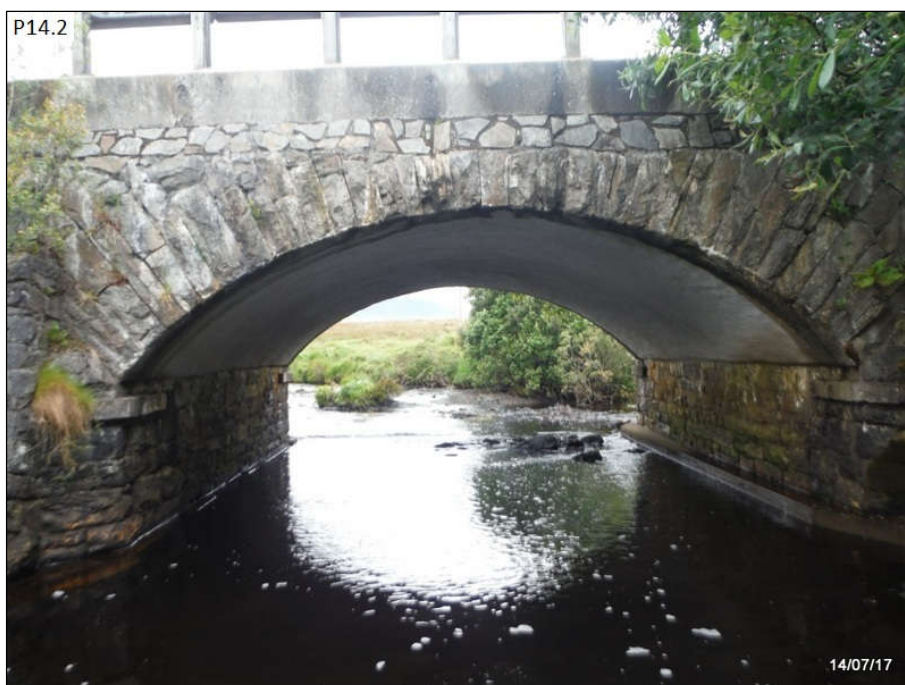
Plate 5-11 Caher Bridge.

Caher Bridge is a single span masonry arch bridge with an overall span width of 6.12m. Steel safety barriers line the road. The bridge crosses the Owentooey River within Maumturk Mountains SAC and 15.2km upstream of Connemara Bog Complex SPA. Plate 5.11 displays the south elevation.

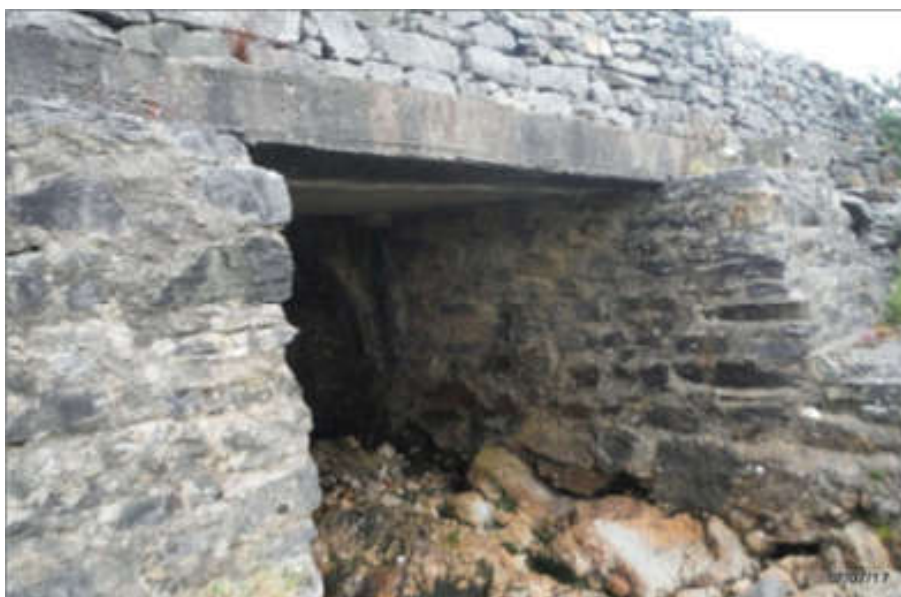
Plate 5-12 Bunsannive Bridge.

The Bunsannive Bridge is a single span bridge. It is a masonry arch in the north side, and it has been widened using a reinforced concrete slab in the south side. The span is 3.17m. The substructure consists of 2 masonry abutments. There are masonry parapets on both sides of the carriageway. The structure is within Connemara Bog Complex SAC and located 2.5km upstream of the of Connemara Bog Complex SPA. Plate 5.12 shows the south elevation.

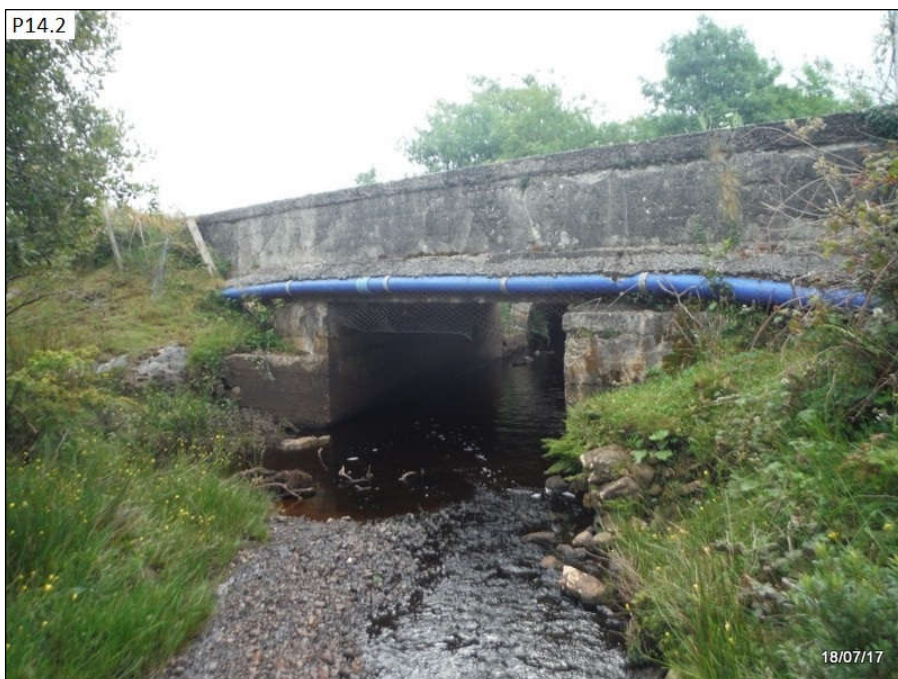
Plate 5-13 Glengowla Bridge.

Glengowla Bridge is a single span concrete slab structure with an overall span width of 3.67m. Concrete parapet walls line the road. The bridge crosses the Bunowen River within Lough Corrib SAC and 6.8km upstream of Lough Corrib SPA. Plate 5.13 displays the north elevation.

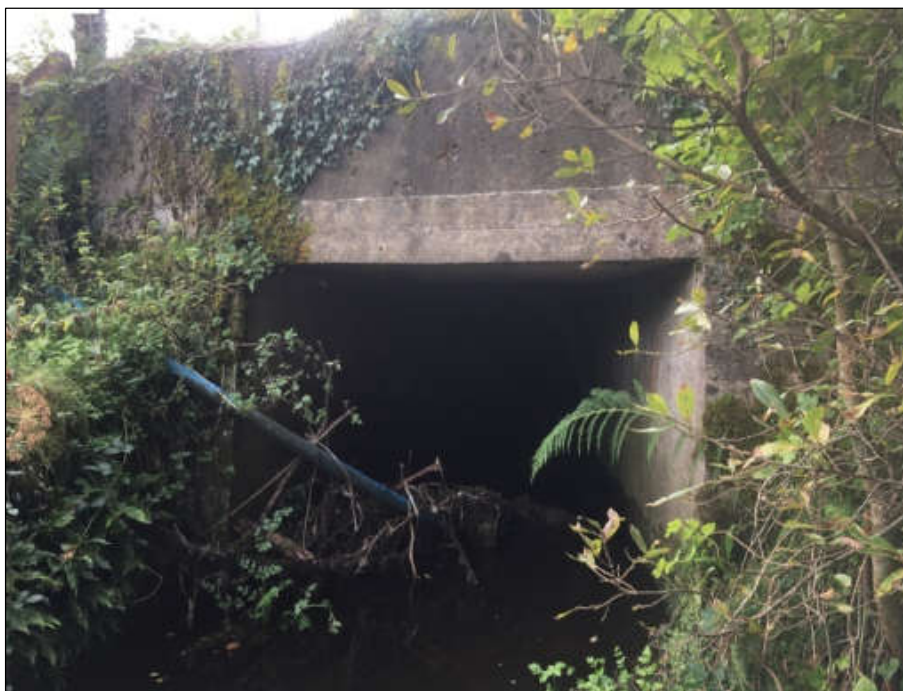
Plate 5-16 Carrowrevagh Bridge.

Carrowrevagh Bridge is a single span masonry arch and concrete slab structure. Masonry and concrete parapet walls line the road. The bridge carries the N59 over the Rooghaun Stream 250m upstream of Mweelrea/Sheeffry/Erriff Complex SAC. Plate 5.16 displays the bridge.
