Our Ref: 5162160CO249

**Re. Submission of Natura Impact Statement pursuant to the Minister for Tourism, Culture, Arts, Gaeltacht, Sport and Media pursuant to the requirements of Regulation 49(9)(c) of the European Communities (Birds and Natural Habitats) Regulations, 2011 (as amended)**

*Northwest Term Maintenance Contract No 3 – Year 3 Structures*

**Table 1 Review of Structures with respect to Otter.**

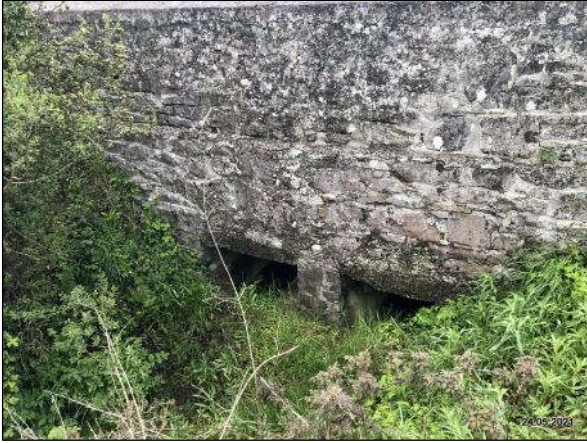
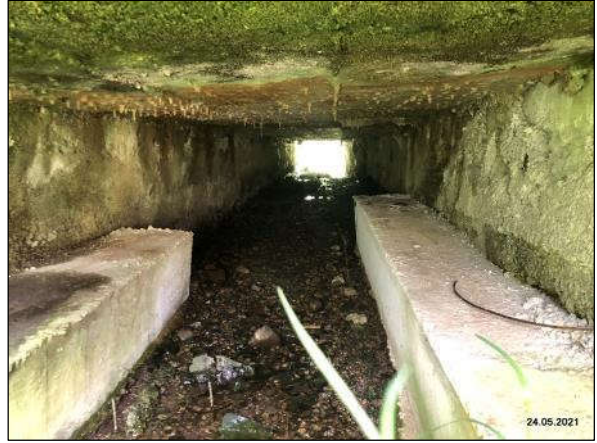
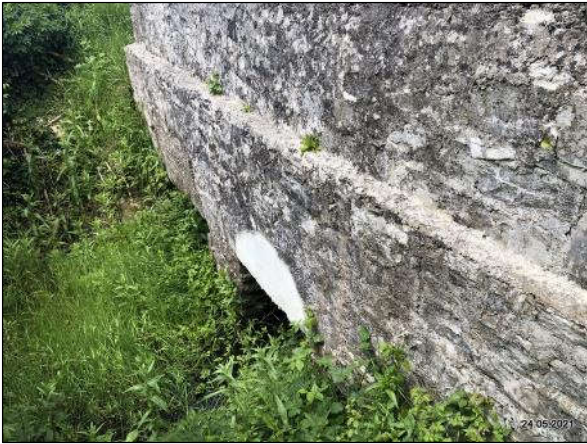
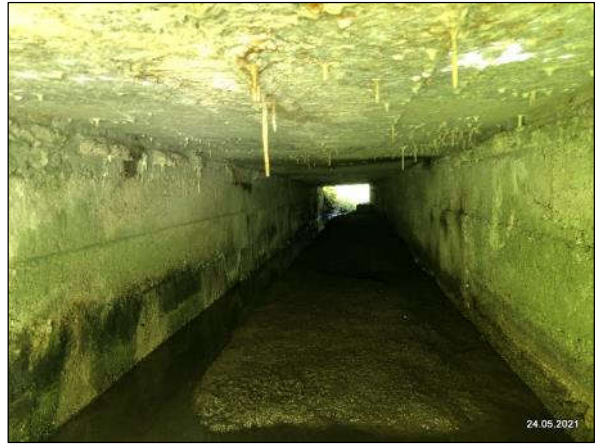
Plate 1 Anrittabeg Bridge.

Anriltabeg Bridge is a very small watercourse, with very little water management required. For the works called up at this structure and the flow present, it would be most practical to install sandbags across the full width of the channel upstream and flume through span 2 (pipe to go in circa 2m) at the downstream end of span 2, sandbags and a flume to be erected to enable the works to be carried out in the dry. The structure is too small to get a flume pipe the whole way through so dewatering at the upstream end and locally at the downstream end of span 2 is proposed.

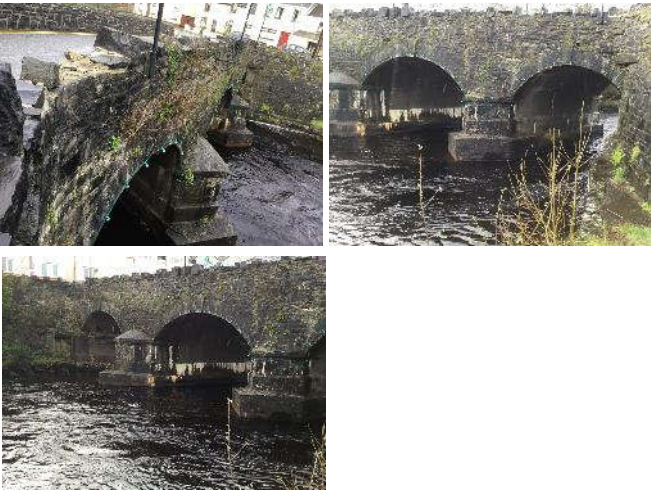
<p>No signs of Otter noted in bat report. Bridge is located within Oughtard. The immediate environs of the bridge are sub-optimal for an otter holt.</p>

The Department raised concerns regarding instream works required to erect works platforms at Oughterard Bridge. Following consultation with engineers, it can be confirmed that a bridge unit can instead be used for works at Oughterard Bridge removing the need to have the footing of a working platform within the river.

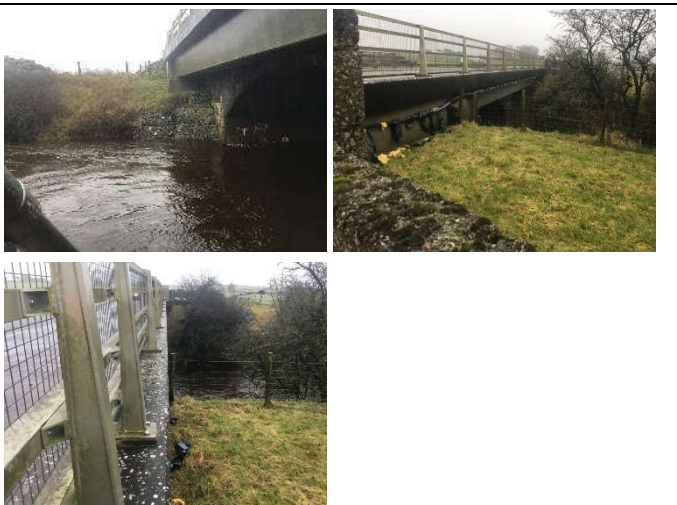
Bridge	Within	Field Surveys undertaken by an Ecologist in 2020	Photo (showing both upstream & downstream)	Information from bat survey
GC-N83-004.00 Cloonmore Bridge	within Lough Corrib SAC	Not surveyed

<p>The photo block for Cloonmore Bridge contains four images. The top-left image shows the bridge structure over a river with some vegetation on the banks. The top-right image shows a grassy bank next to the bridge with a fence. The bottom-left image shows a close-up of the bridge's concrete structure and railing. The bottom-right image shows a view of the river flowing under the bridge.</p>	<p>The immediate environs of the bridge are sub-optimal for an otter holt; with e.g. rock armouring (gabions) in place.</p> <p>Corners of bridge dominated by GA1; residential properties and revegetated spoil from river drainage. Preconstruction survey is required to account for potential changes since preparation of the NIS.</p>

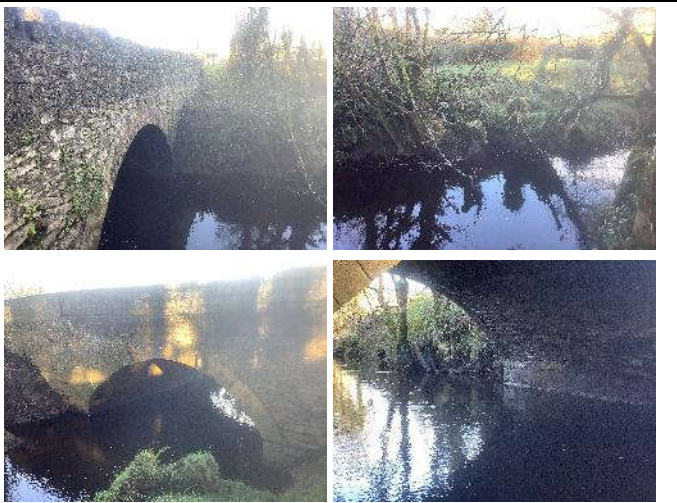
LM-N16-006.00 Scarden River Bridge	within Lough Gill SAC	Not surveyed

<p>The photo block for Scarden River Bridge contains four images. The top-left image shows a stone arch bridge over a river with trees on the banks. The top-right image shows a view of the river flowing under the bridge with trees. The bottom-left image shows a view of the river flowing under the bridge with trees. The bottom-right image shows a view of the river flowing under the bridge with trees.</p>	<p>As the probability of an otter holt is unlikely, it cannot be fully discounted. Thus, a preconstruction survey is required to account for potential changes since preparation of the NIS.</p>

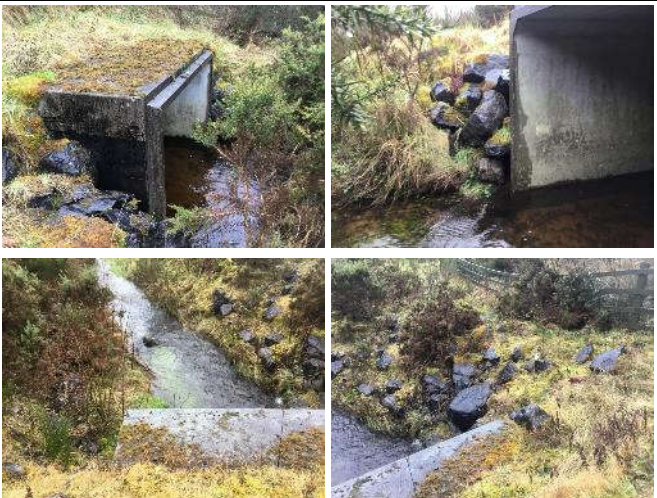
Bridge	Within	Field Surveys undertaken by an Ecologist in 2020	Photo (showing both upstream & downstream)	Information from bat survey
MO-N05-025.00 Mullenmadoge Culvert West	within River Moy SAC	Not surveyed

The immediate environs of the bridge are sub-optimal for an otter holt; with e.g. rock armouring in place.
MO-N58-004.00 Rathrusel Bridge	within River Moy SAC	Bat Survey 2020

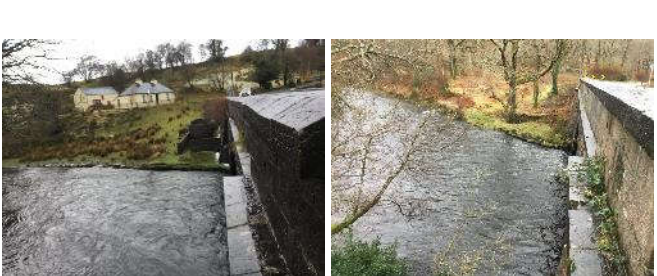
No signs of Otter noted in bat report. The immediate environs of the bridge are sub-optimal for an otter holt.

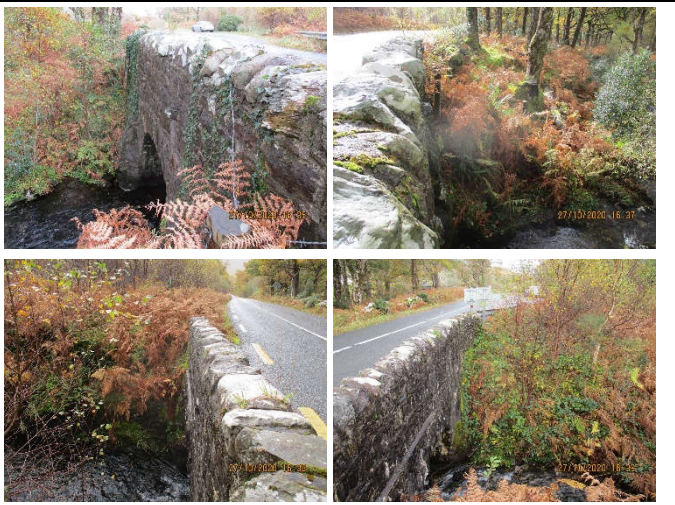
MO-N59-062.00 Luga Buidé Bridge	within Mweelrea/Sheeffry/Erriff Complex SAC	Not surveyed

The immediate environs of the bridge are sub-optimal for an otter holt.

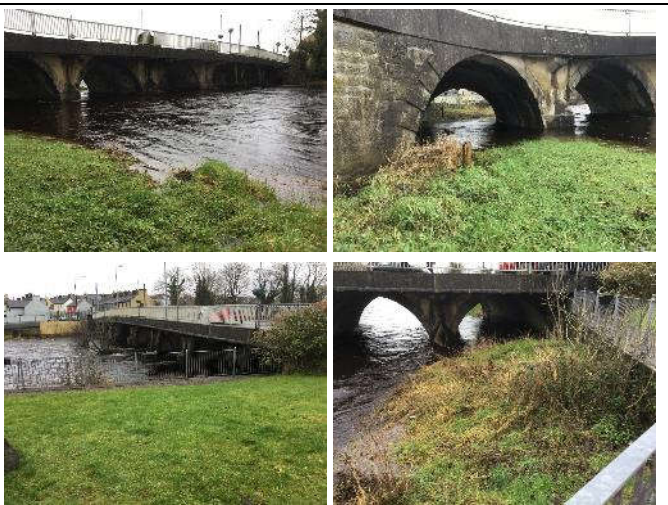
Bridge	Within	Field Surveys undertaken by an Ecologist in 2020	Photo (showing both upstream & downstream)	Information from bat survey
SO-N59-002.00 Ballysadare River Bridge	within Unshin River SAC	Bat Survey 2020

No signs of Otter noted in bat report. Bridge located in an urbanised environment. The immediate environs of the bridge are sub-optimal for an otter holt.
SO-N04-001.00 Michael Hughes Bridge	Cummeen Strand/Drumcliff Bay (Sligo Bay) SAC	Not surveyed

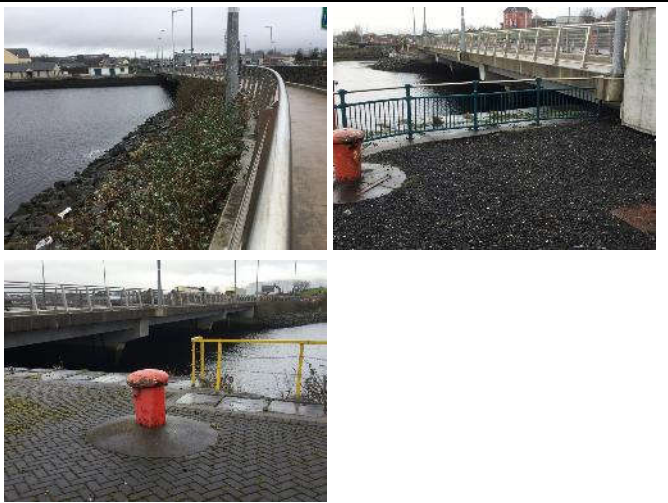
<p>Bridge located in a busy, heavily trafficked urbanised environment. The immediate environs of the bridge itself are sub-optimal for an otter holt.</p> <p>There are however a large number of records of otter from within Sligo Harbour &amp; the Garvogue River (Source: NBDC). Road kill has also been recorded form G691367.</p> <p>However, scale of works relative to bridge are small. A preconstruction survey will be undertaken.</p>
