# A Collaborative Approach To The TII VRS Regional Term Maintenance Pilot Contract

Executive Engineer, Road Design Office  
MAYO COUNTY COUNCIL

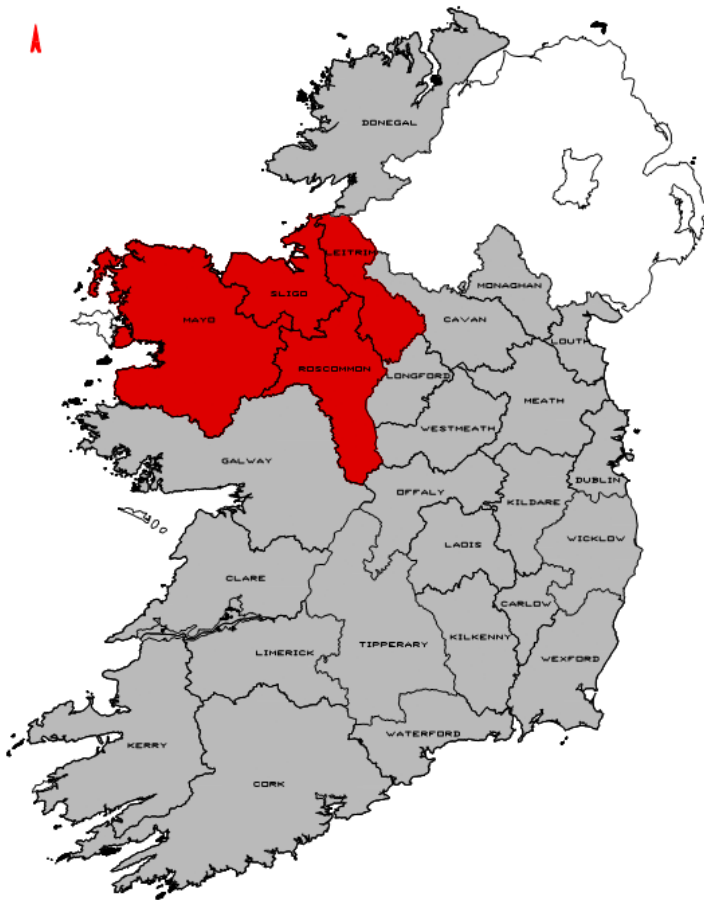
The selected region includes all VRS's on national roads in Counties Mayo, Roscommon, Leitrim and Sligo

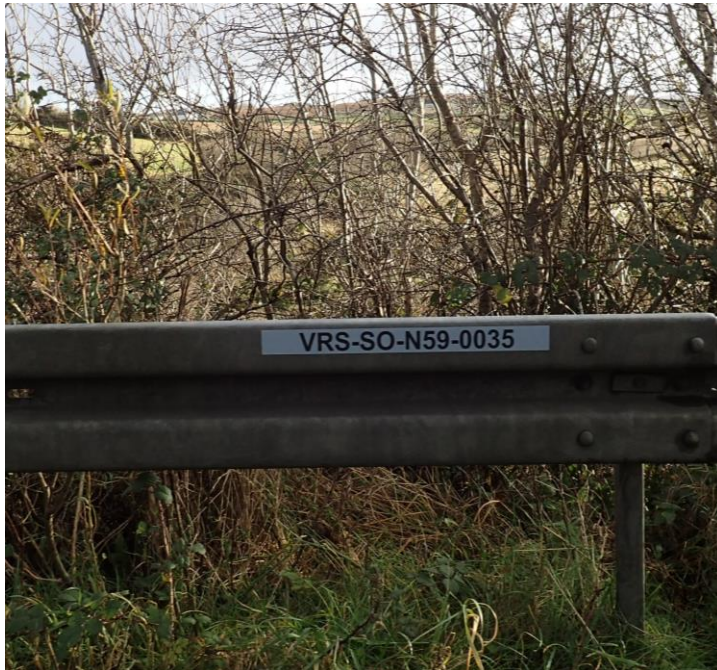
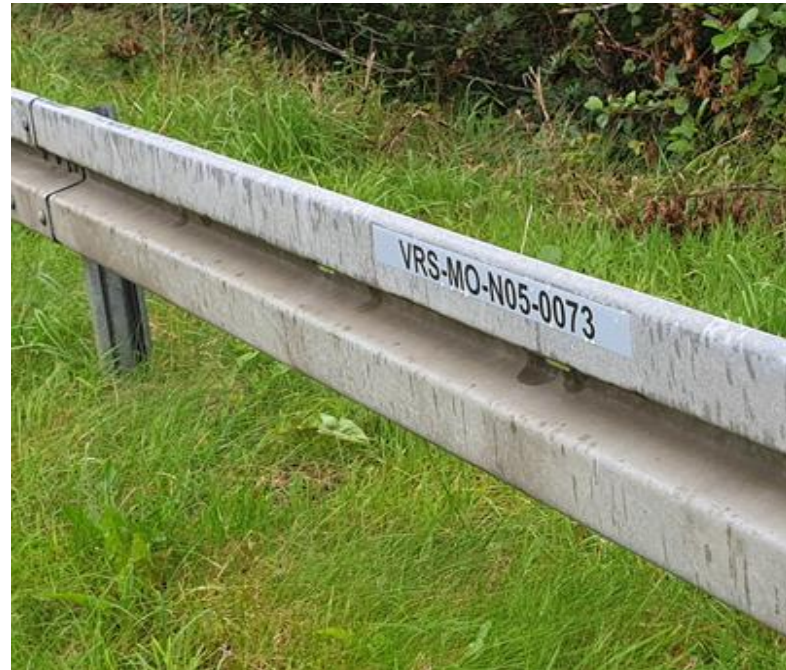
- **VRS Labelling**

- Provide unique ID for every VRS inspected
- Regular intervals – maximum 50m
- Front face of beam or traffic side of posts – readily seen from moving vehicle
- Robust adhesive, black numerals on light grey background
- Concrete barrier – number plate type label

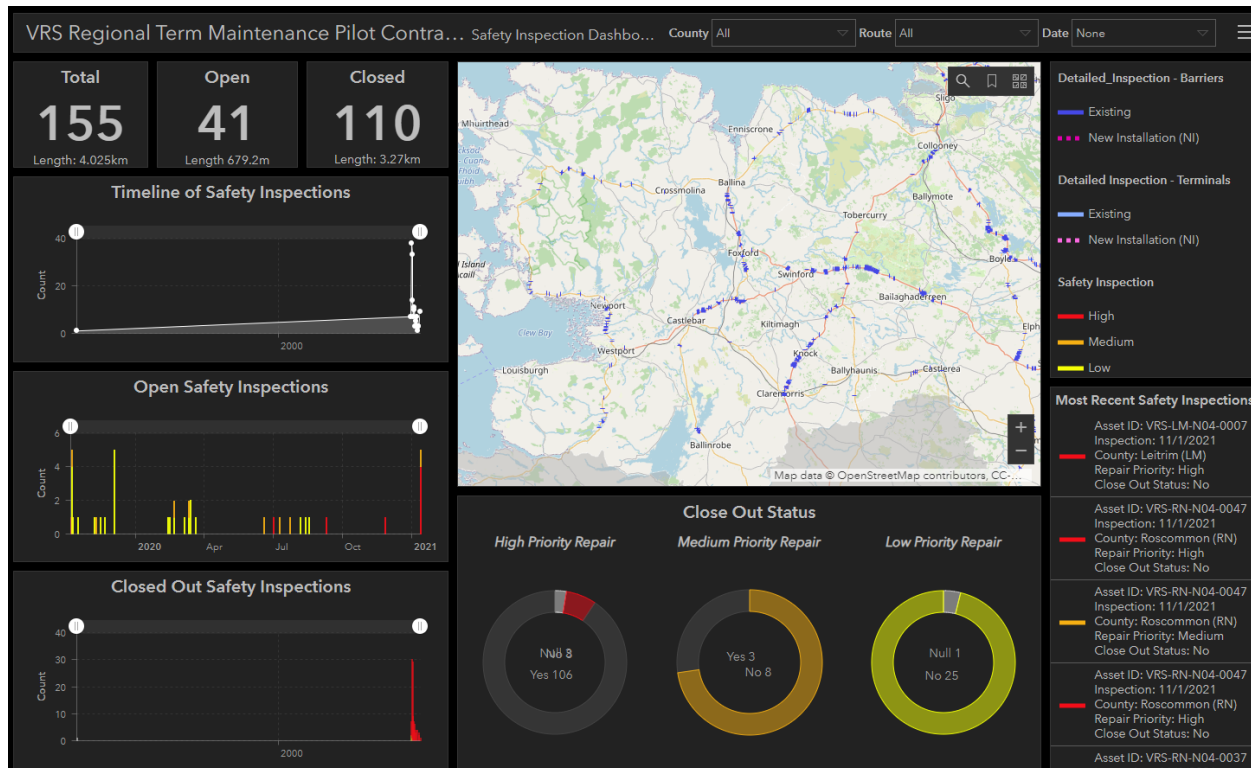
## Safety Inspection Dashboard

Developed in conjunction with ARUP through ArcGIS mapping and analysis platform

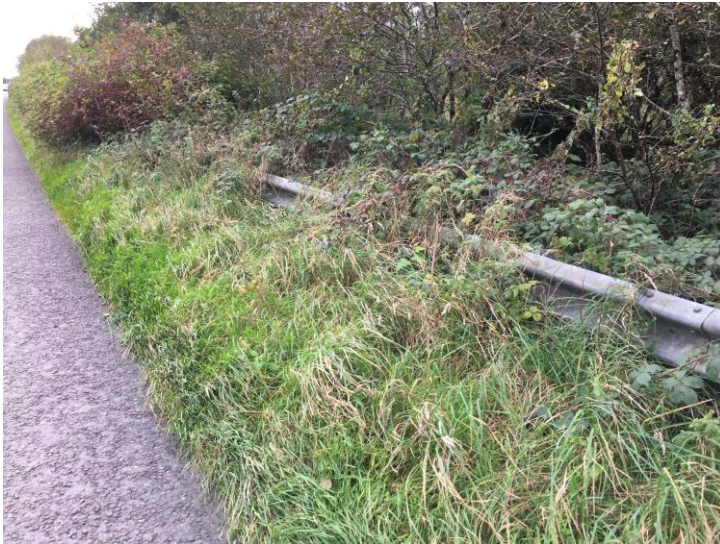
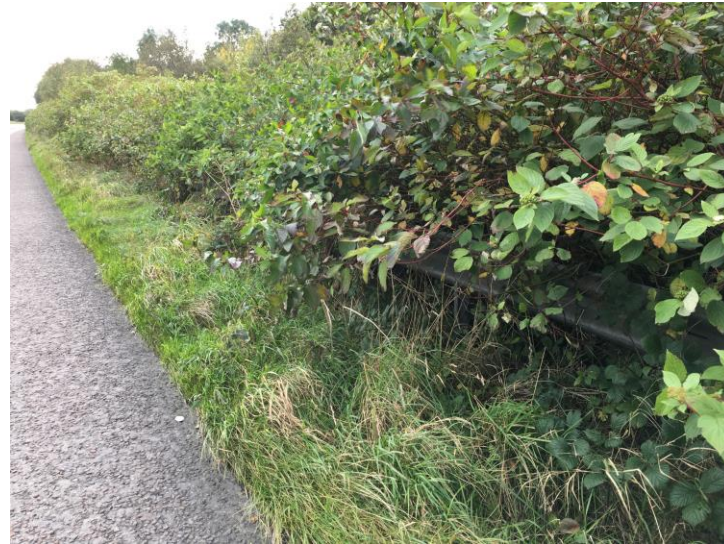
- Workload for the Contractor was heavily front loaded due to:
  - High volume of vegetation removal, 60,000m<sup>2</sup> completed 4,250m<sup>2</sup> envisaged at tender stage
  - Detailed inspection time consuming
