# Bridges and Active Travel

**TII Conference  
22 September 2022**

**Transport Infrastructure Ireland**

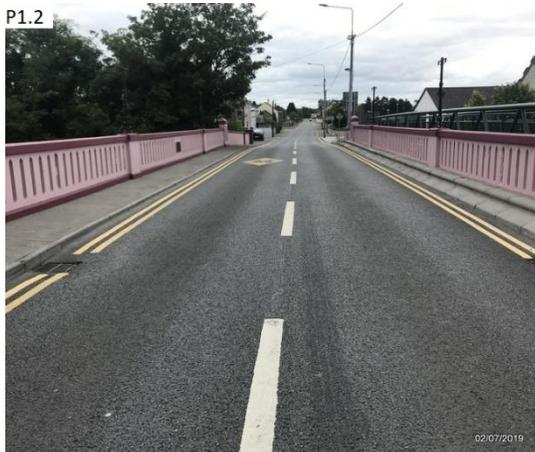
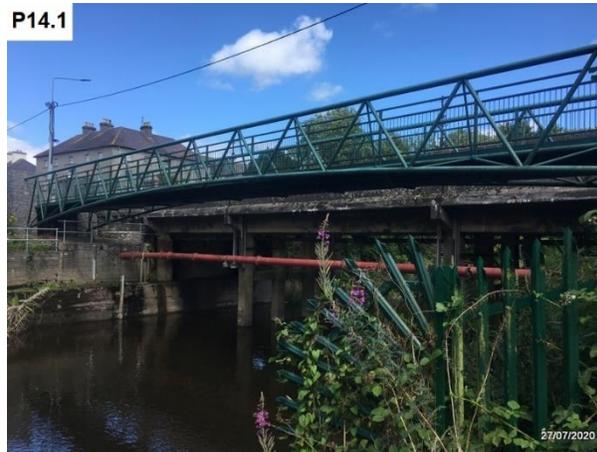
N62 Ferbane Bridge Co Offaly

Improved  
Pedestrian  
Facility

New Footbridge installed in 2009

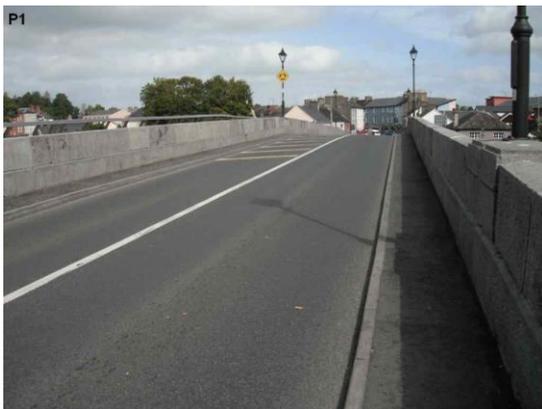
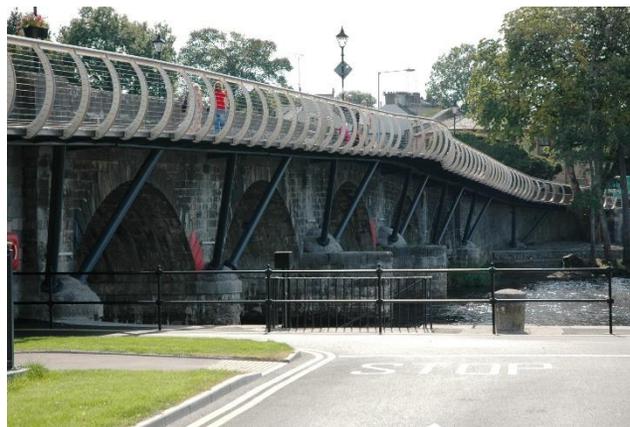
N4 Carrick-on Shannon Bridge

Improved  
Pedestrian  
Facility

New Footbridge installed in 2010

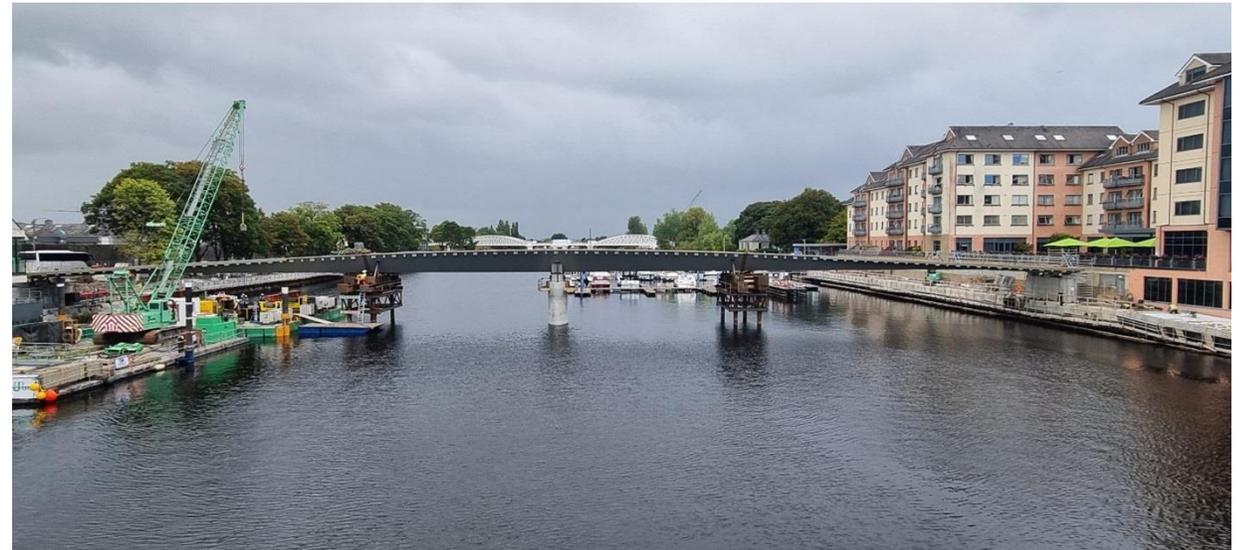
Athlone Bridge Greenway under construction 2022

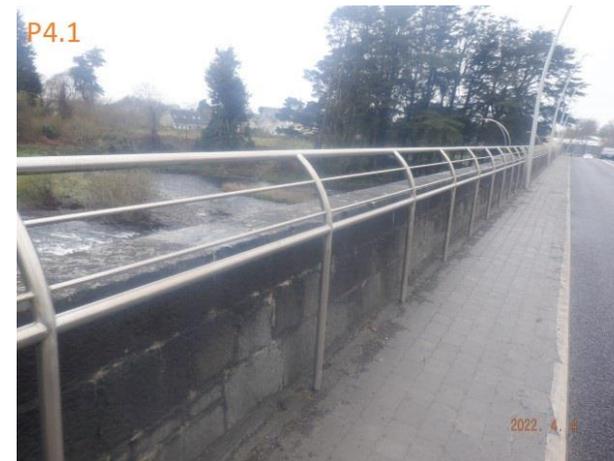
Sympathetic method to increase parapet height for pedestrians

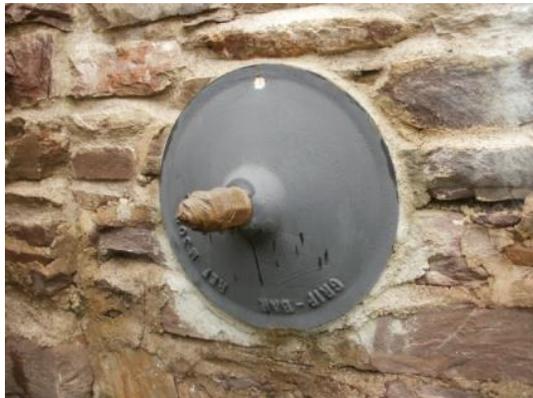
NHL5 Lime Mortar – Specification  
Series 2400

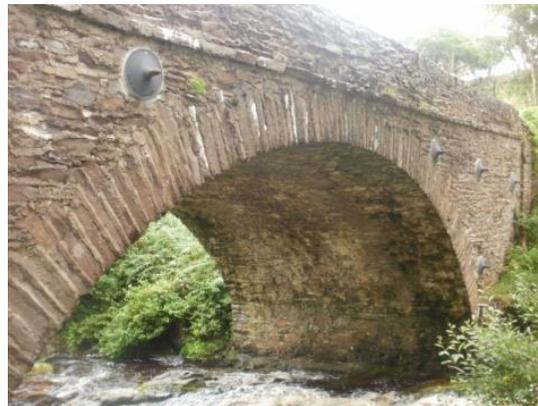
Tie-bars and Pattress plates  
prevent overturning of parapet  
and spandrel wall

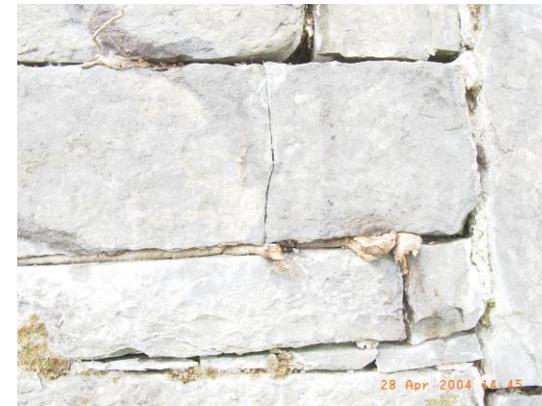
Stonework deterioration due to vegetation

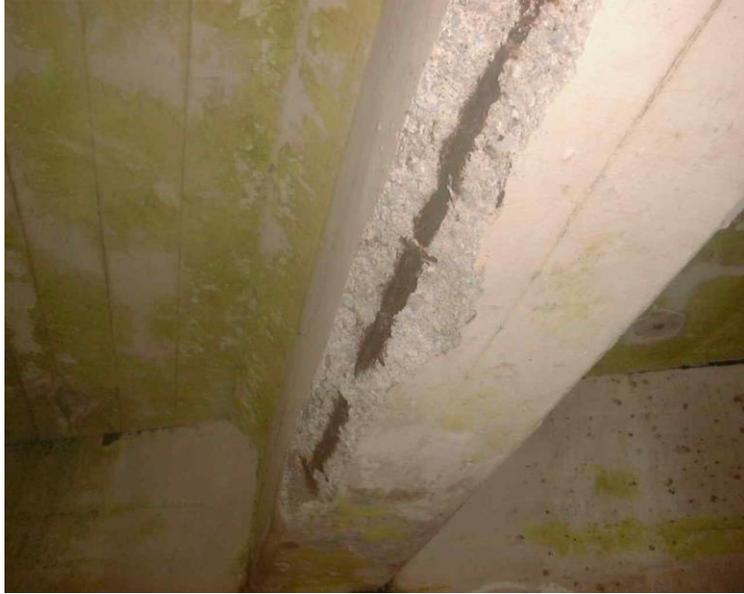
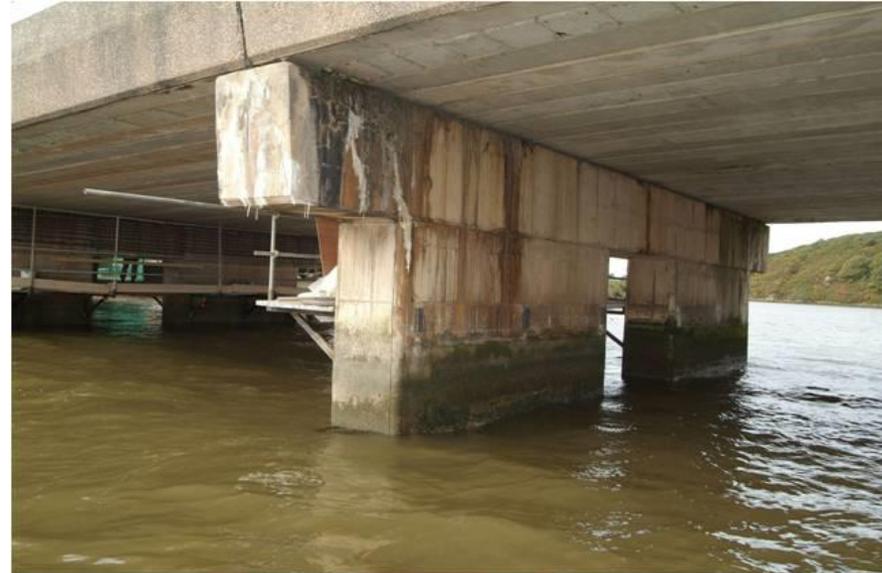
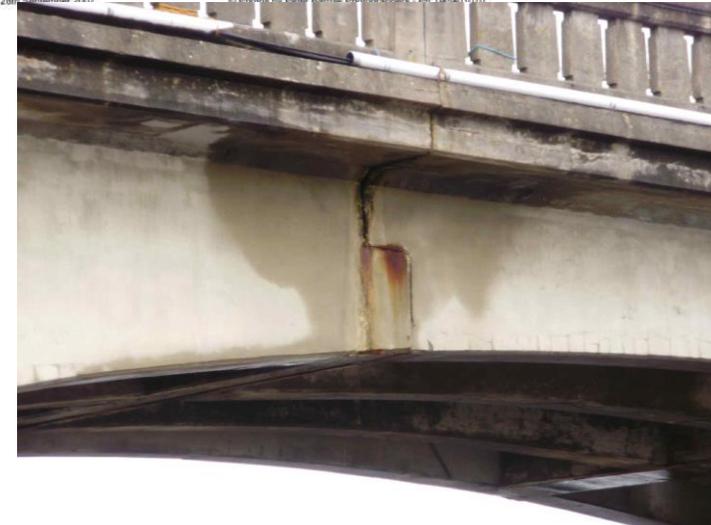
DSCF9861

Concrete delamination, concrete cracking, rust staining, leachate staining, dampness, failed expansion joints, marine environment, vulnerable half-joint detail

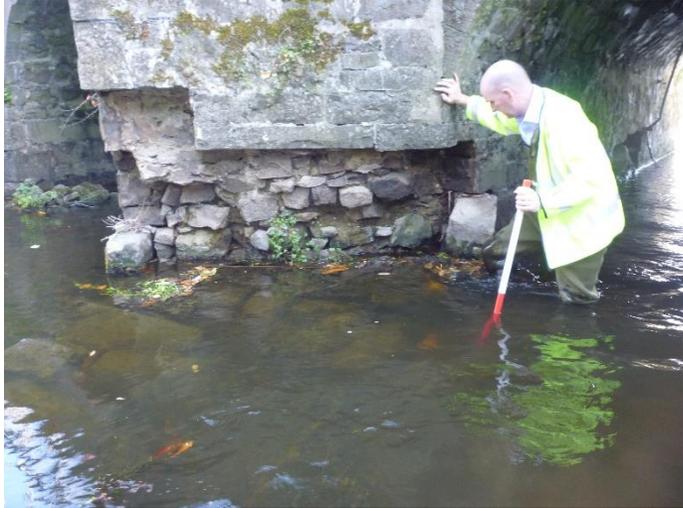
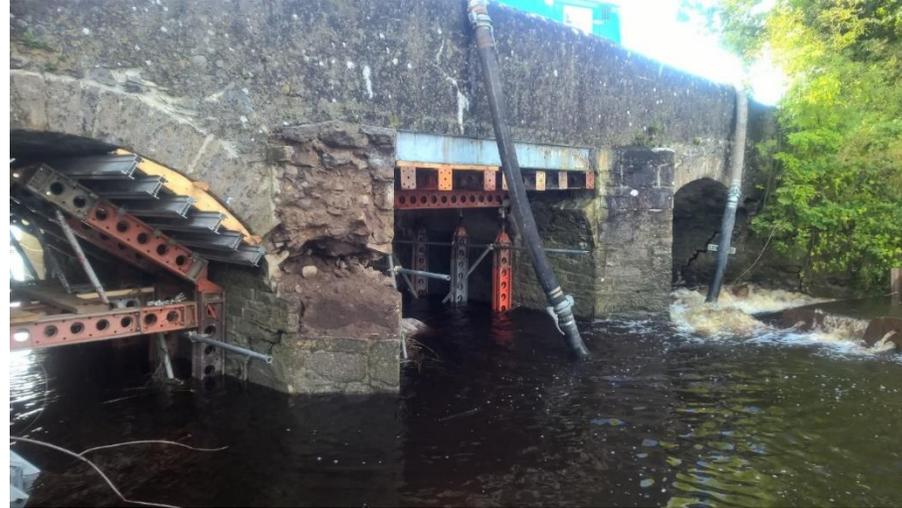
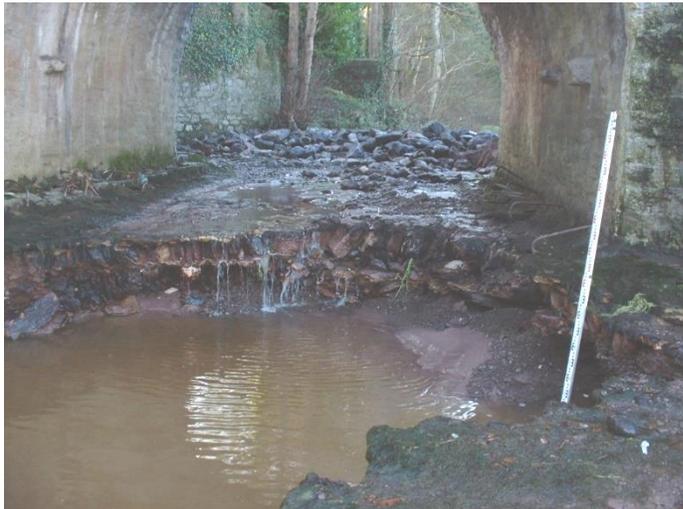
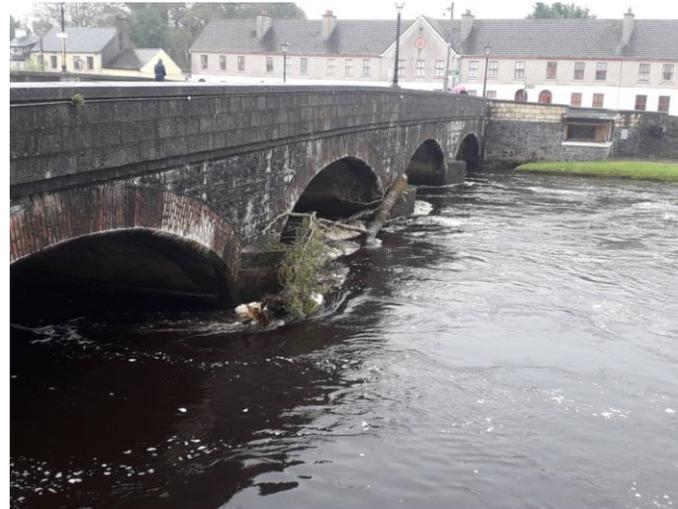
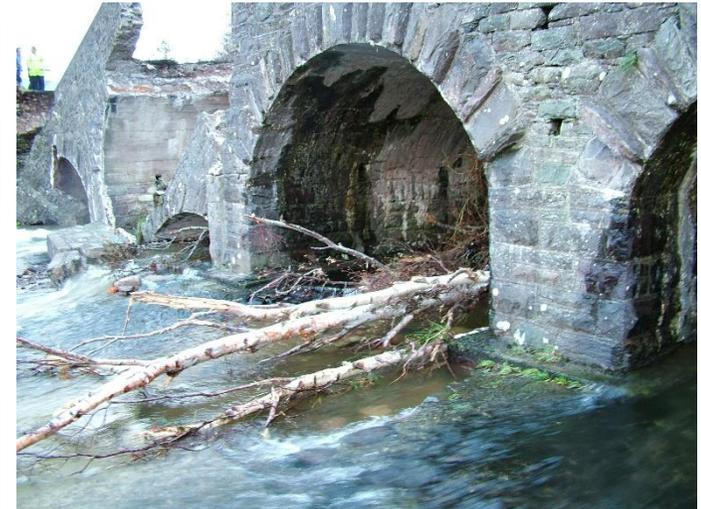
Bridges with shallow foundations are most susceptible to scour damage from erosion of the river bed

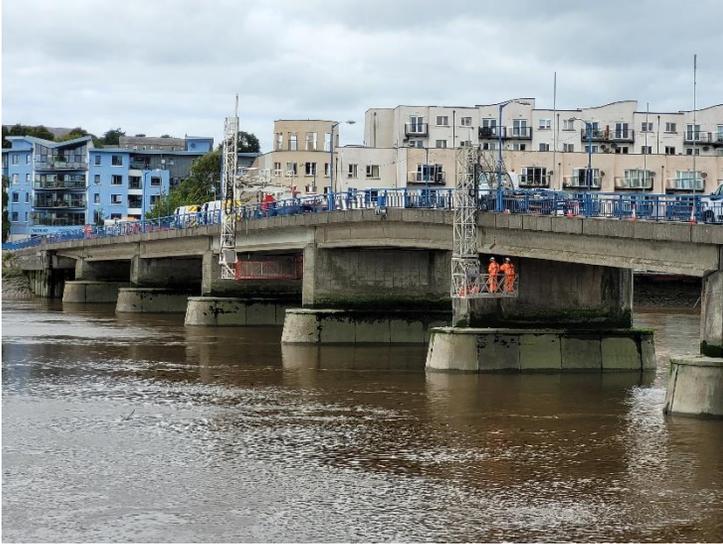
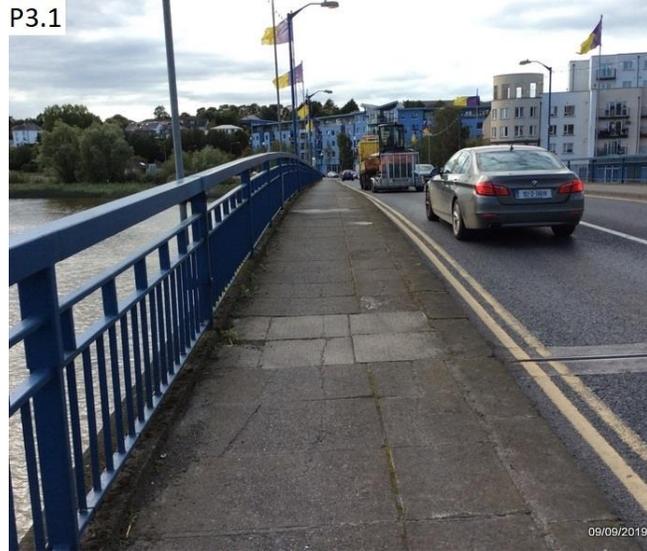
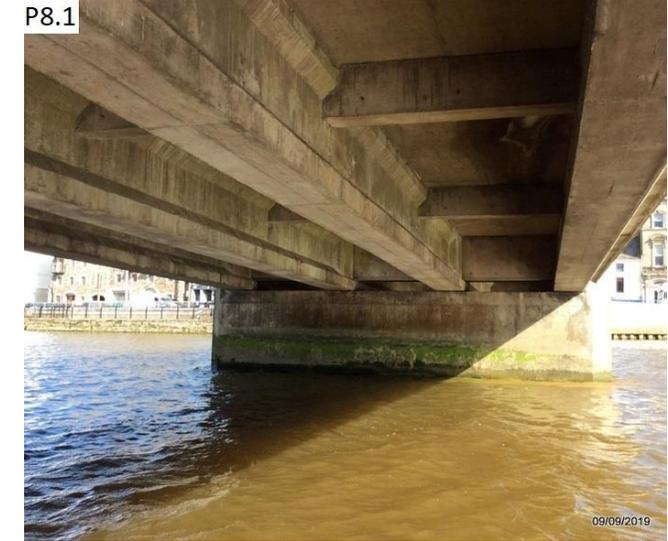
# O'Hanrahan's Bridge New Ross Wexford

- Rehabilitation of 1960s simply supported post-tensioned 170m long river bridge on a de-classified route (old N25)
- Works include Post-Tensioning Special Inspection, potential deck strengthening, replacement expansion joints, replacement parapets 1.4m high and N2 containment, deck waterproofing
- Bridge to be widened by 0.93m on southern side to accommodate a Greenway spur
- Widening of existing quay wall and bridge approach wingwalls required

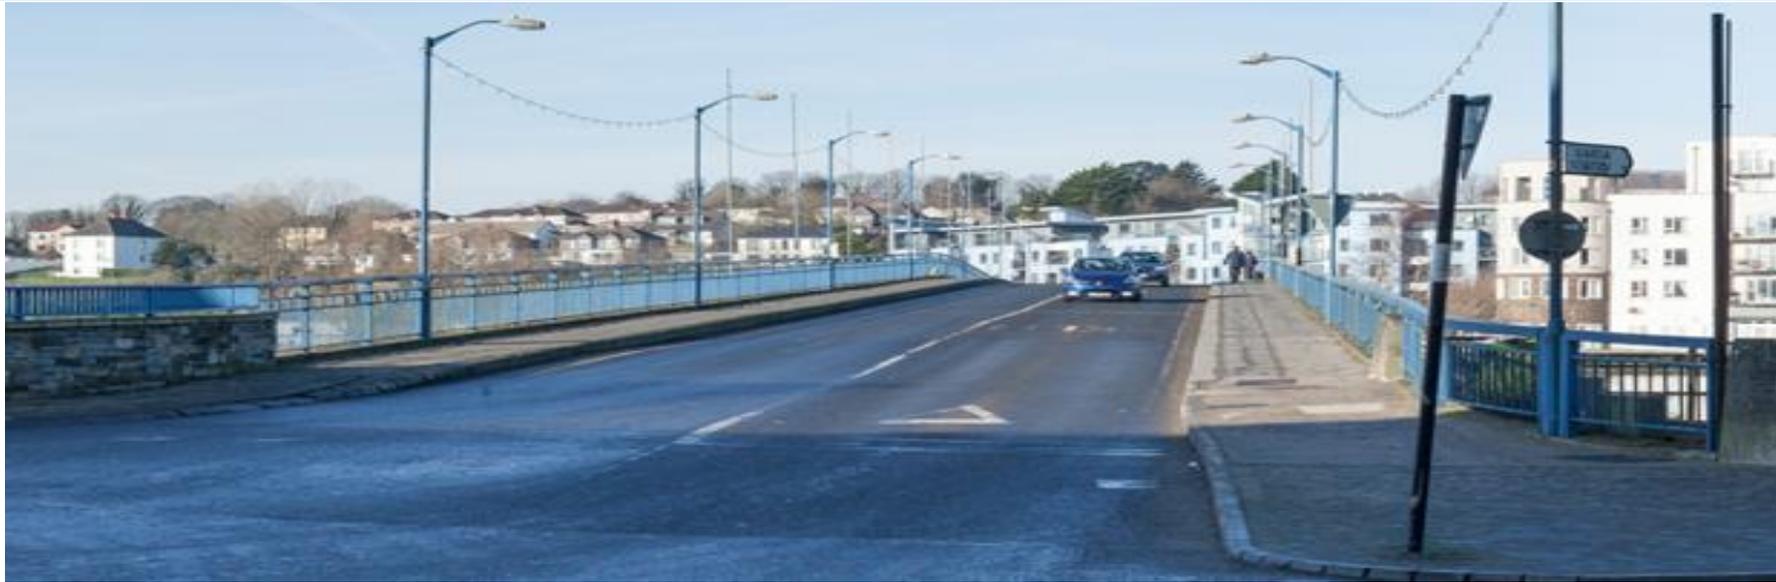
Photo of Existing Road Layout

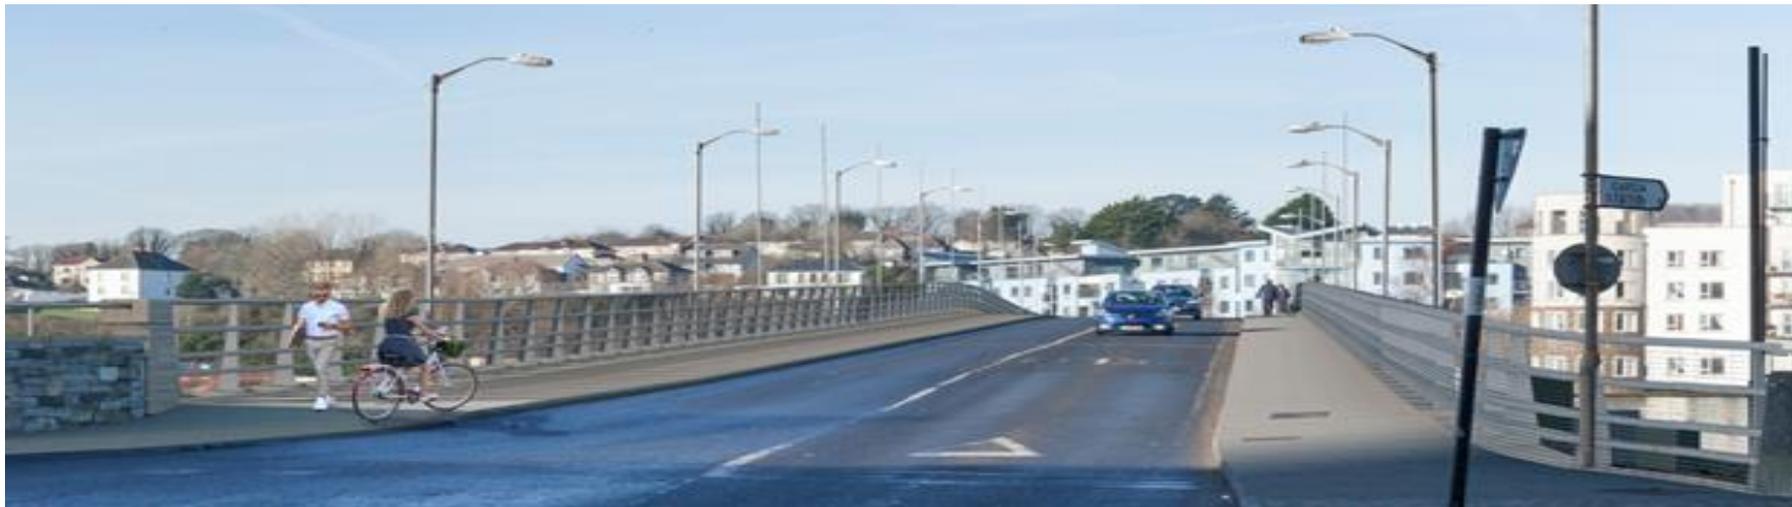
Photomontage of Proposed Road Layout

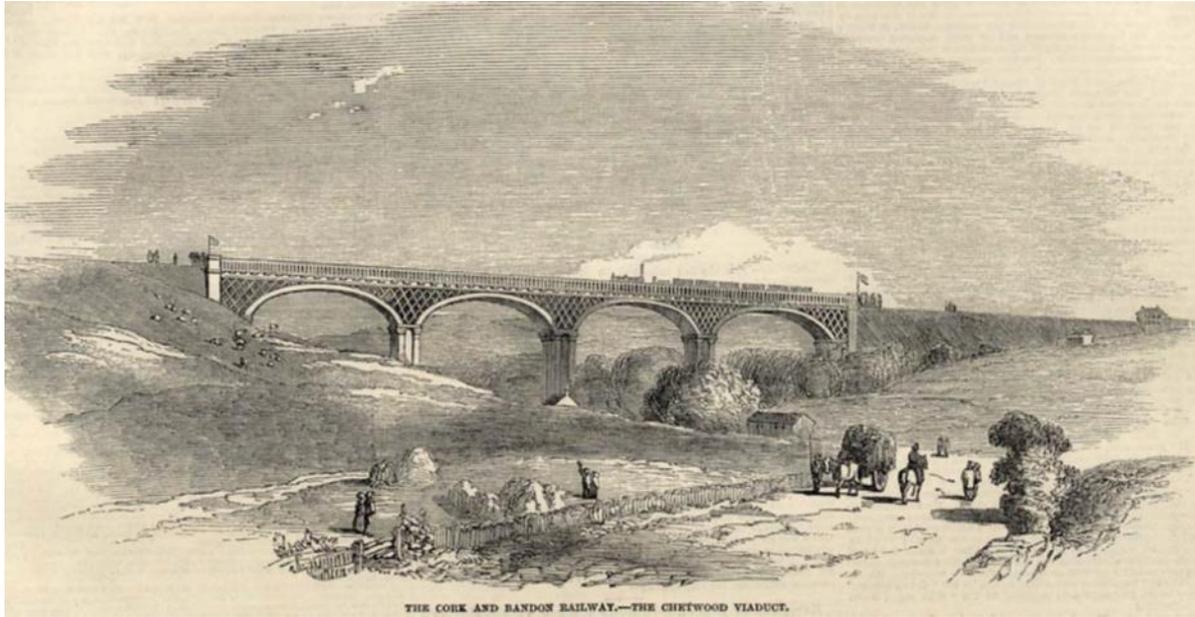
Chetwynd Viaduct, image from Illustrated London News, 1851  
Bridge opened 1851, closed 1961

- Feasibility study in 2013 investigated the viability of a Greenway from Cork to Kinsale along the abandoned railway line
- Structures included 152m long (500 feet) Chetwynd Viaduct and 800m long Goggins Hill rock tunnel
- The feasibility of the proposed West Cork Greenway is about to be reconsidered
- Deck removed in early 1970's

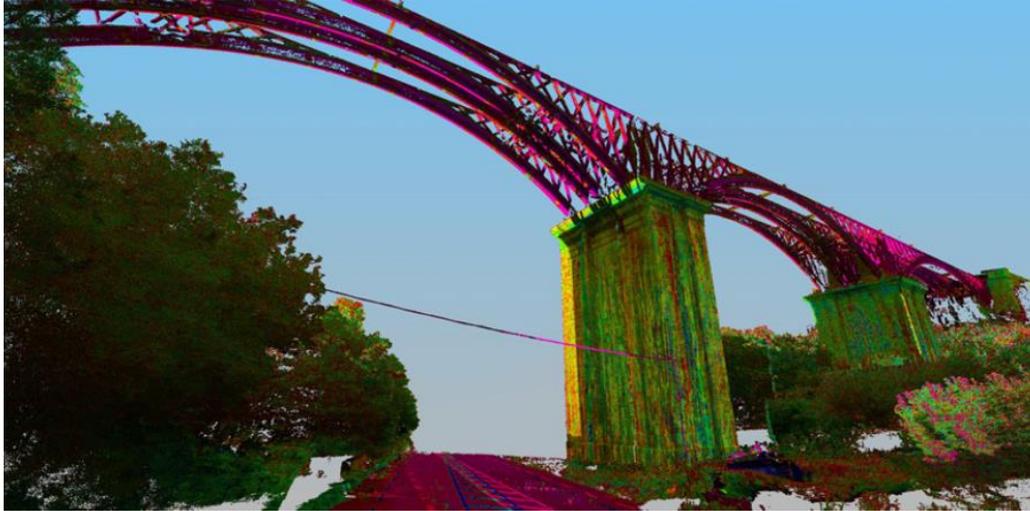
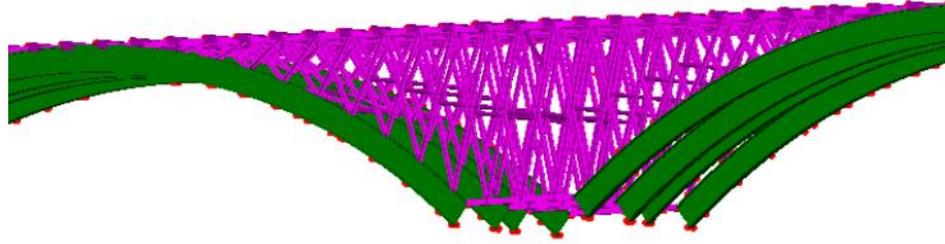
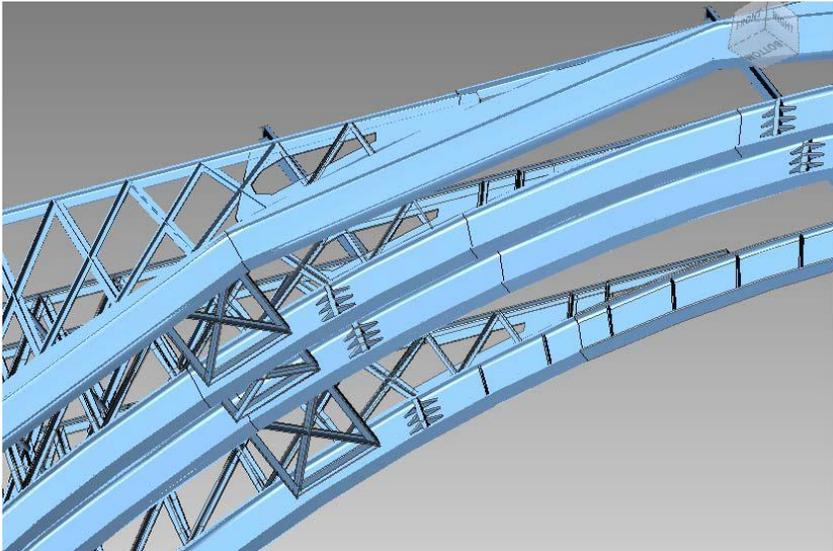
# West Cork Greenway - N71 Chetwynd Viaduct

- RPS undertook a Principal Inspection and structural assessment of the bridge in 2013
- 3D laser scan output and 3D finite element model helped with the structural assessment
- Each deck span comprises four cast iron arch ribs with cast iron bracing and wrought iron tie rods
- Main structural members are in good condition and the bridge passed its assessment for the relatively low proposed live loading

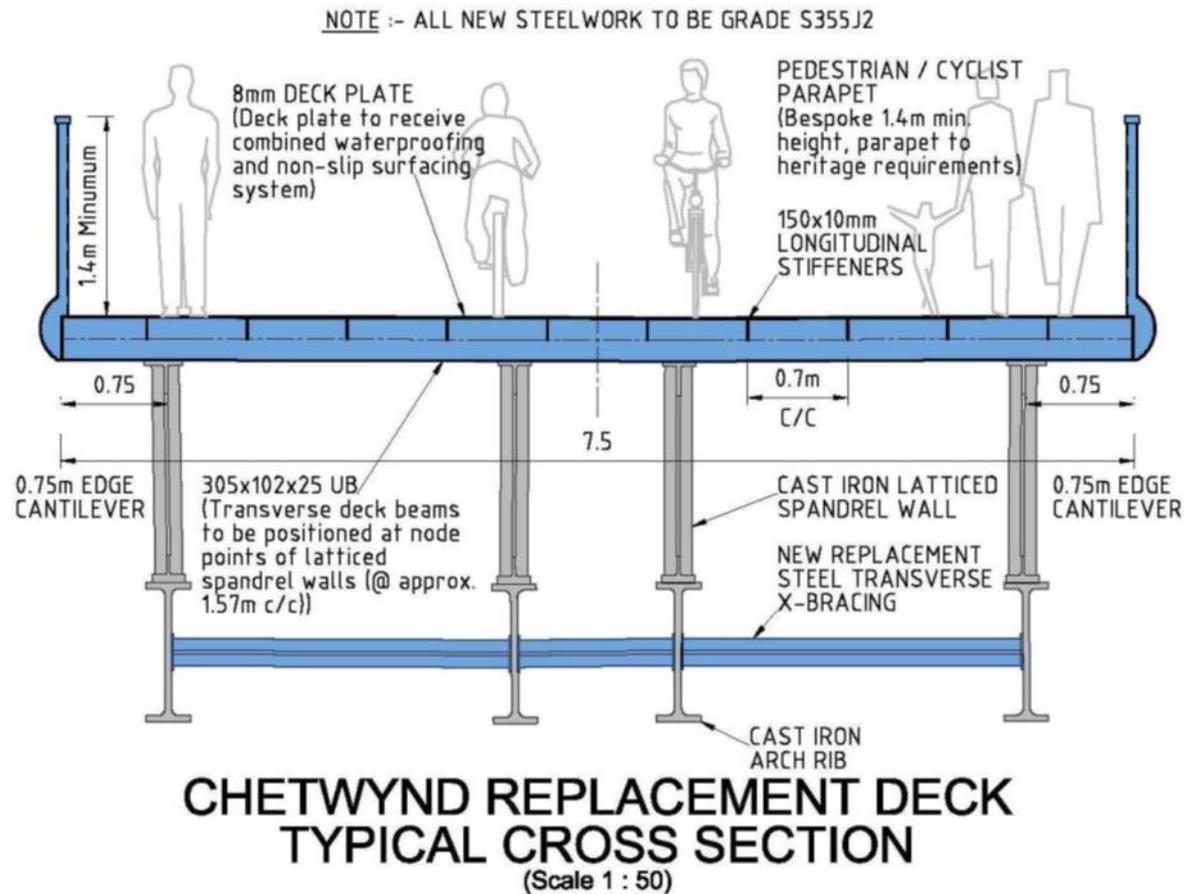
# West Cork Greenway - N71 Chetwynd Viaduct

- Options study will consider the potential of constructing a new steel deck with new steel bracing members
- 1.4m high parapets required for cyclists
- Heritage aspects to be addressed sympathetically
- The structure will have a new lease of life and will be an attraction in itself

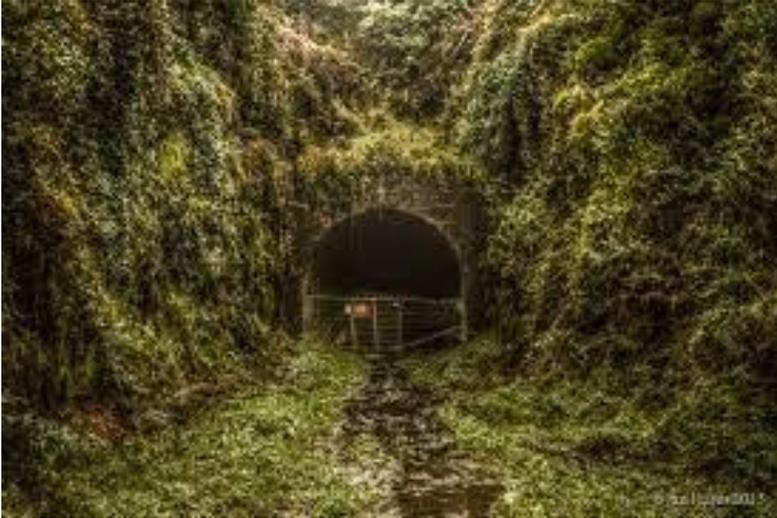
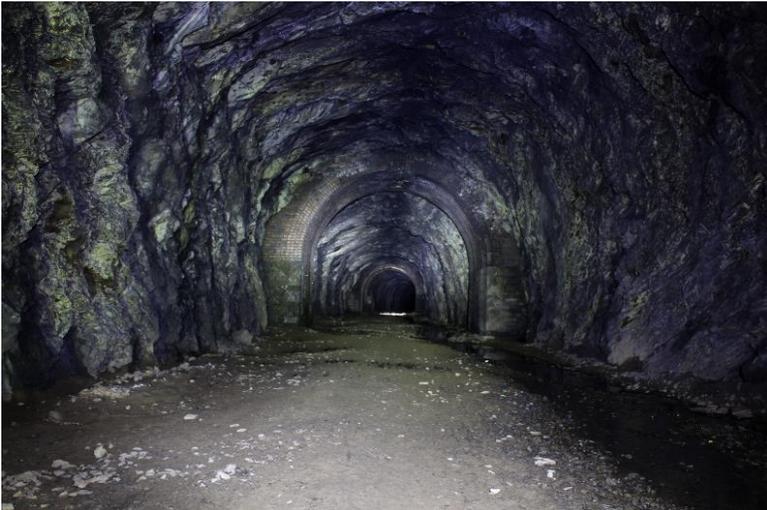
# West Cork Greenway – Goggins Hill Rock Tunnel

- 800m long rock tunnel
- TII will shortly arrange for a Principal Inspection of the tunnel and a feasibility study to ascertain the suitability of the tunnel for use as a Greenway
- Need to consider:
  - Geological investigation of the rock
  - Non-destructive testing of the rock
  - Assessment of the structural stability of the rock face
  - Need for lighting
  - Need for ventilation
  - Social aspects of using such a long tunnel
  - Inspect for rockfalls
  - Need for rockbolts or rock netting?

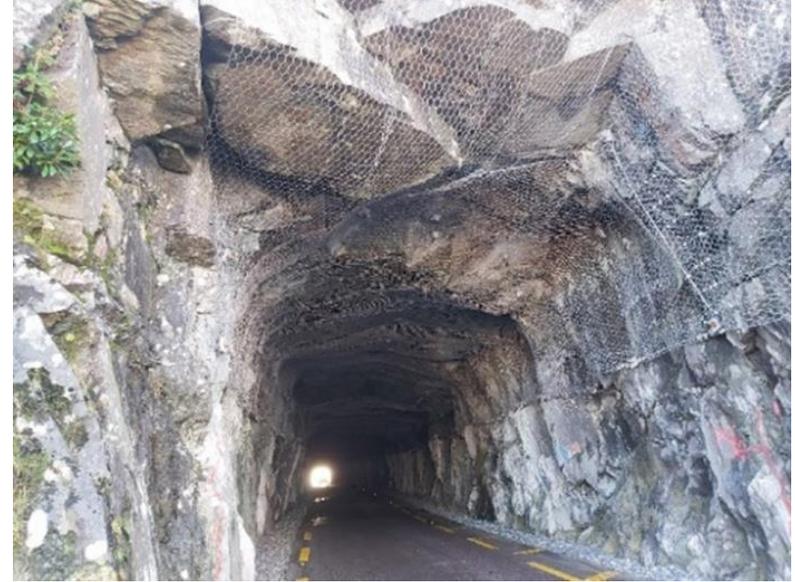
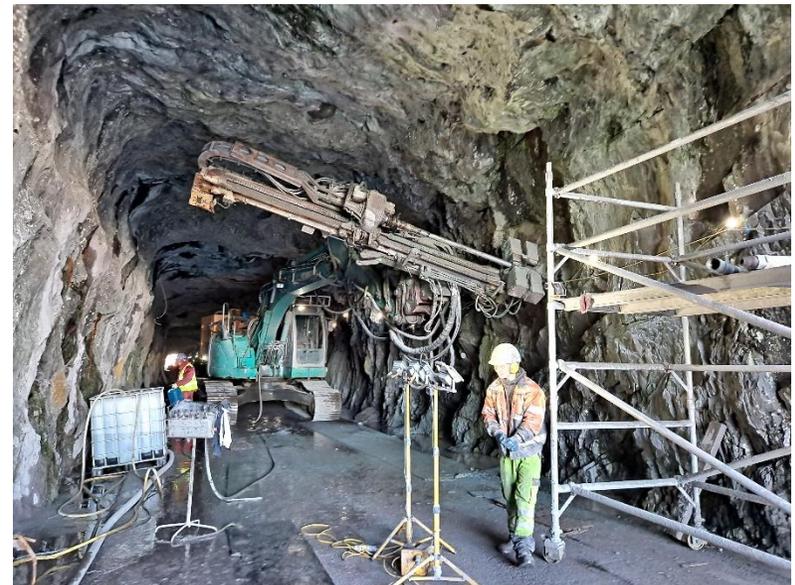
# Caha Rock Tunnel Cork/Kerry Border

- Why does Goggins Hill rock tunnel require careful investigation?
- Reports of rockfalls in the 190m long Caha tunnel reported to Kerry Co Co in 2018
- Engineering and Geological Inspections of the tunnel rock followed by regular monitoring by engineers
- Geophysical Investigation of the tunnel rock
- Ground Penetrating Radar, resistivity testing and seismic profiling required to appraise the extent of fracturing within the rock mass around the tunnel
- Testing identified the need for rockbolts to safeguard the integrity of sections of the tunnel, and rock nets to prevent small rock pieces falling onto traffic
