# Appropriate Assessment Screening - Note TO270/01

Project:	5162555_TO 270 Munster	Bridges		
Subject:	Reactive Maintenance - AA Screening No. TO270/04			
Author:	Paul O'Donoghue, Atkins Principal Ecologist	Atkins No.:	Appropriate Assessment Screening – Note TO270/04. Revision 1.0	
Date of Query:	01/08/2019	Date Issued:	06/08/2019	
Distribution:	Vincent O'Malley Christian Nea	Representing:	Atkins Atkins TII TII

Bridge	Glenbeigh National School Bridge / Coolroe Bridge	
Structure ID	KY-N70-021.00	
County	Kerry	
Location	On the N70, beside Glenbeigh National School (ING ref: 465130 589299).

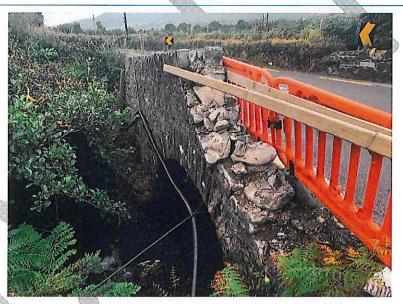
Plate 1. Damage to parapet wall on northern side of the N70.

Following a vehicle impact at KY-N70-021.00, masonry reconstruction measuring 2.9m long x 1.2m high x 0.42m deep is required. The repair will be on a like for like basis. At the area of the damage most stone is available for reuse however some imported stone may be required. Measured area of repair includes minor deformation to masonry still in place. Basic scaffold is required to complete the works which will be decked out with plywood. Any masonry in the watercourse will be recovered by hand. No concrete works are required. All repointing is to be done using NHL 5. Repairs will take approximately 2 days.

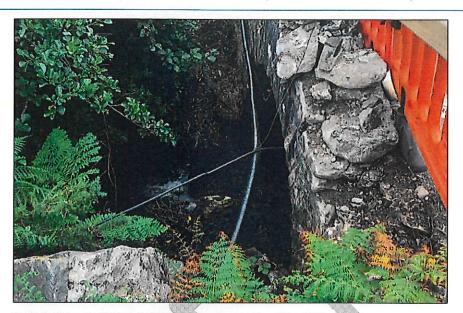
Plate 2. Damage to parapet wall on northern side of the N70.
