# NW Term Maintenance Contract No.3

Year 1 Structures

Transport Infrastructure Ireland

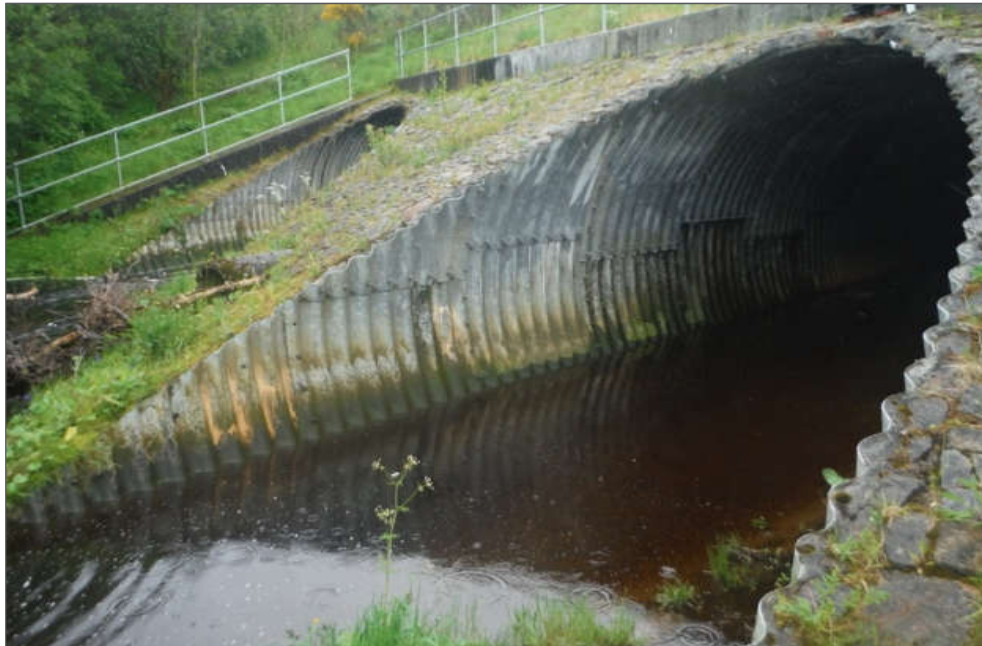
**Plate 2-1 Drumrath Bridge.**

The structure is comprised of 2 corrugated steel pipes with 3.95m diameter each. There is steel safety barrier on both sides of the carriageway and a light steel railing on the headwalls. The structure carries the N15 over the River Drumenny. The structure is within Lough Eske and Ardnamona Wood SAC and located 3.2km upstream of the Donegal Bay SPA. Plate 2-1 shows the east elevation.

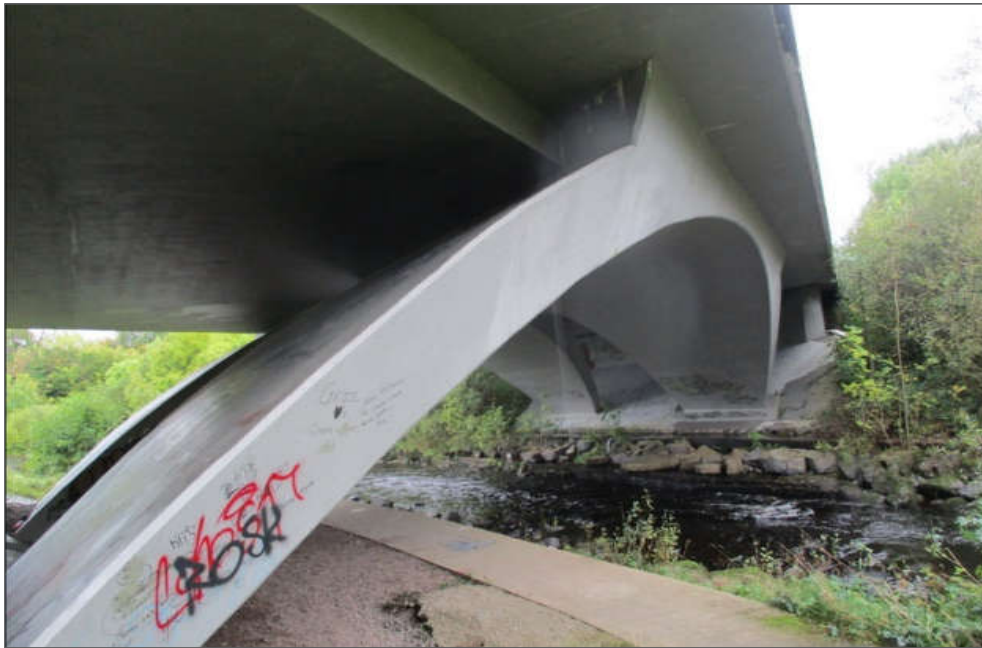
**Plate 2-2 River Eske Bridge.**

The River Eske Bridge is a 3-span reinforced concrete arch bridge. The substructure piers consist of arched columns, with the end spans reinforced concrete slabs spanning from the arch to abutments. The mid-span is 14m and the side spans are 12.4m each. The structure is within Lough Eske and Ardnamona Wood SAC and located 1.7km upstream of the Donegal Bay SPA. Plate 2-2 shows the north elevation.

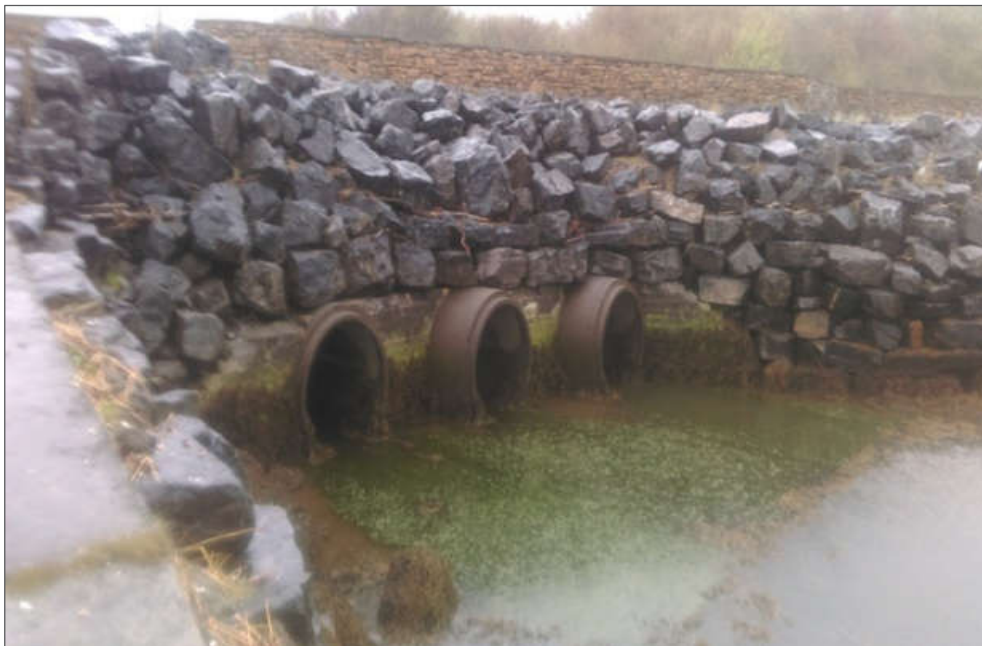
**Plate 2-3 Eddrim Bridge.**

The structure is comprised of 3 precast reinforced concrete pipes with 1.8m diameter each. There are masonry parapets on both sides of the carriageway. The riverbed is tidal. The structure is within the Donegal Bay (Murvagh) SAC and the Donegal Bay SPA. Plate 2-3 shows the south elevation.

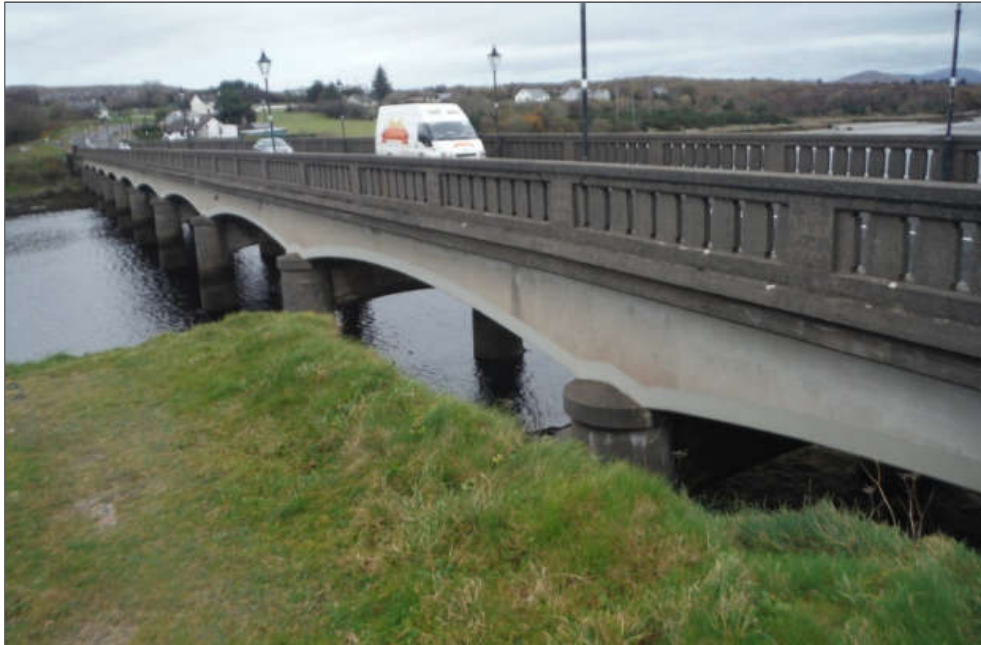
**Plate 2-4** Gweebarra Bridge.

The Gweebarra Bridge is a 11-span reinforced concrete arch bridge with in-situ concrete parapets on both sides of the carriageway. The maximum span is 18.29m and the minimum span is 8.80m. Spans 3/5/7/9 are suspended spans of 8.64m length. The structure is within the West of Ardara/Maas Road SAC. Plate 2-4 shows the west elevation.

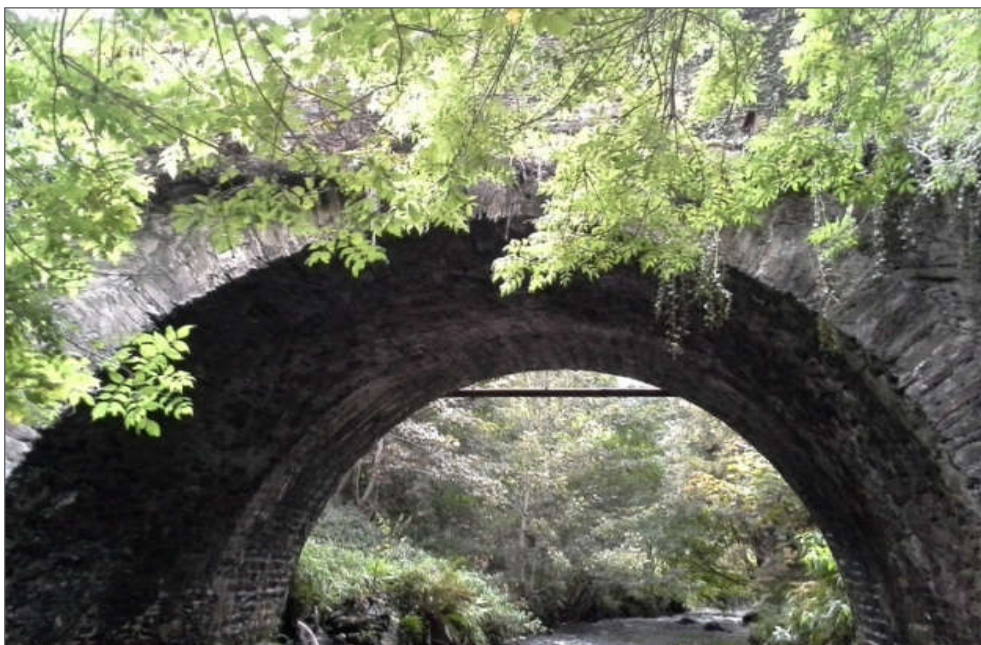
**Plate 2-5** Bedlam Bridge.

The Bedlam Bridge is a 9.12m single span masonry arch bridge with masonry arch extension. There are masonry parapets on both sides of the carriageway. The rise of arch barrel at crown is 3.74m. The structure carries N56 over the River Glenna. The Plate 2-5 shows the south elevation.

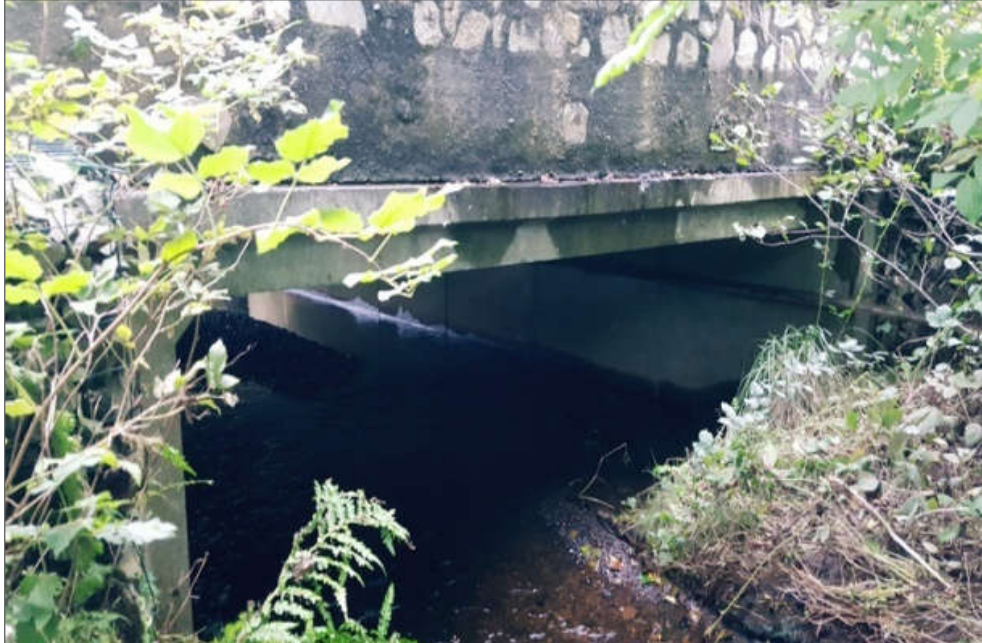
**Plate 2-6 N56 Barnes Bridge.**

The N56 Barnes Bridge is a 4.2m single span reinforced concrete structure. The bridge is a portal structure constructed of precast inverted U-shaped units on concrete base. There are steel safety barriers before the masonry parapets on both sides of the carriageway. The structure is located 3.2km upstream of the Leannan River SAC and 10.4km upstream of the Lough Fern SPA. Plate 2-6 shows the west elevation.

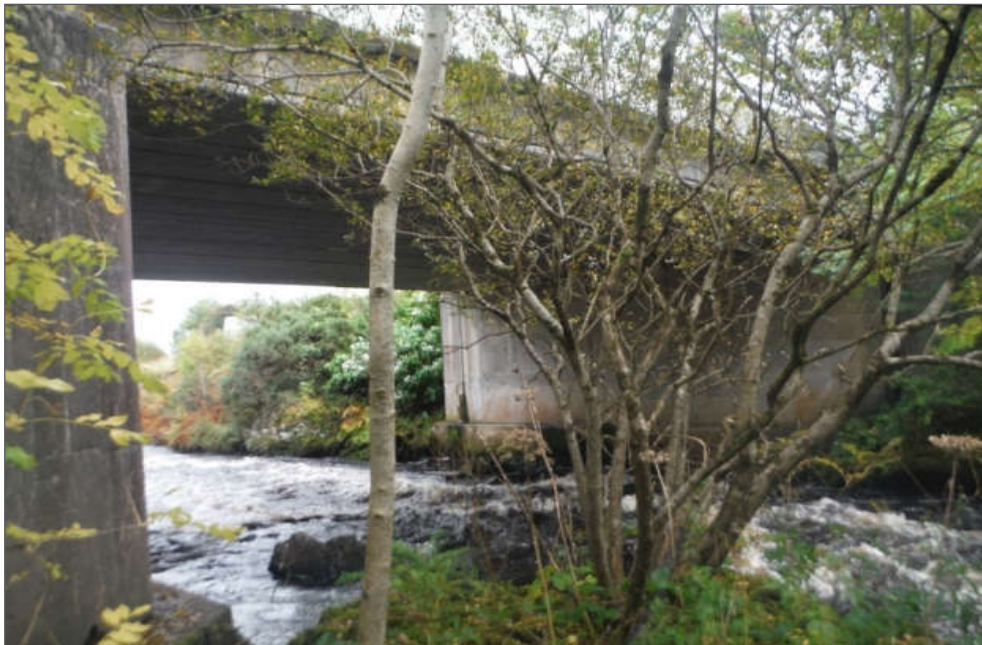
**Plate 2-7 Milltown Bridge.**

The Milltown Bridge is a 14.59m single span reinforced concrete bridge with steel parapets on both sides of the carriageway. The structure carries N56 over the River Leannan. The structure is within the Leannan River SAC and located 3km upstream of the Lough Fern SPA. Plate 2-7 shows the west elevation.

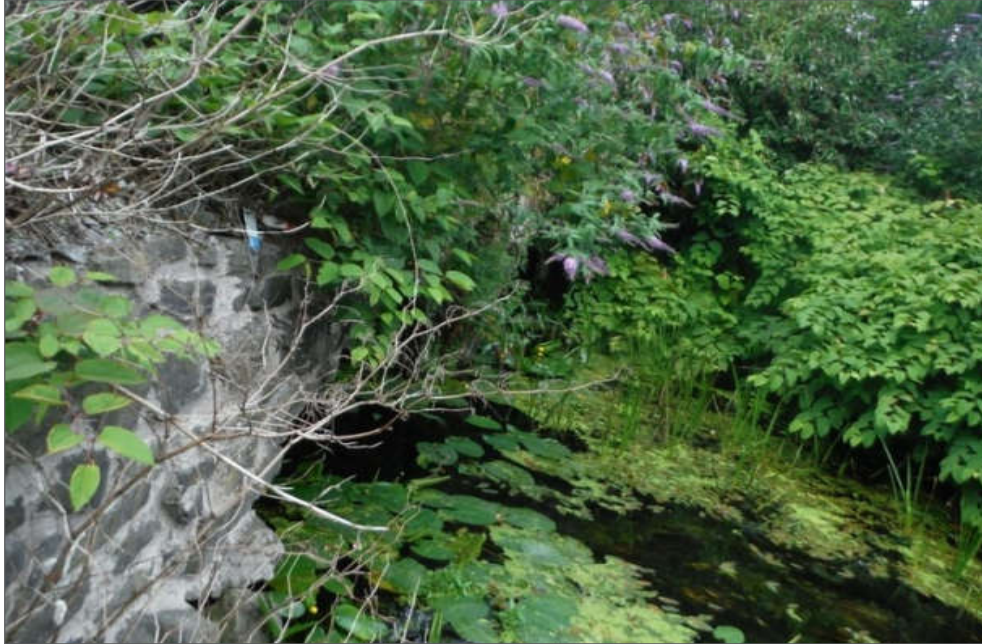
**Plate 2-8 Terryland River Bridge No. 3.**

The structure is comprised of 2 corrugated steel pipes with 2.80m diameter each. Each culvert is in two sections. There is the galvanised corrugated steel pipe 15m in length to the east side and then a 5 degree kink to the second section which is also a corrugated steel pipe but with a bituminous coating. The structure is located 1.2km upstream of the Lough Corrib SAC and 3.7km upstream of the Inner Galway Bay SPA. Plate 2-8 shows the east elevation.

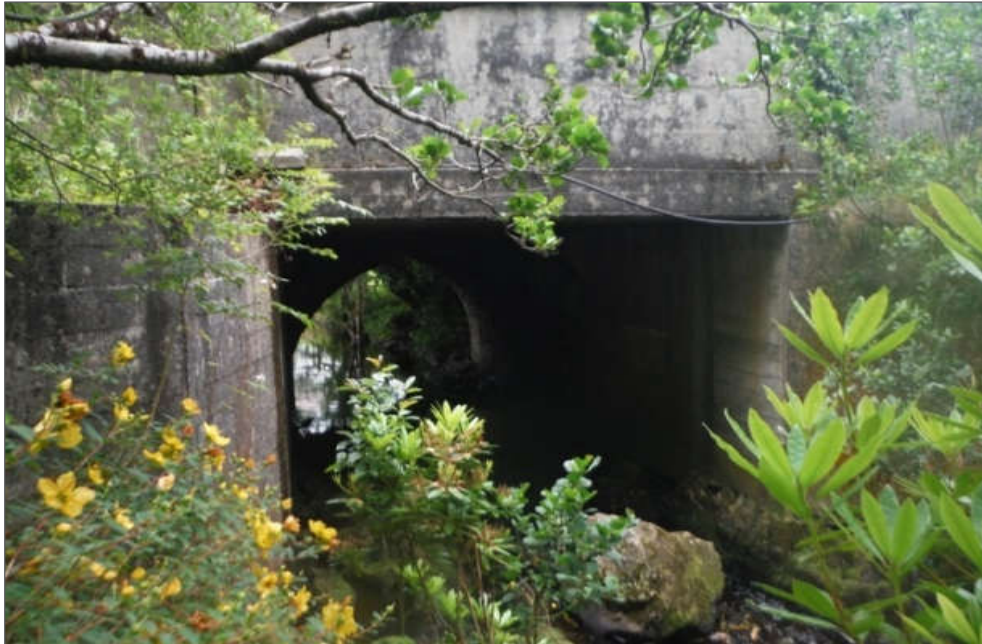
**Plate 2-9 Letterfore Bridge.**

The Letterfore Bridge is a 3.67m single span masonry arch bridge with reinforced concrete extension to north end. The rise of arch barrel at crown is 1.49m. The bridge is located in the Connemara Bog Complex SAC and located 12.6km upstream of the Lough Corrib SPA. Plate 2-9 shows the north elevation.

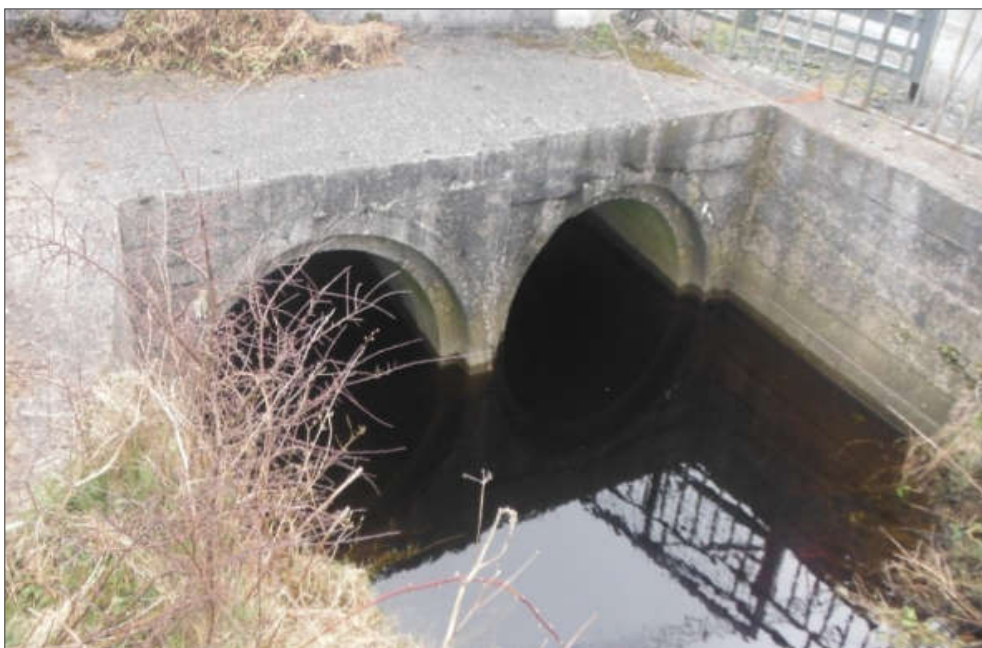
**Plate 2-10 Drinaun Bridge.**

The Drinaun Bridge is comprised of 2 precast reinforced concrete pipes with 1.40m diameter each. There are concrete blockwall parapets on both sides of the carriageway. The structure is located 3.2km upstream of the River Suck Callows SPA. Plate 2-10 shows the north elevation.

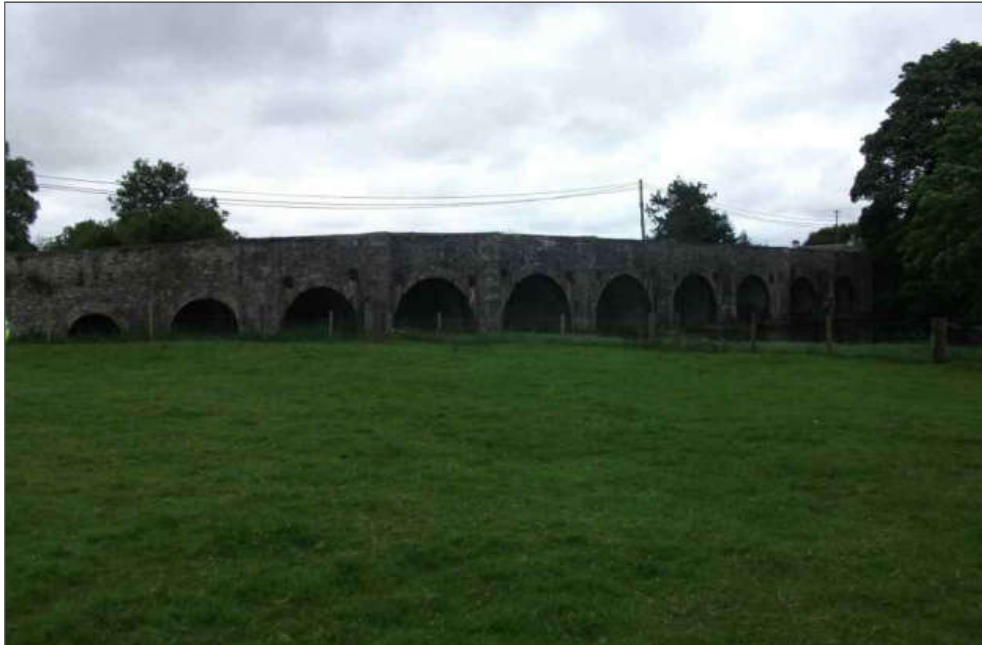
**Plate 2-11** Mount Talbot Bridge.

The Mount Talbot Bridge is a 12-span masonry arch bridge carries N63 over the River Suck. The maximum span is 5.35m and the minimum span is 1.91m. All arches have been shotcreted. Each arch has two tie bars passing through its adjacent spandrel wall. The structure is within the River Suck Callows SPA. Plate 2-11 shows the east elevation.

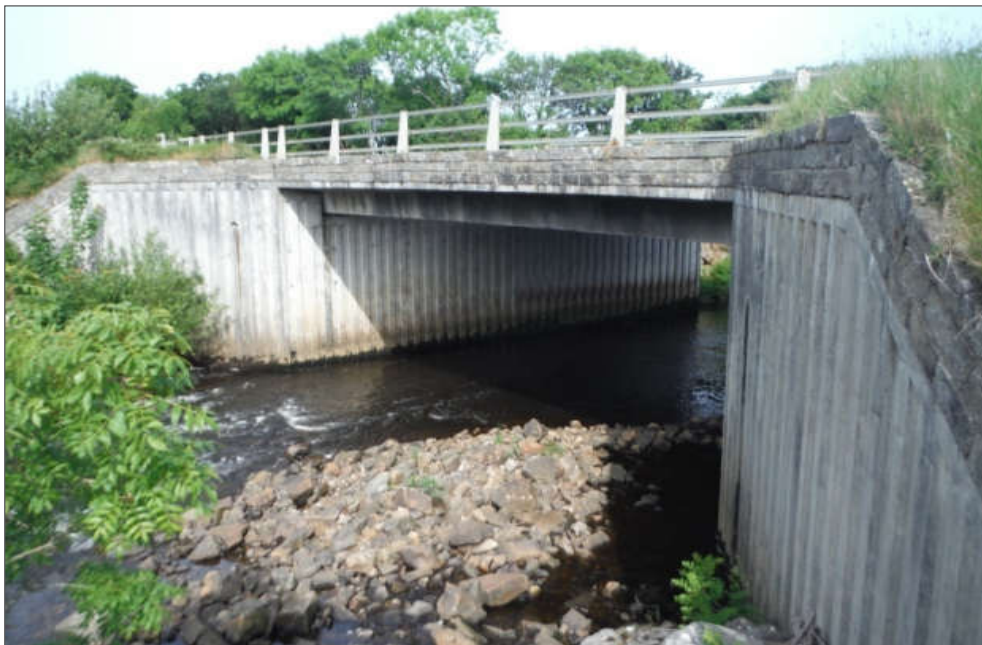
**Plate 2-12** Banduff River Bridge.

The Banduff River Bridge is a 15.5m single span reinforced concrete bridge with steel parapets on both sides of the structure. The structure is within the Bunduff Lough and Machair / Trawalua / Mullaghmore SAC. Plate 2-12 shows the south elevation.

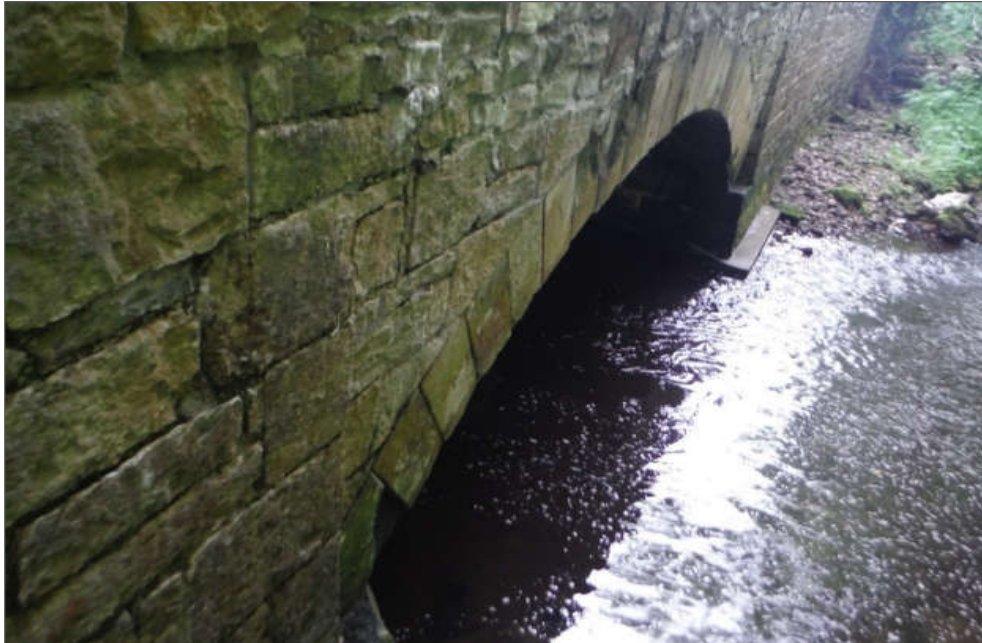
**Plate 2-13** Pollboy Bridge West.

The structure is a 6.1m single span masonry arch bridge with masonry parapets on both sides of the structure. The rise of arch span barrel at crown is 1.25m. The structure is within the Lough Gill SAC. Plate 2-13 shows the north elevation.

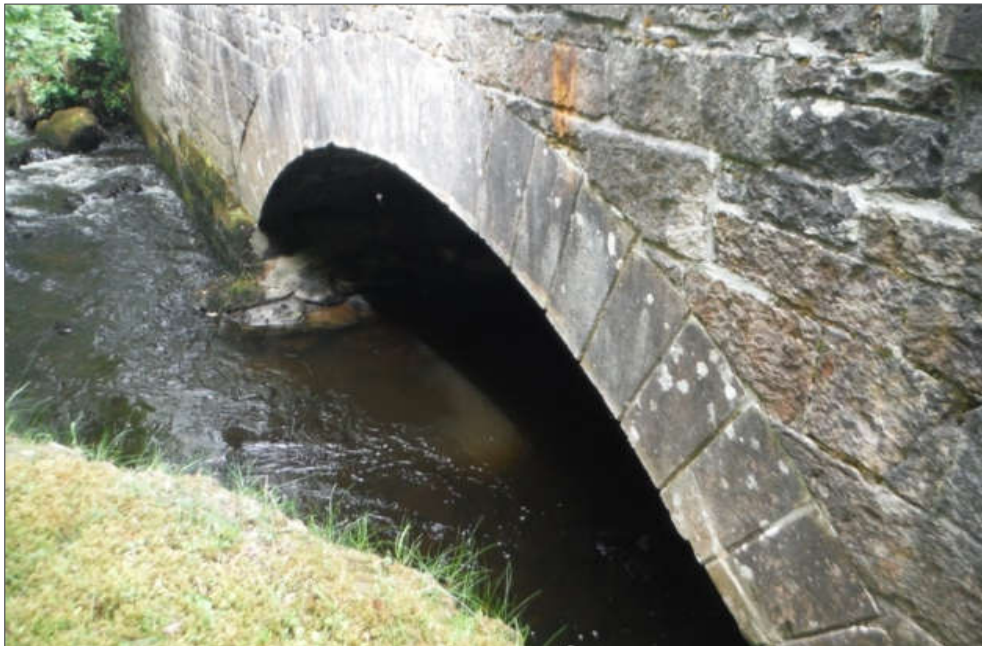
**Plate 2-14** Pollboy Bridge East.

The structure is a 6.1m single span masonry arch bridge with masonry parapets on both sides of the structure. The rise of arch span barrel at crown is 1.26m. The structure is located 0.2km upstream of the Lough Gill SAC. Plate 2-14 shows the south elevation.

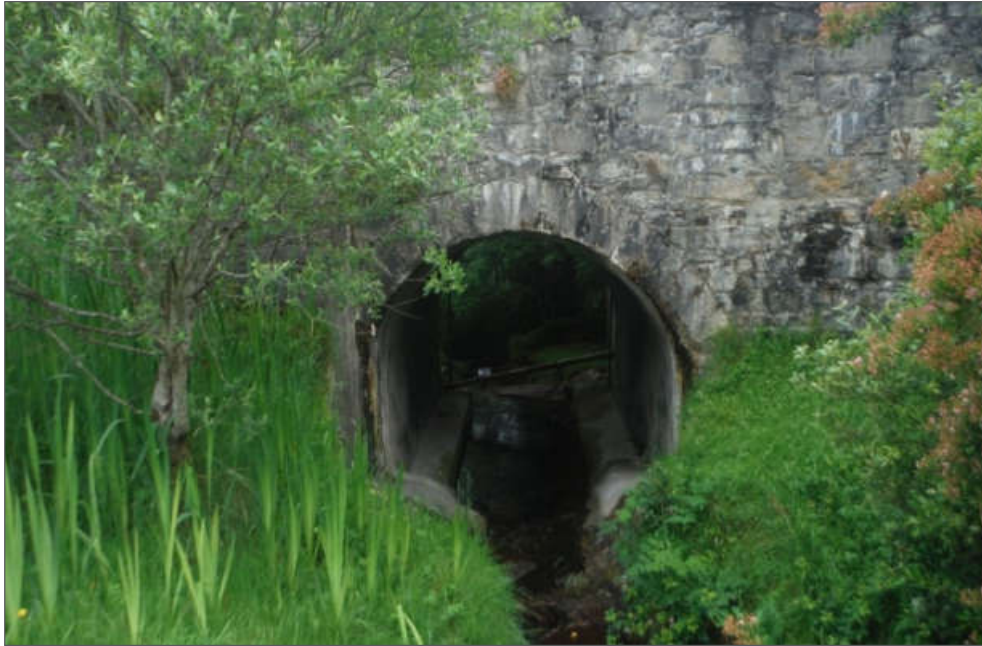
**Plate 2-15** Meenaphuill Bridge.

The structure is a 3.05m single span masonry arch bridge with masonry parapets on both sides of the structure. The rise of arch span barrel at crown is 1.12m. The structure is within the Ben Bulbin, Gleniff and Glenade Complex SAC. Plate 2-15 shows the south elevation.

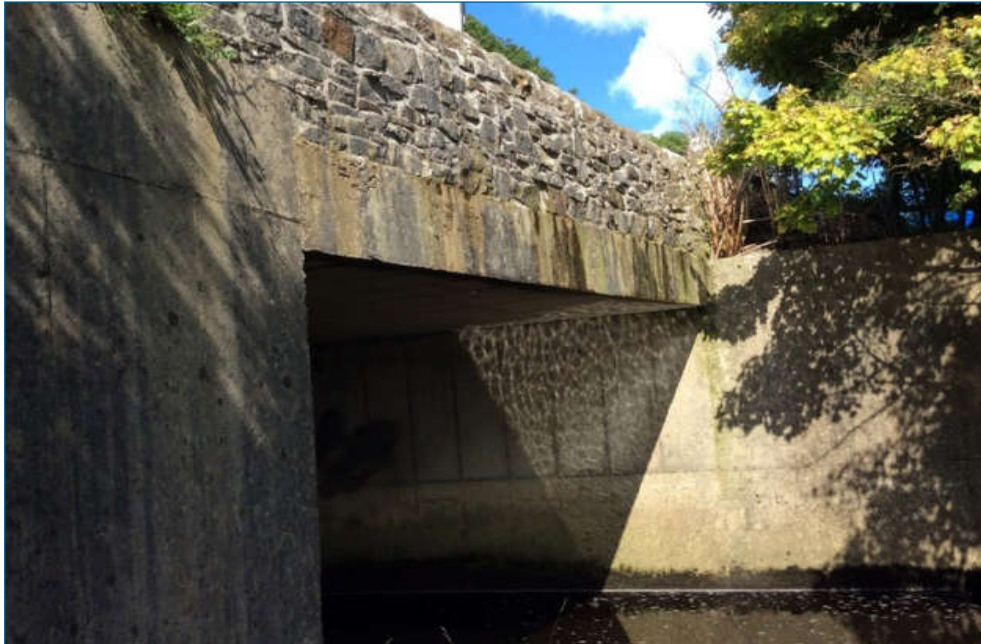
**Plate 2-16 Little River Bridge.**

The Little River Bridge is a 3-span masonry arch bridge with reinforced concrete extension. The maximum span is 3.1m and the minimum span is 1.5m. The RC deck slab is simply supported on both abutments and bears directly onto a 25mm thick timber board. The bridge is located 5.6km upstream of the River Moy SAC. Plate 2-16 shows the north elevation.

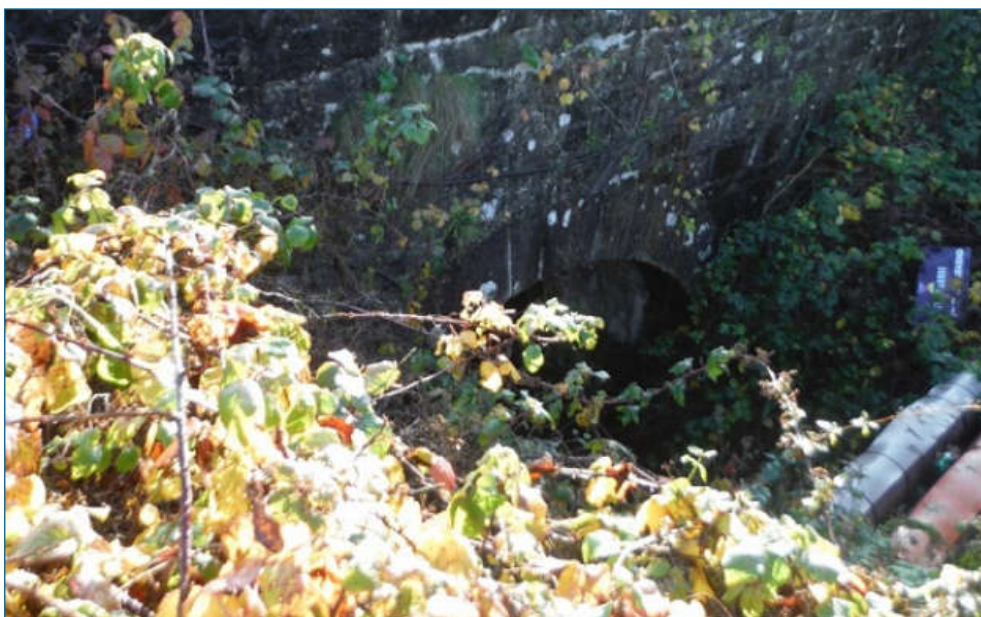
**Plate 2-17 Rahans Bridge.**

The original bridge is a 3.65m single span masonry arch structure. It has been extended by a 1.88m wide masonry arch on the west side and a 1.82m masonry arch on the east side which is extended further by a 2.55m wide corrugated steel arch and a 900mm wide concrete arch. There are masonry parapets on both sides of the carriageway. The structure is located 450m upstream of the River Moy SAC. Plate 2-17 shows the east elevation.

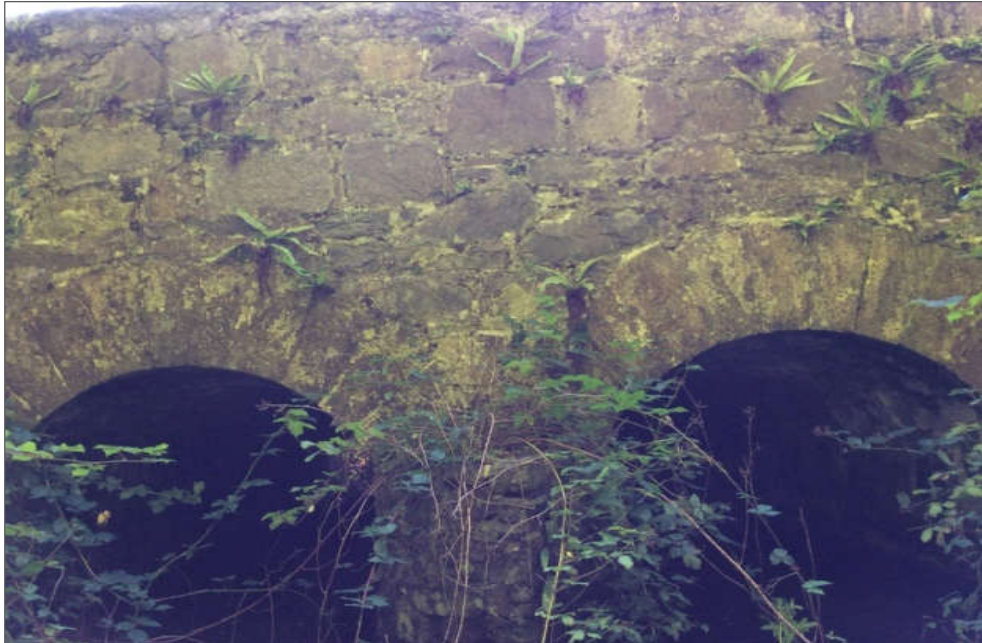
**Plate 2-18 Coolcraun Bridge.**

The Coolcraun Bridge is a 2-span masonry arch bridge with 1.56m span each. The rise of arch barrel at crown is 0.41m. There are masonry parapets on both sides of the carriageway. The structure is located 1.3km upstream of the River Moy SAC. Plate 2-18 shows the east elevation.

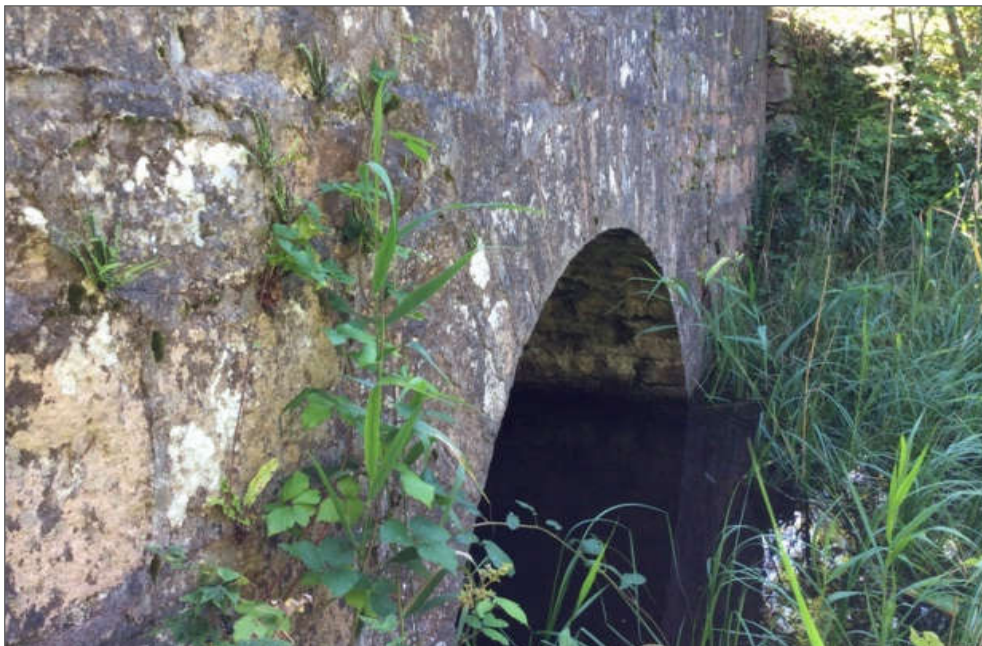
**Plate 2-19 Carrick Bridge.**

The Carrick Bridge is a 3.35m single span masonry arch bridge with masonry parapets on both sides of the carriageway. The rise of arch barrel at crown is 1.22m. The structure carries N26 over the Stream Carrow Loughs. The structure is located 2.4km upstream of the River Moy SAC. Plate 2-19 shows the east elevation.

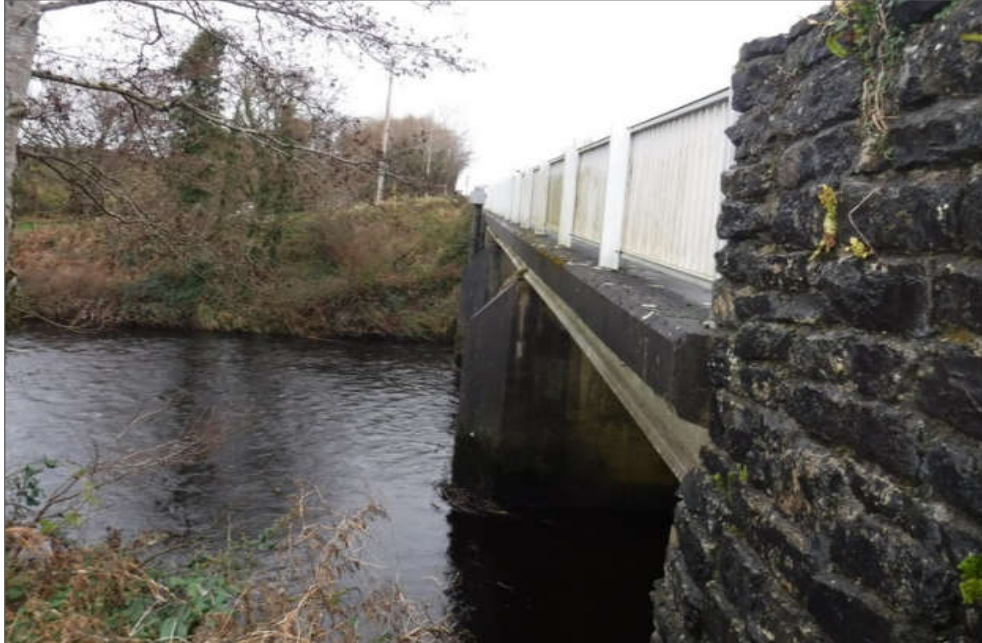
**Plate 2-20** Knockadangan Bridge.

The Knockadangan Bridge is a 3-span reinforced concrete bridge carries N59 over the River Deel. The maximum span is 11.04m and the minimum span is 10.20. There are 24 pre-stressed precast beams in each span of the structure. There are drainage tubes through the deck in the western span. The structure is within the River Moy SAC and located 4.8km upstream of the Lough Conn and Lough Cullin SPA. Plate 2-20 shows the north elevation.

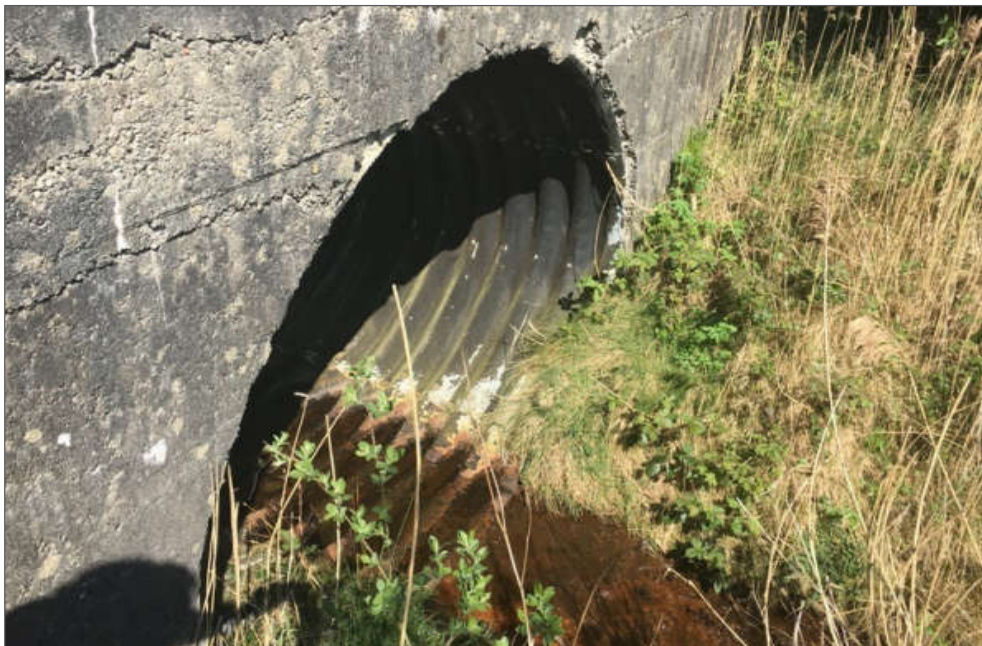
**Plate 2-21** Coolturk Bridge.

The structure is a 3.04m diameter corrugated steel pipe culvert with masonry parapets on both sides of the carriageway. The structure is located 3km upstream of the River Moy SAC. Plate 2-21 shows the south elevation.

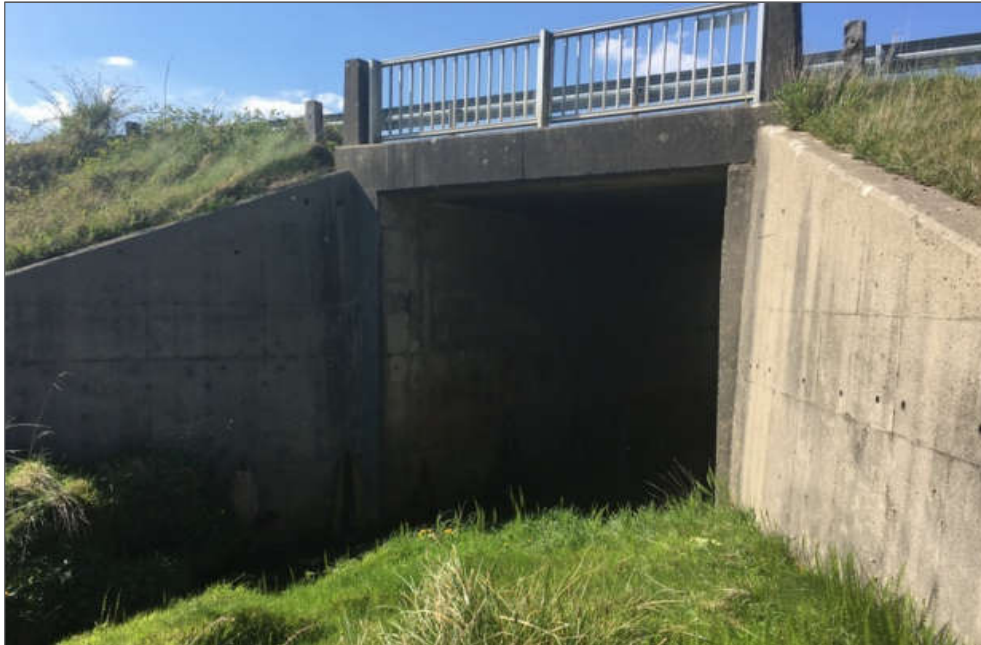
**Plate 2-22** Eskeragh Bridge.

The Eskeragh Bridge is a 4.08m single span in-situ reinforced concrete bridge which carries N59 over the River Fiddaunatooghaun. There are steel safety barriers before the aluminium railing parapets on both sides of the carriageway. The structure is within the Bellacorick Bog Complex SAC. Plate 2-22 shows the south elevation.

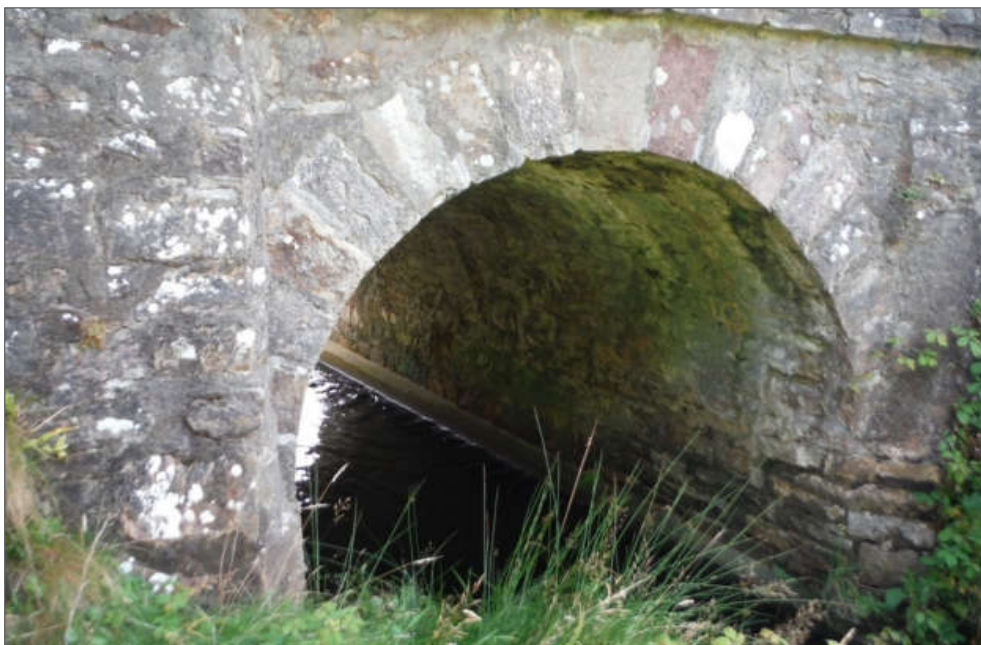
**Plate 2-23** Lagduff Bridge.

The structure is a 2.43m single span masonry arch bridge with masonry parapets on both sides of the carriageway. The rise of arch barrel at crown is 1.21m. The structure is within the Owenduff/Nepin Complex SPA. Plate 2-23 shows the east elevation.

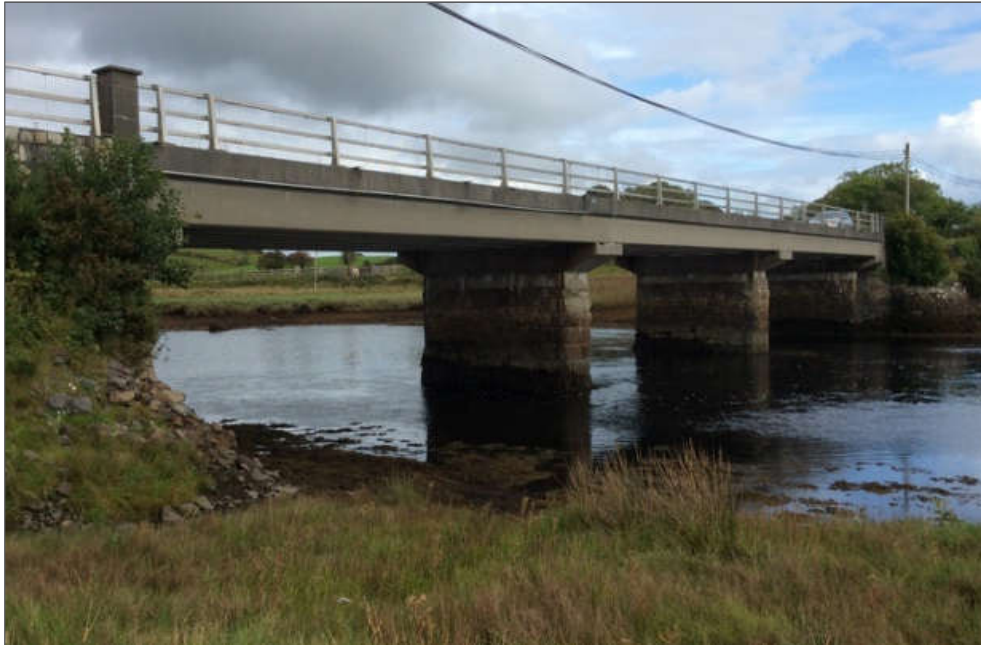
**Plate 2-24 Burrishoole Bridge.**

The Burrishoole Bridge is a 3-span reinforced concrete bridge with aluminium railing parapets on both sides of the carriageway. The deck consists of 6 No. pre-stressed spaced beams with a reinforced concrete deck slab. The maximum span is 15.45m and the minimum span is 15.27m. The structure is within the Clew Bay Complex SAC. Plate 2-24 shows the south elevation.

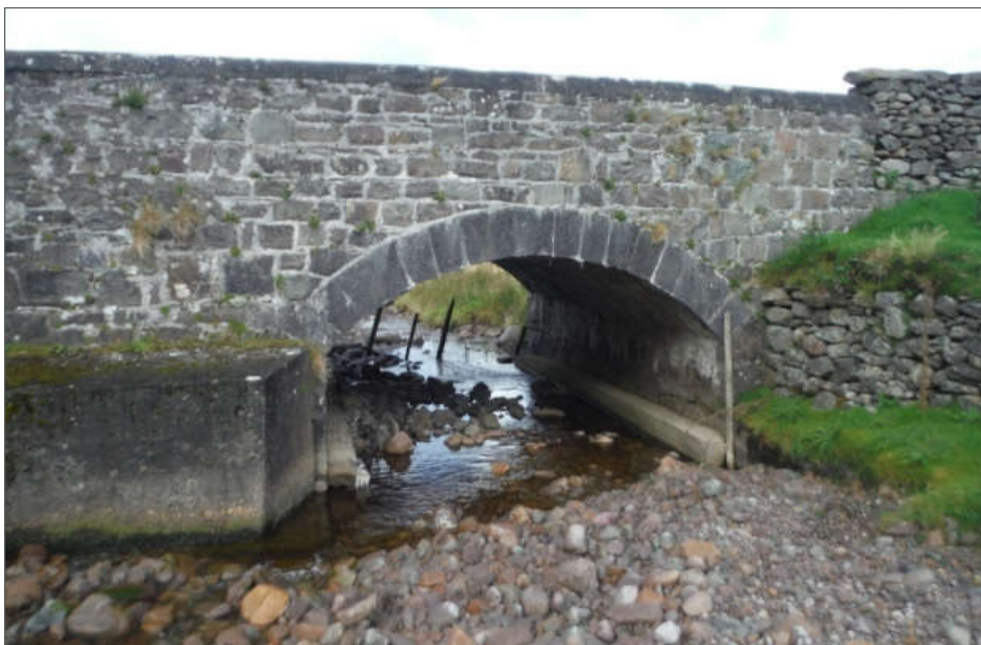
**Plate 2-25 Gowlan Bridge.**

The structure is a 4.02m single span masonry arch bridge with masonry parapets on both sides of the carriageway. The rise of arch barrel at crown is 0.85m. The structure is within the Mweelrea/Sheeffry/Erriff Complex SAC. Plate 2-25 shows the east elevation.

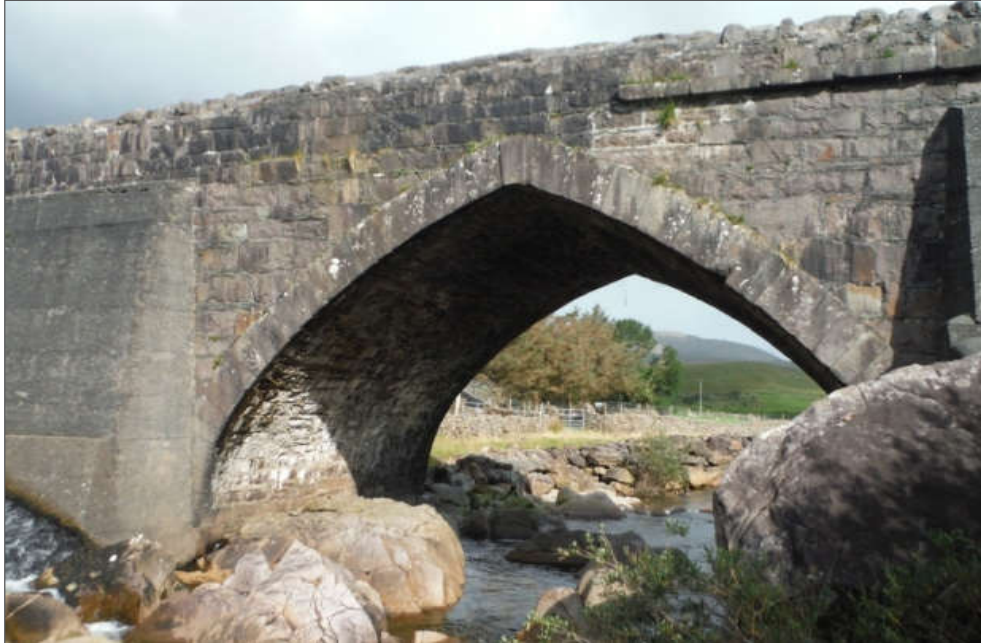
**Plate 2-26** Glenacally Bridge.

The structure is a 9.05m single span masonry arch bridge with masonry parapets on both sides of the carriageway. The rise of arch barrel at crown is 4.8m. Bridge spans a tributary of the Erriff River. The structure is within the Mweelrea/Sheeffry/Erriff Complex SAC. Plate 2-26 shows the south elevation.

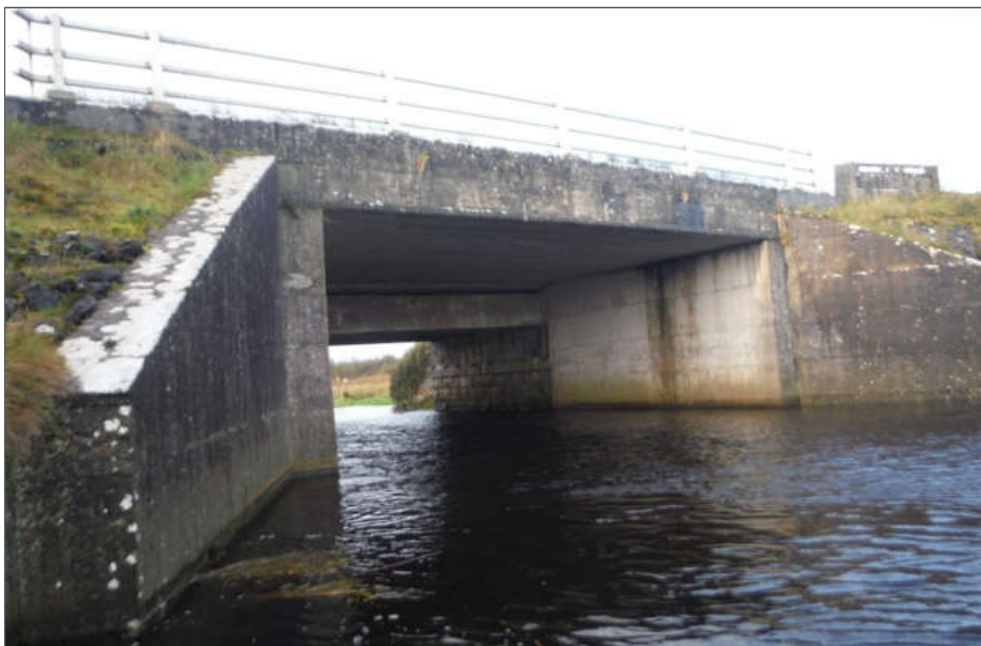
**Plate 2-27** Manulla Bridge.

The Manulla Bridge is a 9.12m single span reinforced concrete bridge with in-situ reinforced concrete extension. There are aluminium railing parapets on both sides of the carriageway. The structure is within the River Moy SAC. Plate 2-27 shows the north elevation.

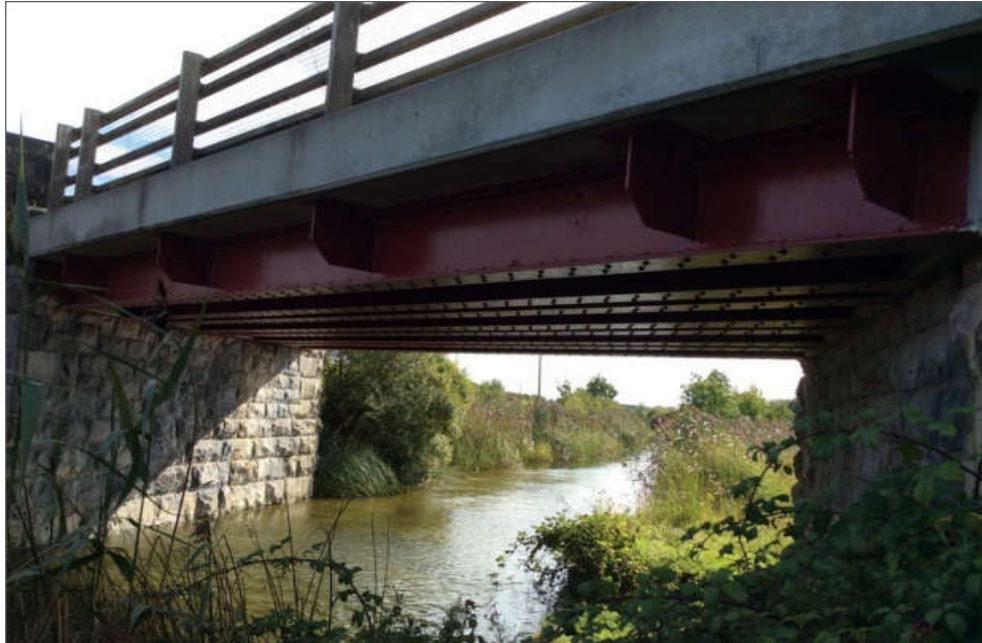
**Plate 2-28**      **Keel Bridge.**

The Keel Bridge is a 11.55m single span steel and concrete composite bridge. There are masonry parapets on both sides of the carriageway. The structure is within the Lough Carra/Mask Complex SAC and Lough Carra SPA. Plate 2-28 shows the east elevation.

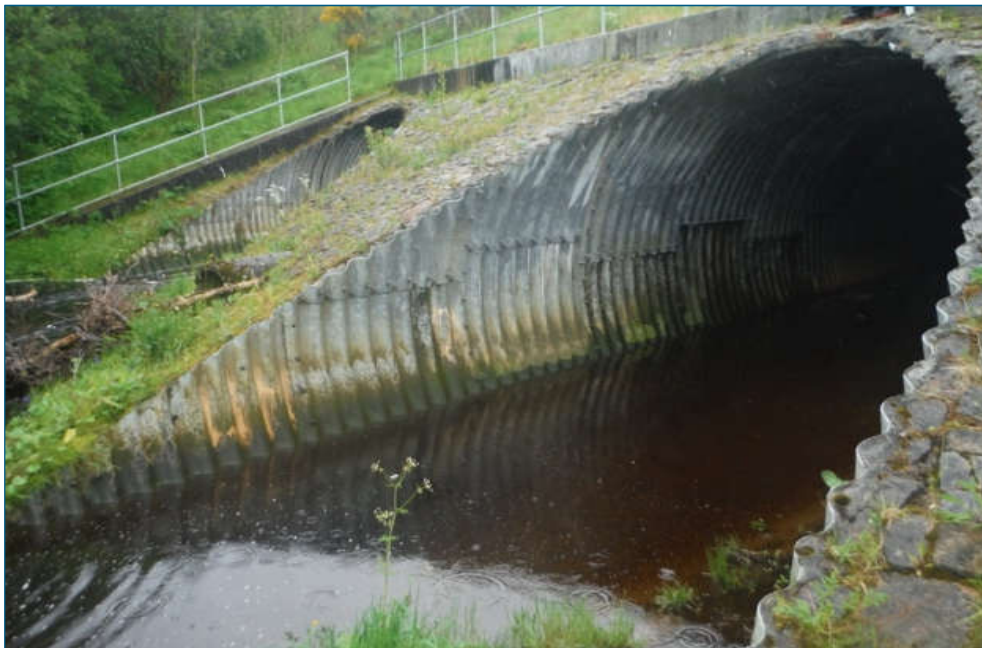
**Plate 5-1 Drumrath Bridge.**

The structure is comprised of 2 corrugated steel pipes with 3.95m diameter each. There is steel safety barrier on both sides of the carriageway and a light steel railing on the headwalls. The structure carries the N15 over the River Drumenny. The structure is within Lough Eske and Ardnamona Wood SAC and located 3.2km upstream of the Donegal Bay SPA. Plate 5-1 shows the east elevation.

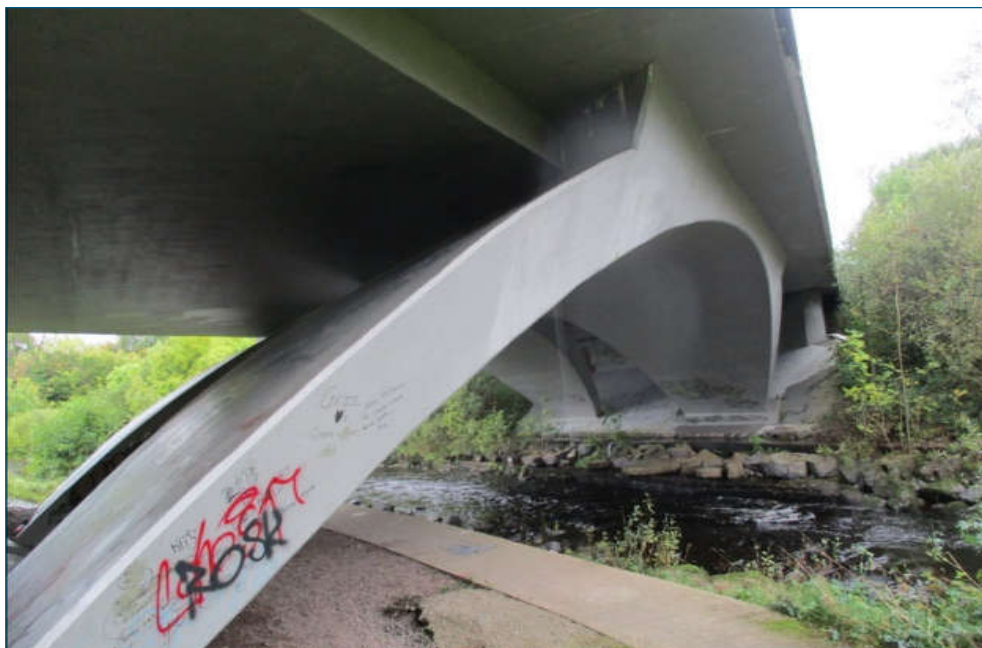
**Plate 5-2 River Eske Bridge.**

The River Eske Bridge is a 3-span reinforced concrete arch bridge. The substructure piers consist of arched columns, with the end spans reinforced concrete slabs spanning from the arch to abutments. The mid-span is 14m and the side spans are 12.4m each. The structure is within Lough Eske and Ardnamona Wood SAC and located 1.7km upstream of the Donegal Bay SPA. Plate 5-2 shows the north elevation.

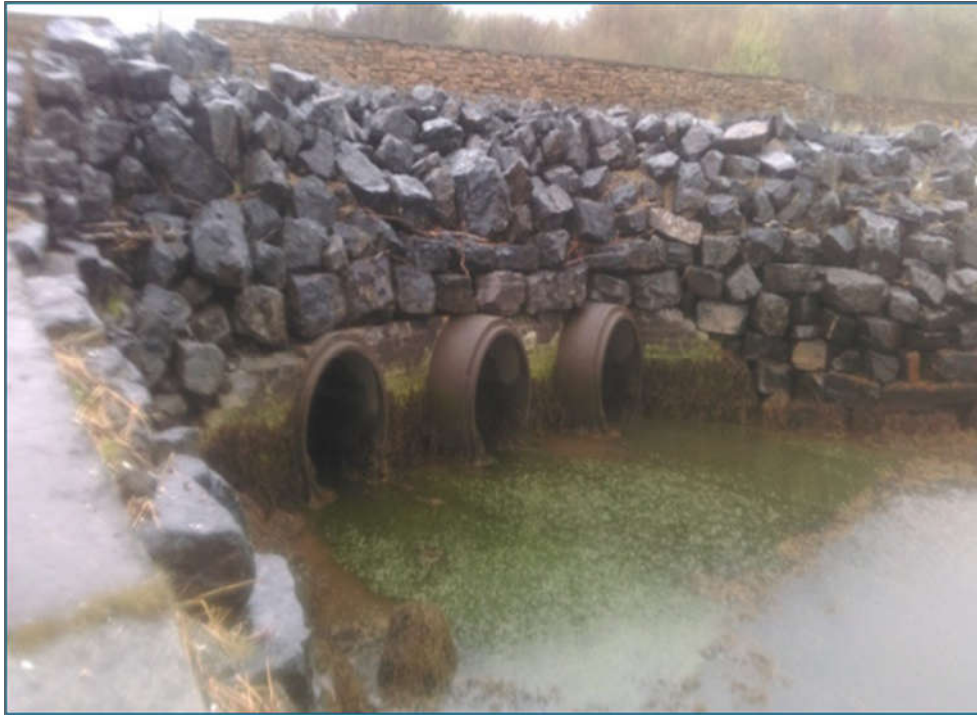
**Plate 5-3 Eddrim Bridge.**

The structure is comprised of 3 precast reinforced concrete pipes with 1.8m diameter each. There are masonry parapets on both sides of the carriageway. The riverbed is tidal. The structure is within the Donegal Bay (Murvagh) SAC and the Donegal Bay SPA. Plate 5-3 shows the south elevation.
