# NW Term Maintenance Contract No.3

Year 1 Structures

Transport Infrastructure Ireland

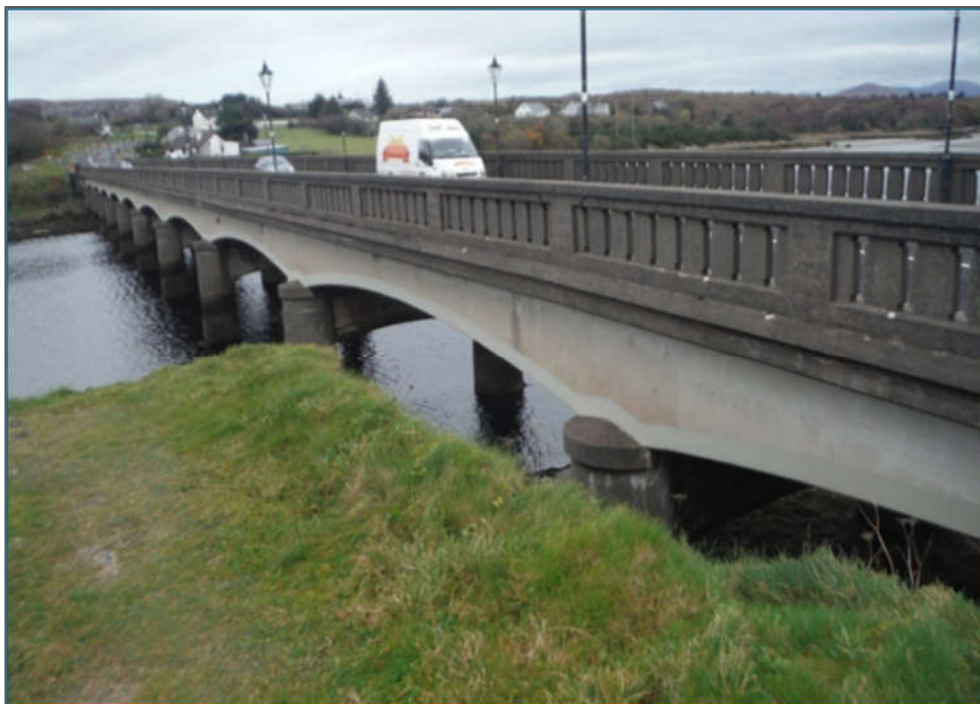
**Plate 5-4 Gweebarra Bridge.**

The Gweebarra Bridge is a 11-span reinforced concrete arch bridge with in-situ concrete parapets on both sides of the carriageway. The maximum span is 18.29m and the minimum span is 8.80m. Spans 3/5/7/9 are suspended spans of 8.64m length. The structure is within the West of Ardara/Maas Road SAC. Plate 5-4 shows the west elevation.

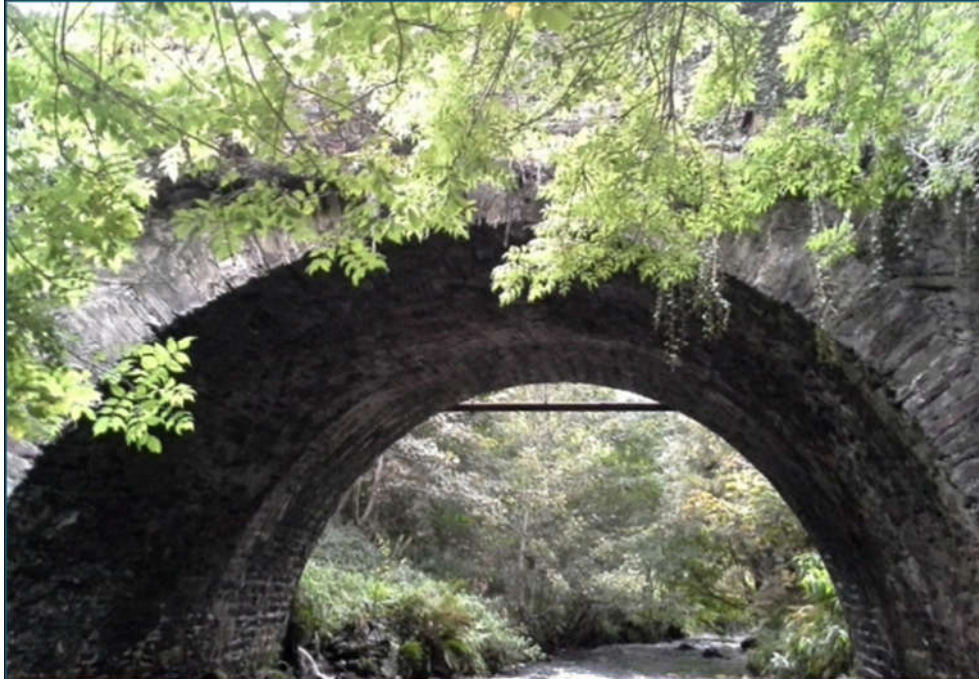
**Plate 5-5 Bedlam Bridge.**

The Bedlam Bridge is a 9.12m single span masonry arch bridge with masonry arch extension. There are masonry parapets on both sides of the carriageway. The rise of arch barrel at crown is 3.74m. The structure carries N56 over the River Glenna. Bedlam Bridge is within the Ballyness Bay SAC. Falcarragh to Meenlaragh SPA is ca. 1.8km downstream of the bridge. The Plate 5-5 shows the south elevation.

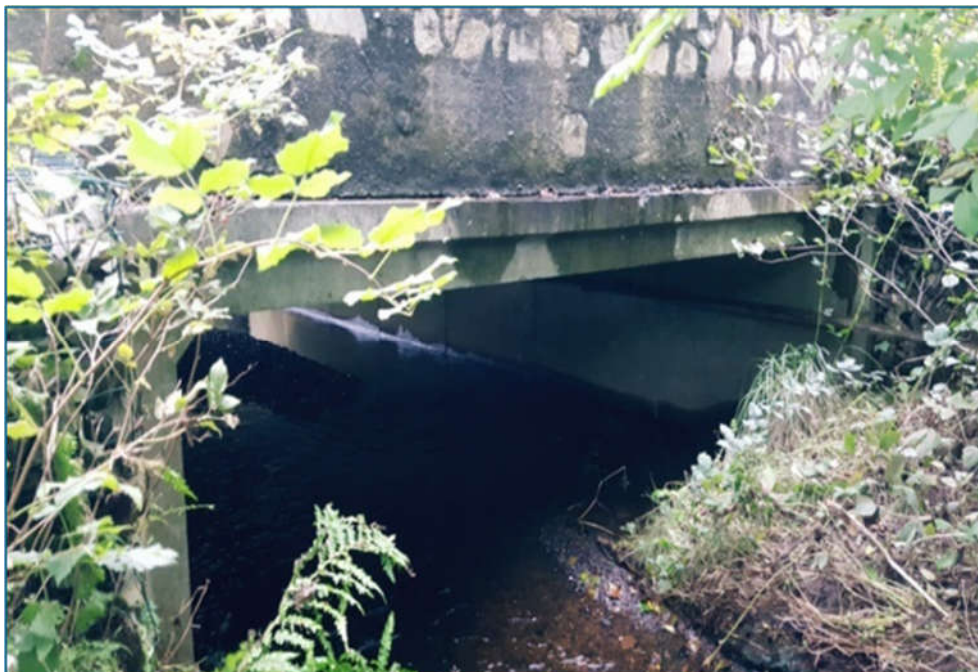
**Plate 5-6 M56 Barnes Bridge.**

The N56 Barnes Bridge is a 4.2m single span reinforced concrete structure. The bridge is a portal structure constructed of precast inverted U-shaped units on concrete base. There are steel safety barriers before the masonry parapets on both sides of the carriageway. The structure is located 3.2km upstream of the Leannan River SAC and 10.4km upstream of the Lough Fern SPA. Plate 5-6 shows the west elevation.

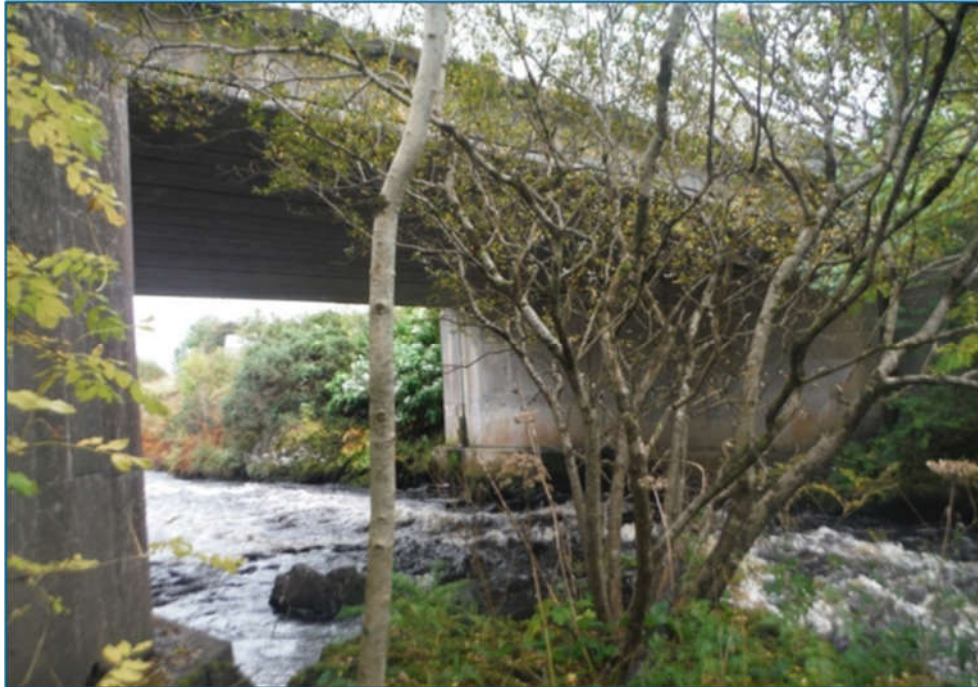
Plate 5-7 Milltown Bridge.

The Milltown Bridge is a 14.59m single span reinforced concrete bridge with steel parapets on both sides of the carriageway. The structure carries N56 over the River Leannan. The structure is within the Leannan River SAC and located 3km upstream of the Lough Fern SPA. Plate 5-7 shows the west elevation.

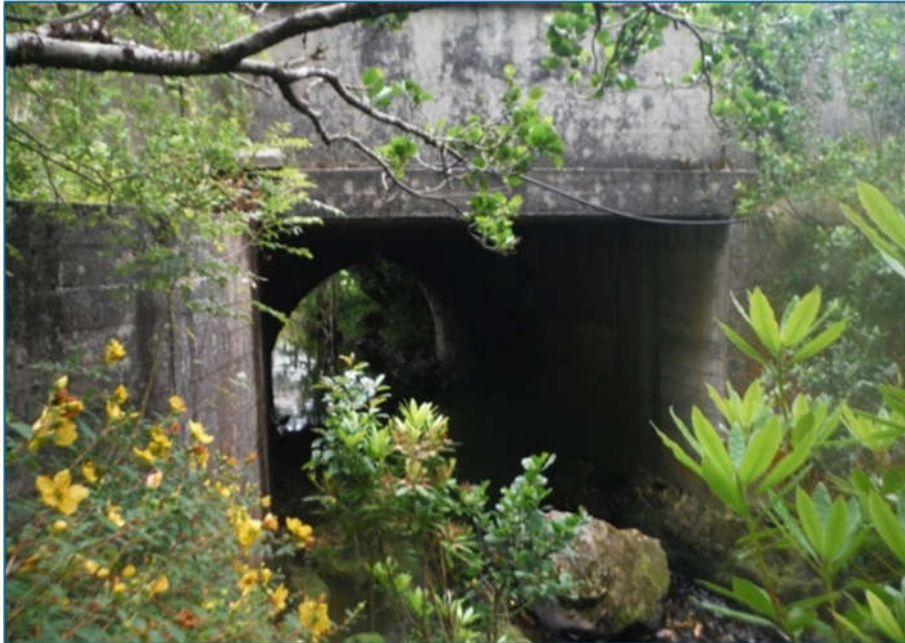
**Plate 5-9 Letterfore Bridge.**

The Letterfore Bridge is a 3.67m single span masonry arch bridge with reinforced concrete extension to north end. The rise of arch barrel at crown is 1.49m. The bridge is located in the Connemara Bog Complex SAC and located 12.6km upstream of the Lough Corrib SPA. Plate 5-9 shows the north elevation.

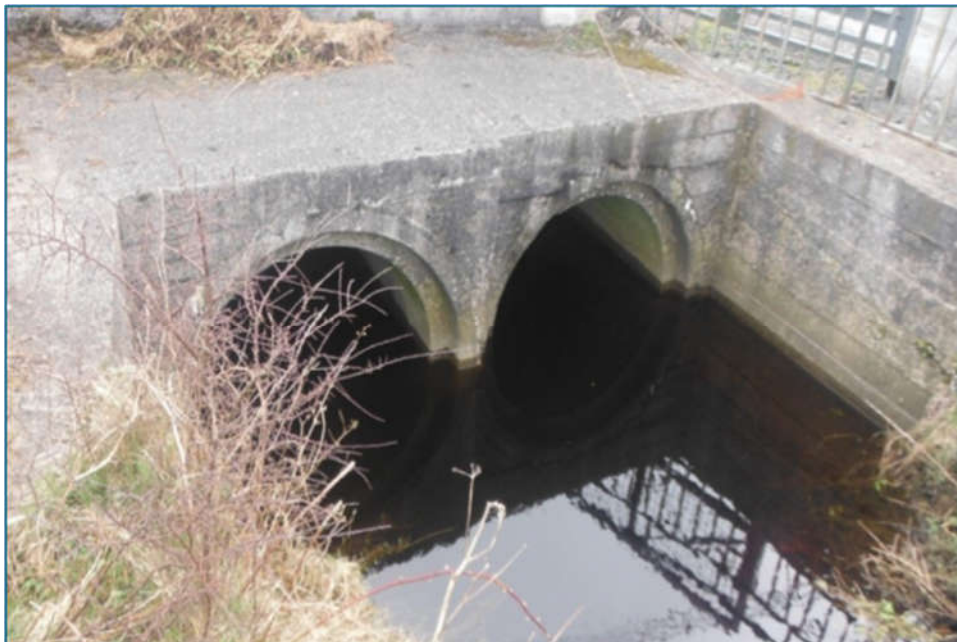
**Plate 5-10 Drinaun Bridge.**

The Drinaun Bridge is comprised of 2 precast reinforced concrete pipes with 1.40m diameter each. There are concrete blockwall parapets on both sides of the carriageway. The structure is located 3.2km upstream of the River Suck Callows SPA. Plate 5-10 shows the north elevation.

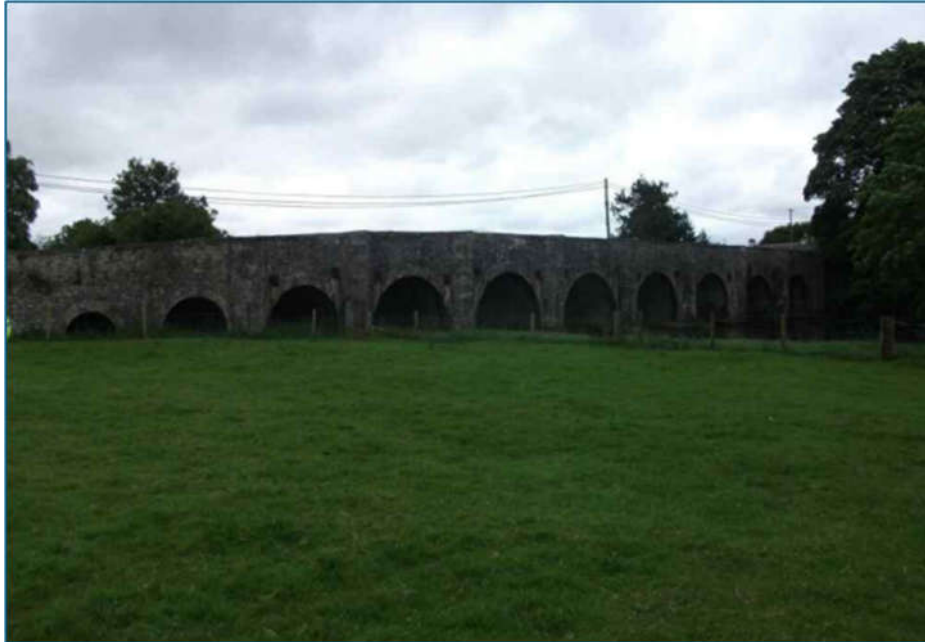
**Plate 5-11 Mount Talbot Bridge.**

The Mount Talbot Bridge is a 12-span masonry arch bridge carries N63 over the River Suck. The maximum span is 5.35m and the minimum span is 1.91m. All arches have been shotcreted. Each arch has two tie bars passing through its adjacent spandrel wall. The structure is within the River Suck Callows SPA. Plate 5-11 shows the east elevation.

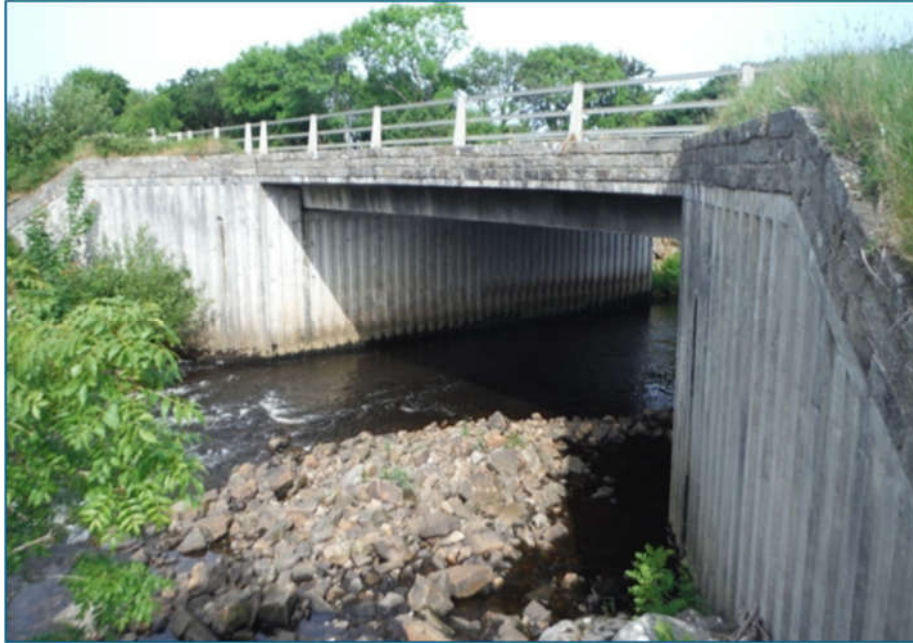
**Plate 5-12 Bunduff River Bridge.**

The Bunduff River Bridge is a 15.5m single span reinforced concrete bridge with steel parapets on both sides of the structure. The structure lies on the inland boundary of the Bunduff Lough and Machair/Trawalua/Mullaghmore SAC. Plate 5-12 shows the south elevation.

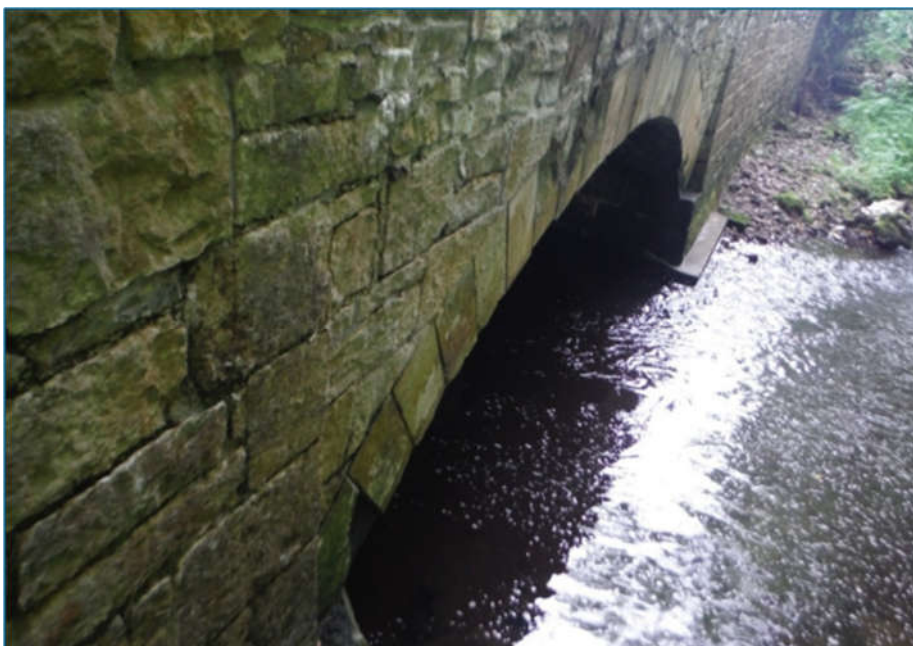
**Plate 5-13**      **Pollboy Bridge West.**

The structure is a 6.1m single span masonry arch bridge with masonry parapets on both sides of the structure. The rise of arch span barrel at crown is 1.25m. The structure is within the Lough Gill SAC. Plate 5-13 shows the north elevation.

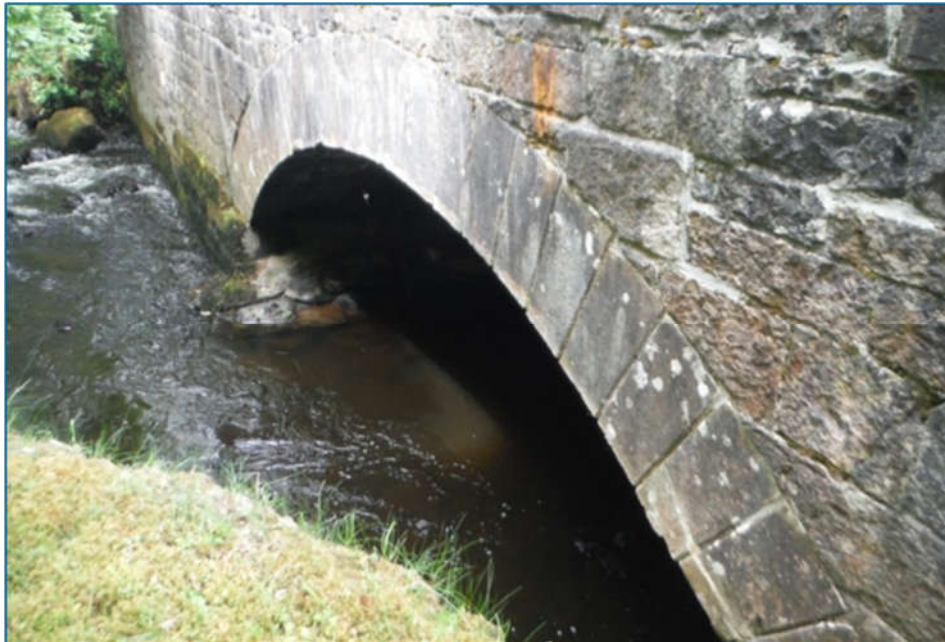
**Plate 5-14 Pollboy Bridge East.**

The structure is a 6.1m single span masonry arch bridge with masonry parapets on both sides of the structure. The rise of arch span barrel at crown is 1.26m. The structure is located 0.2km upstream of the Lough Gill SAC. Plate 5-14 shows the south elevation.

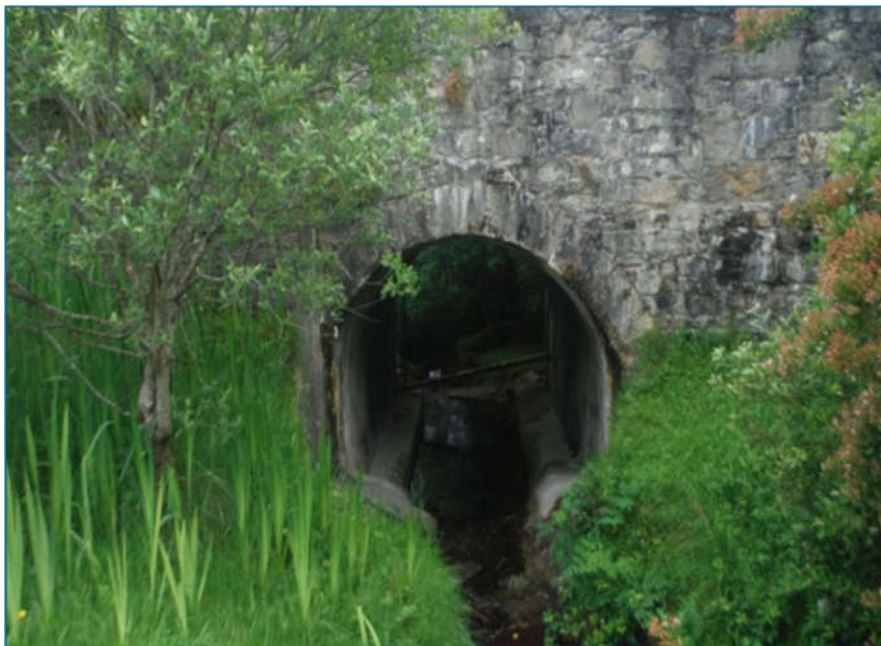
**Plate 5-15 Meenaphuill Bridge.**

The structure is a 3.05m single span masonry arch bridge with masonry parapets on both sides of the structure. The rise of the arch span barrel at the crown is 1.12m. The structure is within the Ben Bulben, Gleniff and Glenade Complex SAC. Plate 5-15 shows the south elevation.

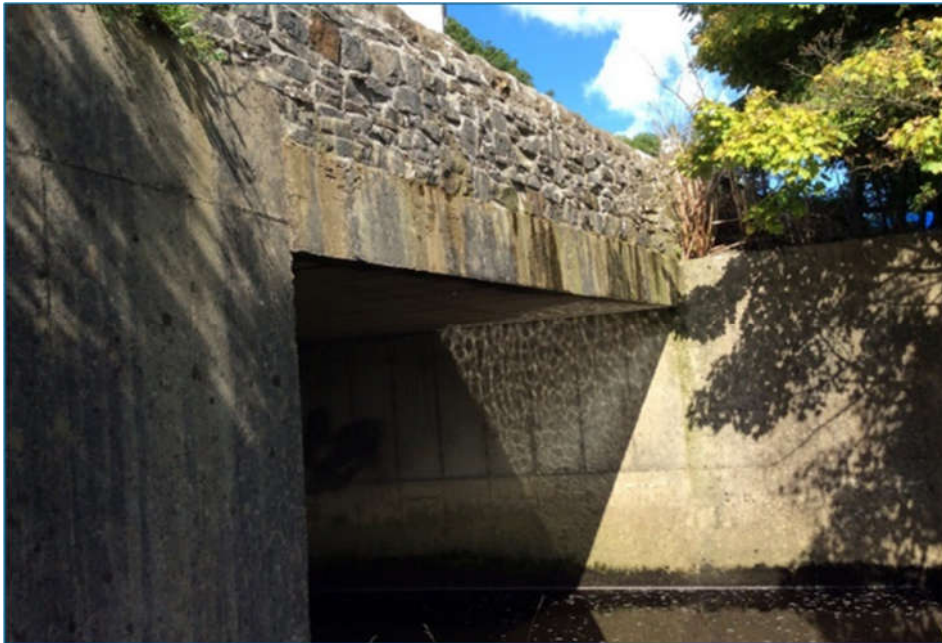
**Plate 5-16 Little River Bridge.**

The Little River Bridge is a 3-span masonry arch bridge with reinforced concrete extension. The maximum span is 3.1m and the minimum span is 1.5m. The Reinforced Concrete deck slab is simply supported on both abutments and bears directly onto a 25mm thick timber board. The bridge is located 5.6km upstream of the River Moy SAC. Plate 5-16 shows the north elevation.

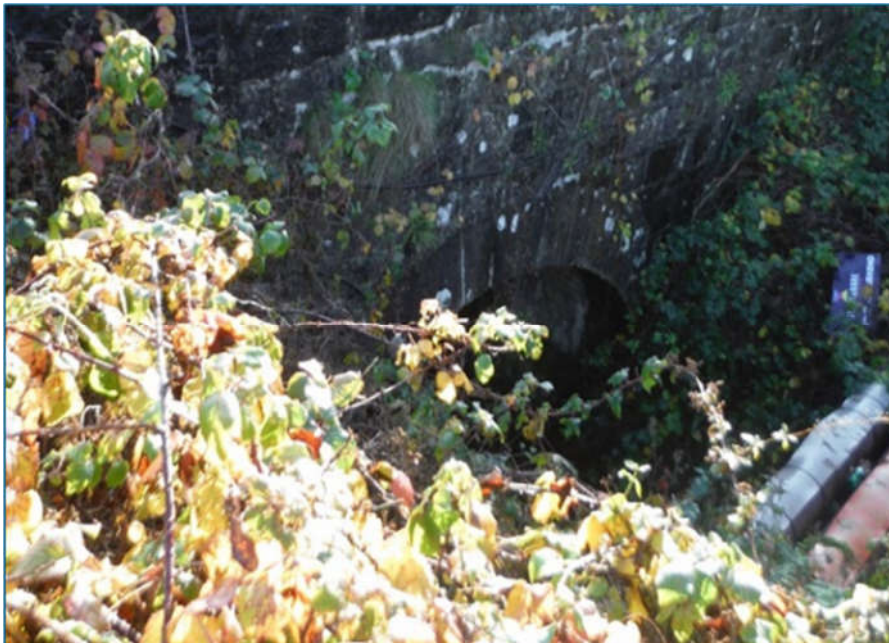
**Plate 5-17 Rahans Bridge.**

The original bridge is a 3.65m single span masonry arch structure. It has been extended by a 1.88m wide masonry arch on the west side and a 1.82m masonry arch on the east side which is extended further by a 2.55m wide corrugated steel arch and a 900mm wide concrete arch. There are masonry parapets on both sides of the carriageway. The structure is located 450m upstream of the River Moy SAC. Plate 5-17 shows the east elevation.

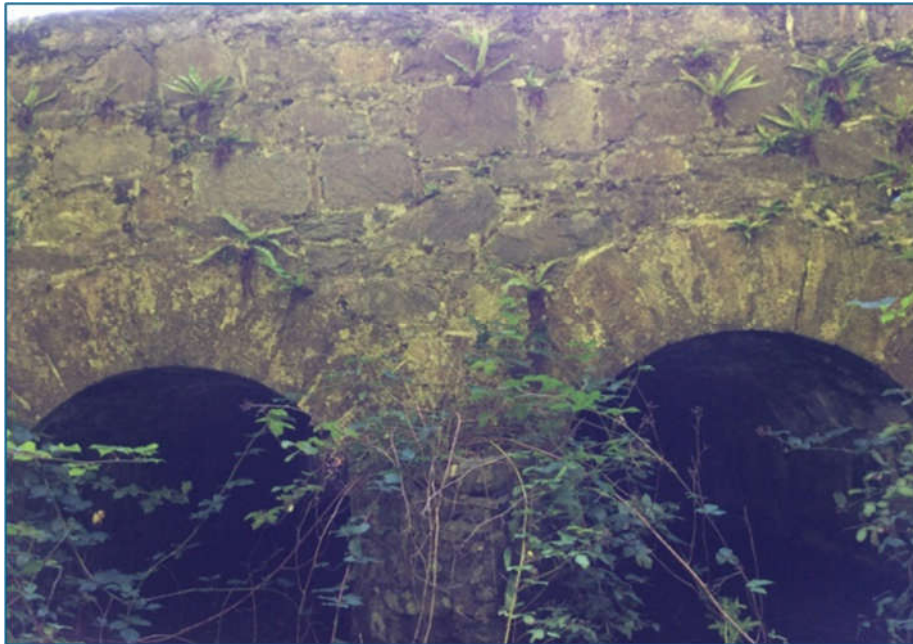
**Plate 5-18 Coolcraun Bridge.**

The Coolcraun Bridge is a 2-span masonry arch bridge with 1.56m span each. The rise of arch barrel at crown is 0.41m. There are masonry parapets on both sides of the carriageway. The structure is located 1.3km upstream of the River Moy SAC. Plate 5-18 shows the east elevation.

Abutments	There is mortar washout throughout and local missing masonry measuring 200mm high x 100mm wide x 200mm deep at the north abutment in span 1 which should be reinstated.	Screened in – use of wet mortar over water and therefore a surface water pathway is present.

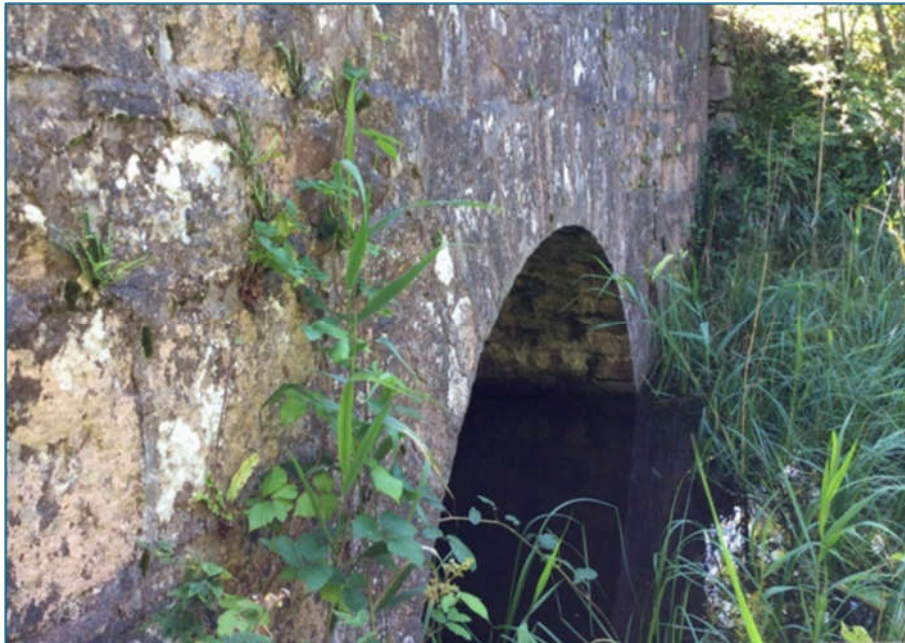
**Plate 5-19 Carrick Bridge.**

The Carrick Bridge is a 3.35m single span masonry arch bridge with masonry parapets on both sides of the carriageway. The rise of arch barrel at crown is 1.22m. The structure carries N26 over the Carrow Loughs stream. The structure is located 2.4km upstream of the River Moy SAC. Plate 5-19 shows the east elevation.

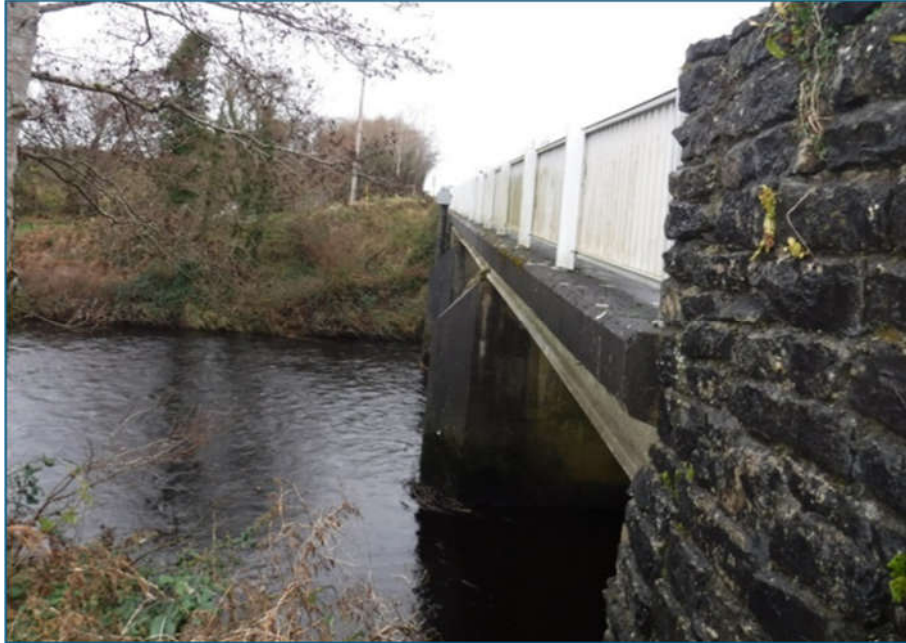
**Plate 5-20 Knockadangan Bridge.**

The Knockadangan Bridge is a 3-span reinforced concrete bridge carries N59 over the River Deel. The maximum span is 11.04m and the minimum span is 10.20m. There are 24 pre-stressed precast beams in each span of the structure. There are drainage tubes through the deck in the western span. The structure is within the River Moy SAC and located 4.8km upstream of the Lough Conn and Lough Cullin SPA. Plate 5-20 shows the north elevation.

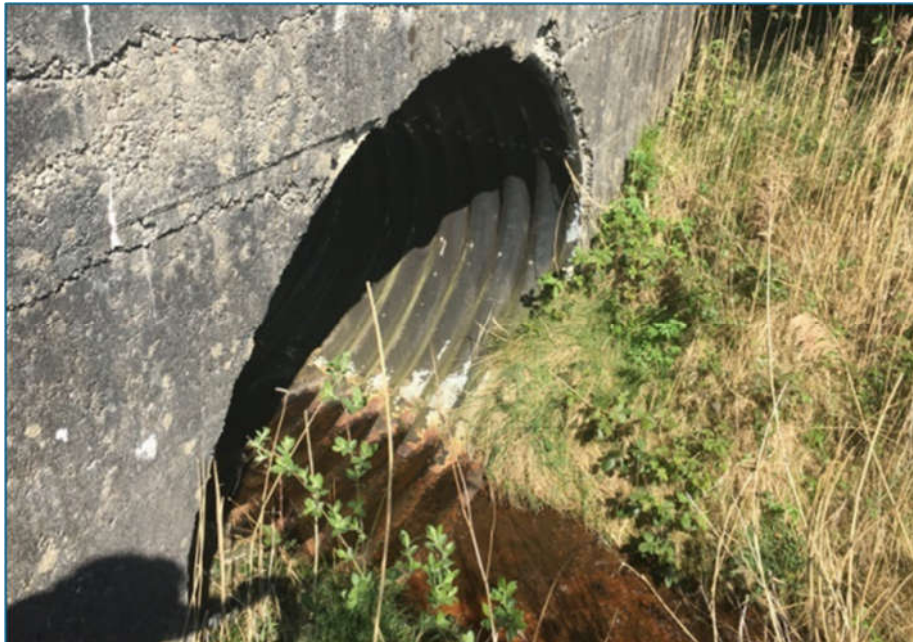
**Plate 5-21 Coolturk Bridge.**

The structure is a 3.04m diameter corrugated steel pipe culvert with masonry parapets on both sides of the carriageway. The structure is located 3km upstream of the River Moy SAC. Plate 5-21 shows the south elevation.

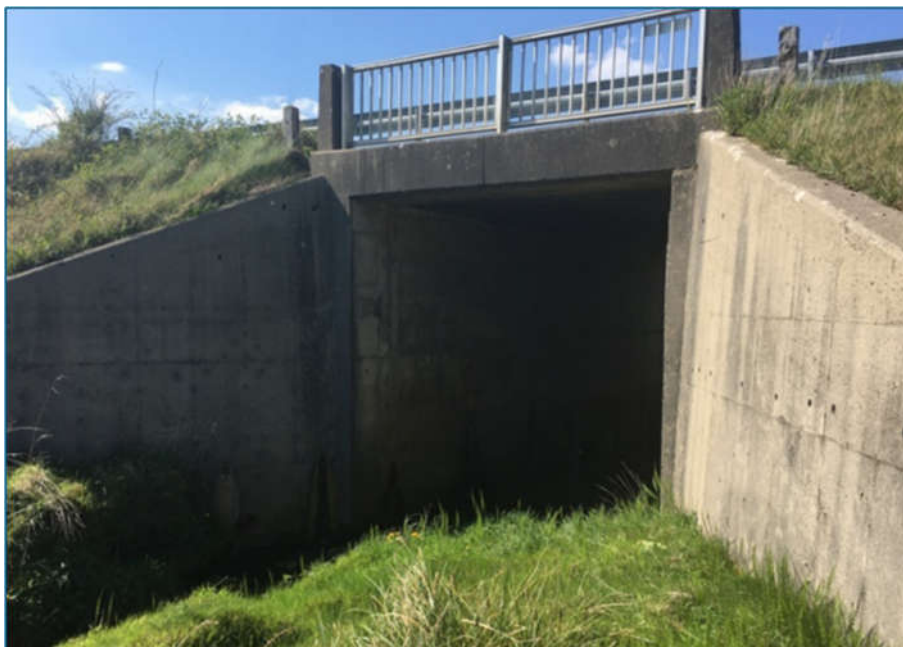
**Plate 5-22 Eskeragh Bridge.**

The Eskeragh Bridge is a 4.08m single span in-situ reinforced concrete bridge which carries N59 over the Fiddaunatooghaun stream. There are steel safety barriers before the aluminium railing parapets on both sides of the carriageway.

The structure is on the boundary of the Bellacorick Bog Complex SAC and the Fiddaunatooghaun stream flows through the SAC. The Fiddaunatooghaun stream flows into the Shavolahan River, which is a tributary of the River Deel. The lower reaches of the River Shavolahan River and the River Deel are within the River Moy SAC. Plate 5-22 shows the south elevation.

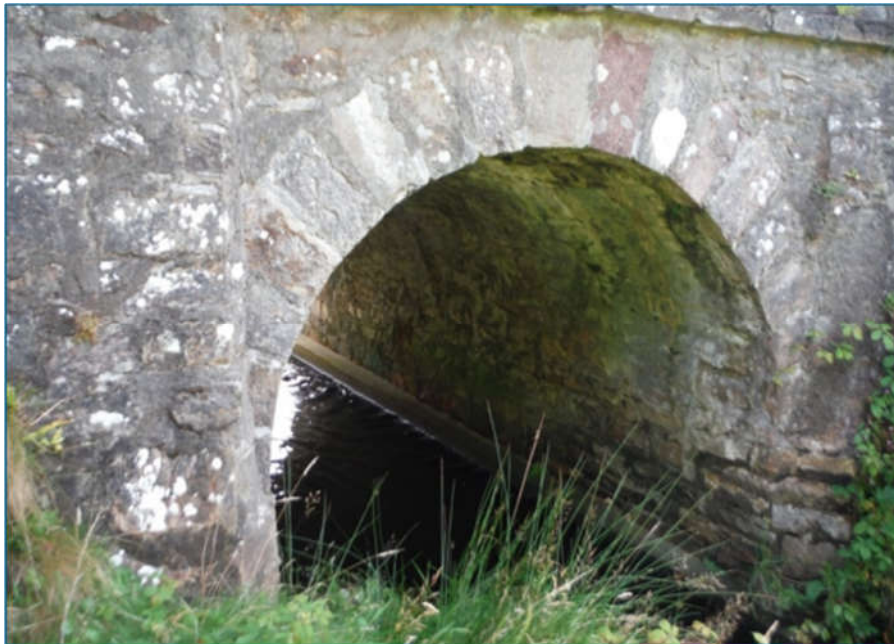
**Plate 5-23 Lagduff Bridge.**

The structure is a 2.43m single span masonry arch bridge with masonry parapets on both sides of the carriageway. The rise of arch barrel at crown is 1.21m. The structure lies on the boundary of the Owenduff/Nepin Complex SAC and the Owenduff/Nepin Complex SPA. This SPA and SAC are predominantly a SAC and SPA that cover the mountain range to the east of the N59. Lagduff Bridge lies on the boundary line of the SAC and SPA.

The bridge spans on a small unnamed stream that flows into Tullaghan Bay. Tullaghan Bay is encompassed by Blacksod Bay/Broadhaven SPA. Therefore, the bridge has surface water connectivity to Blacksod Bay/ Broadhaven SPA. Plate 5-23 shows the east elevation.

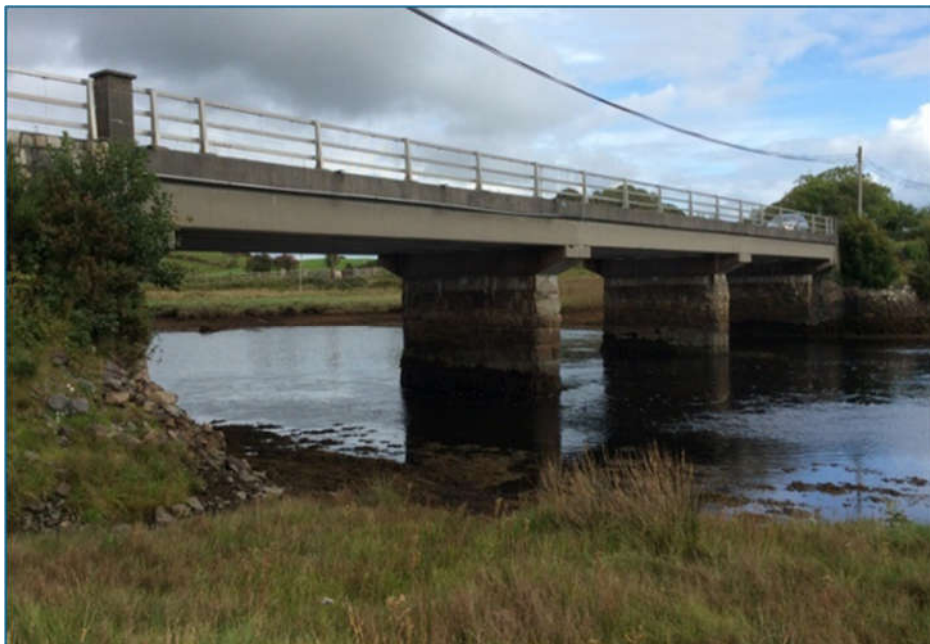
**Plate 5-24 Burrishoole Bridge.**

The Burrishoole Bridge is a 3-span reinforced concrete bridge with aluminium railing parapets on both sides of the carriageway. The deck consists of 6 No. pre-stressed spaced beams with a reinforced concrete deck slab. The maximum span is 15.45m and the minimum span is 15.27m. The structure is within the Clew Bay Complex SAC. Plate 5-24 shows the south elevation.

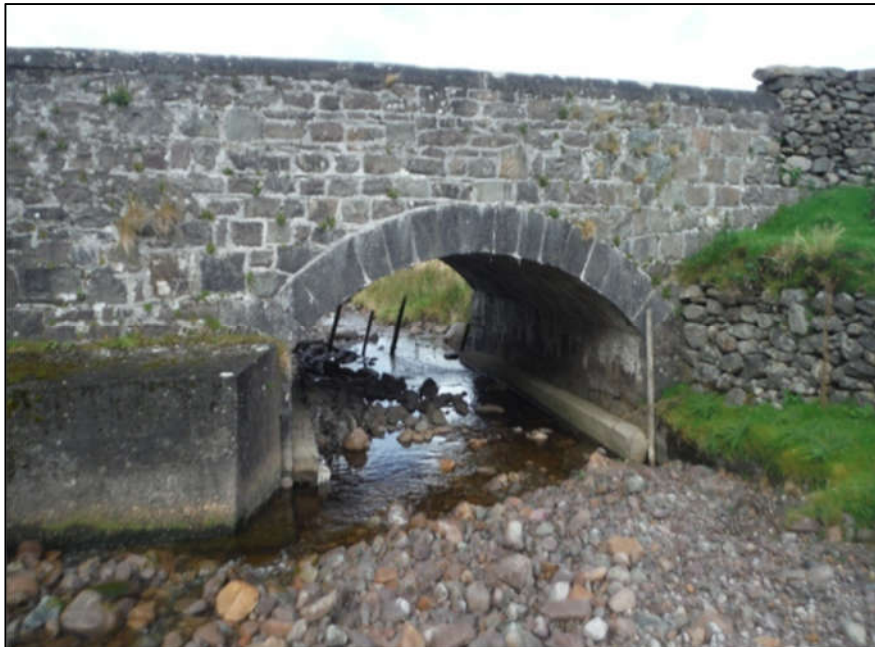
**Plate 5-25 Gowlan Bridge.**

The structure is a 4.02m single span masonry arch bridge with masonry parapets on both sides of the carriageway. The rise of arch barrel at crown is 0.85m. The structure is approximately 50m upstream of the Mweelrea/Sheeffry/Erriff Complex SAC. Plate 5-25 shows the east elevation.

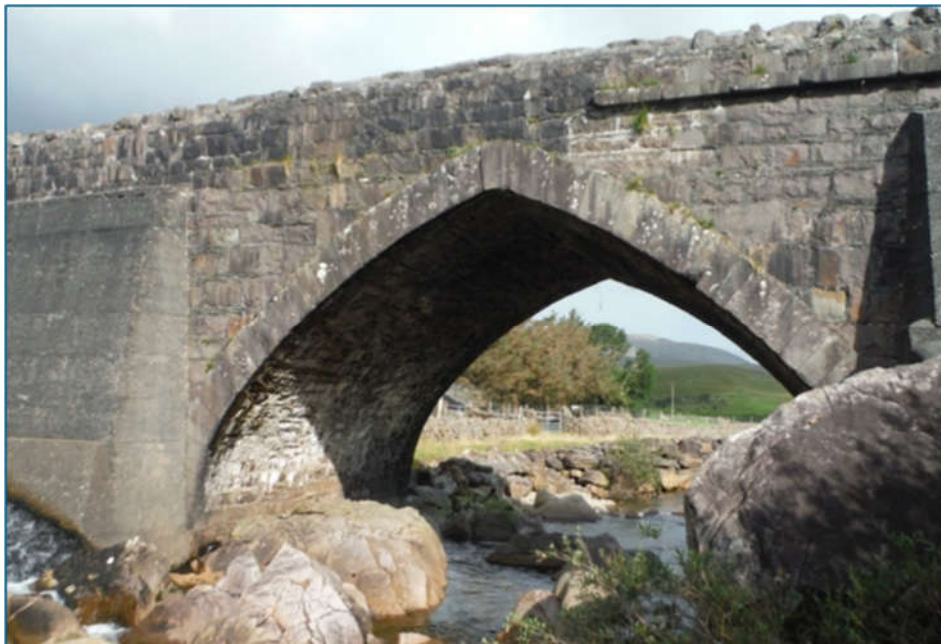
**Plate 5-26 Glenacally Bridge.**

The structure is a 9.05m single span masonry arch bridge with masonry parapets on both sides of the carriageway. The rise of arch barrel at crown is 4.8m. Bridge spans a tributary of the Erriff River. The structure is within the Mweelrea/Sheeffry/Erriff Complex SAC. Plate 5-26 shows the south elevation.

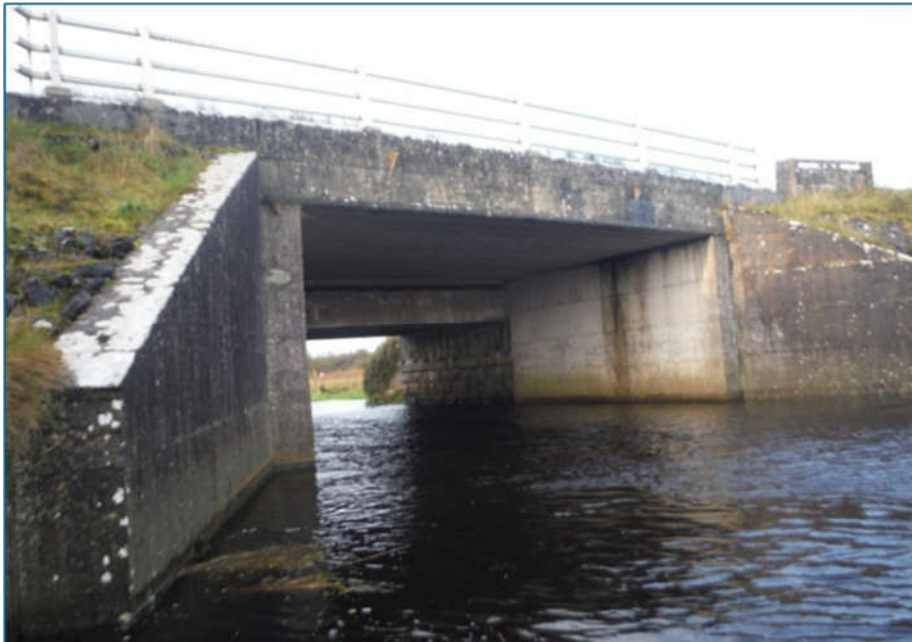
**Plate 5-27 Manulla Bridge.**

The Manulla Bridge is a 9.12m single span reinforced concrete bridge with in-situ reinforced concrete extension. There are aluminium railing parapets on both sides of the carriageway. The structure is within the River Moy SAC. Plate 5-27 shows the north elevation.

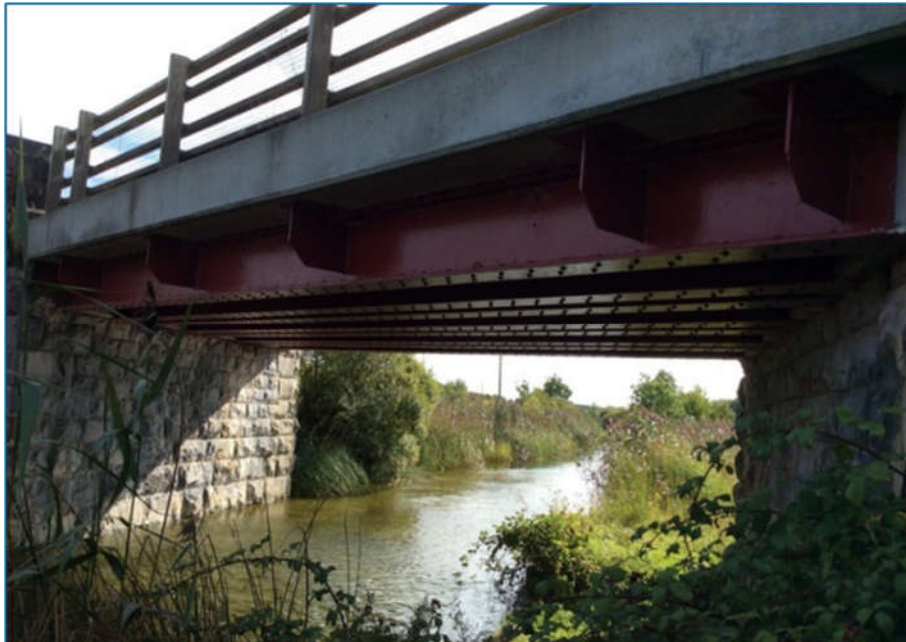
Plate 5-28 Keel Bridge.

The Keel Bridge is a 11.55m single span steel and concrete composite bridge. There are masonry parapets on both sides of the carriageway. The structure is within the Lough Carra/Mask Complex SAC and Lough Carra SPA. Plate 5-28 shows the east elevation.
